Schools caught in the crossfire:

Documenting damage to Myanmar's education system since the coup

REPORT BY MYANMAR WITNESS, 10 July 2024

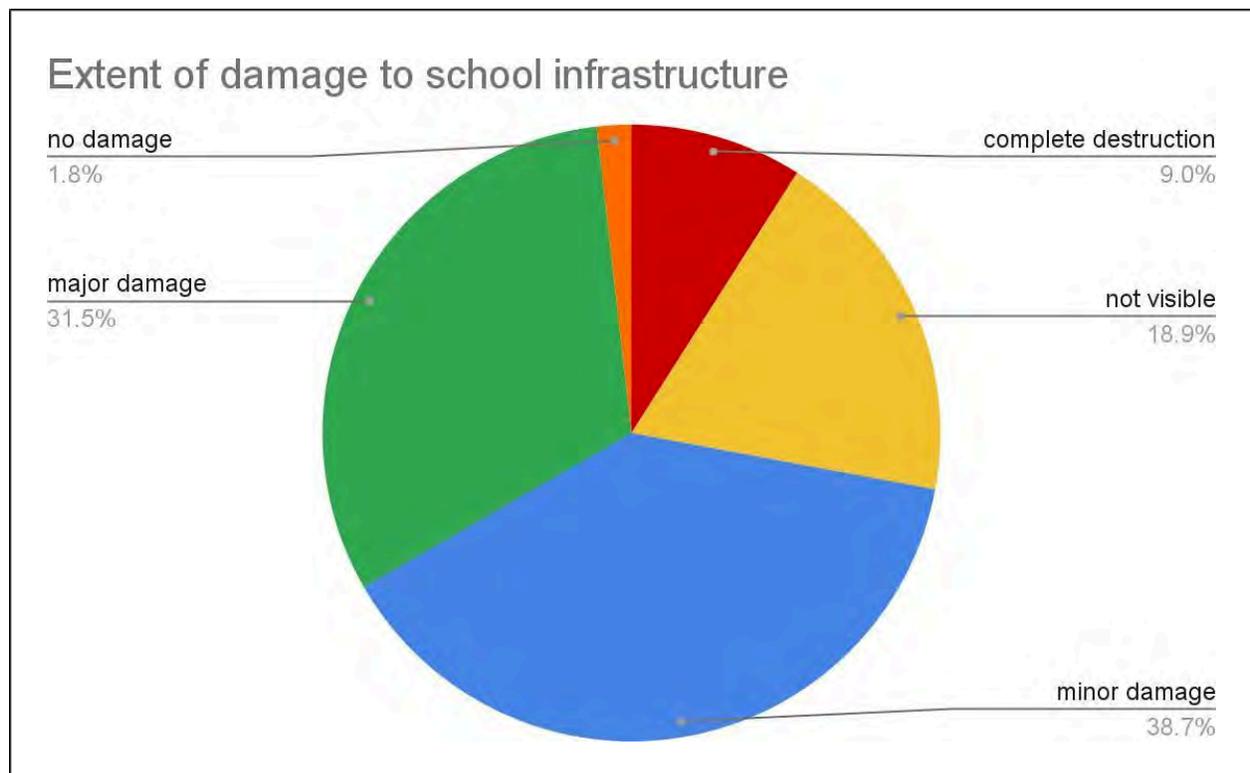
- 43 incidents (38.7%) had minor damage (e.g. bullet holes or minor damage to walls and school gate; school facility may remain operable)
- 35 incidents (31.5%) had major damage (e.g. such as severe roofing and wall damage that rendered the school potentially inoperable)
- 21 incidents (18.9%) were categorised as damage 'not visible' (e.g. UGC not available showing the surrounding area)
- 10 incidents (9%) were completely destroyed

Figure 4: Pie chart showing the proportion of schools that suffered from varying levels of damage, from the primary dataset.

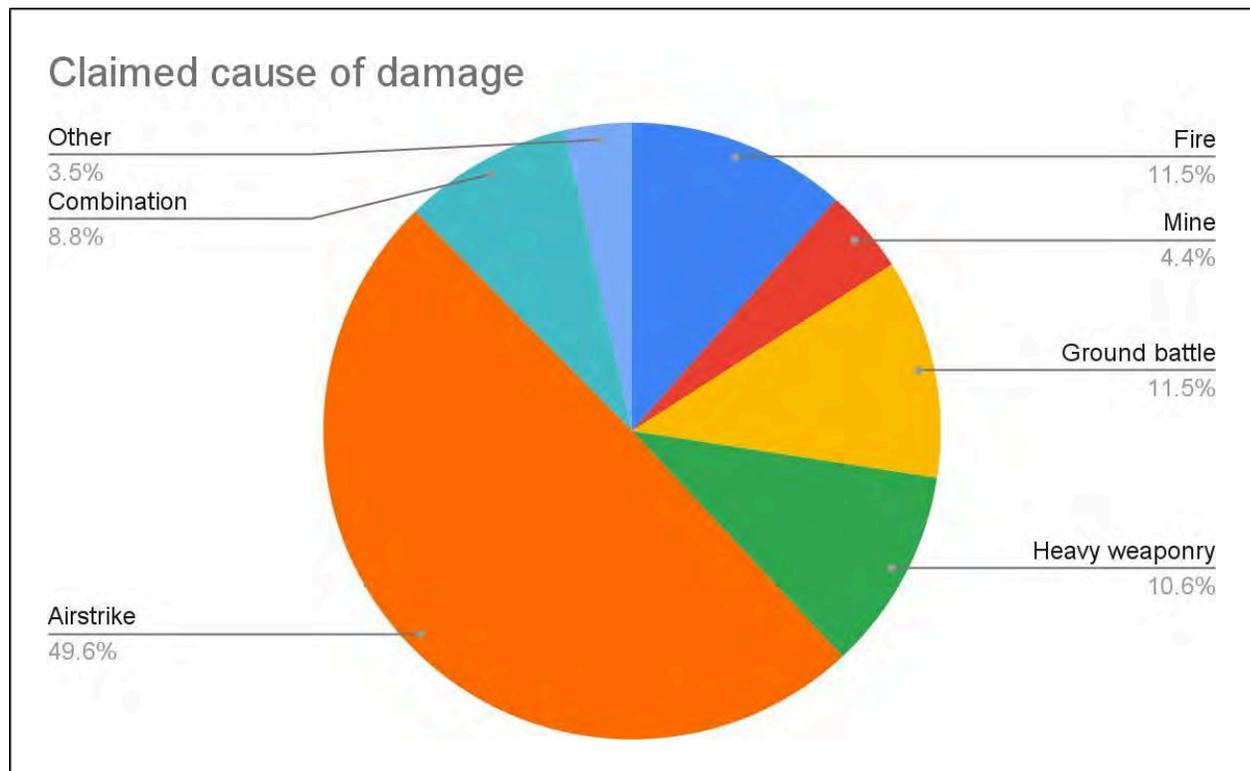
Between February 2021 and to April 2024, the most common cause of damage to school infrastructure identified in the primary dataset was airstrikes (49.6%), followed by fire (11.5%) and ground battles (11.5%). See figure 10. As the Myanmar Air Force is the only actor capable of carrying out airstrikes with manned aircraft, this implicates them in a high proportion of these events. 'The 'cause' classification was determined through identification of claims associated with an event, and where possible corroboration with UGC analysis for higher confidence in the claims.

Figure 10: Pie chart showing the causes of infrastructure damage to schools in the primary dataset.

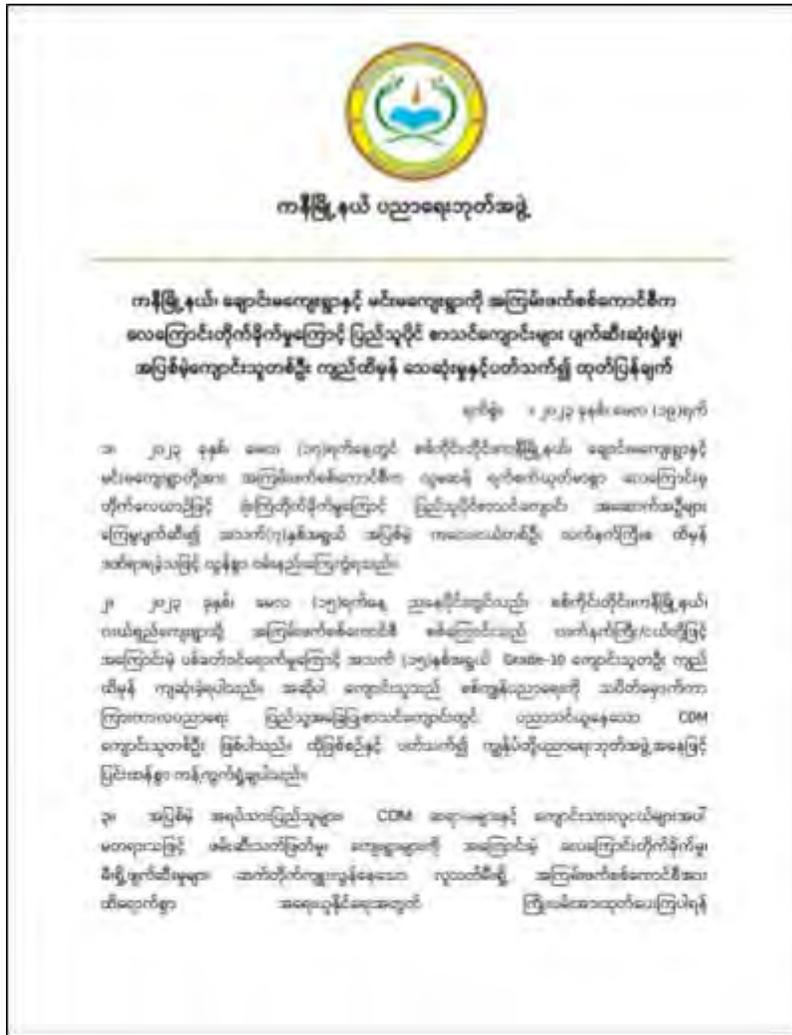
Figure 13: Kani Board of Education Facebook page reported on the destruction of schools in Kani township, including Chaung Ma and Min Ma village on 28 May 2023 (source: Facebook).

An airstrike on 28 May 2023 also reportedly hit another school in Kani Township (Min Ma village), according to the [Kani Board of Education Facebook page](#) (figure 13) but due to limited UGC, this event has not been explored in this case study.

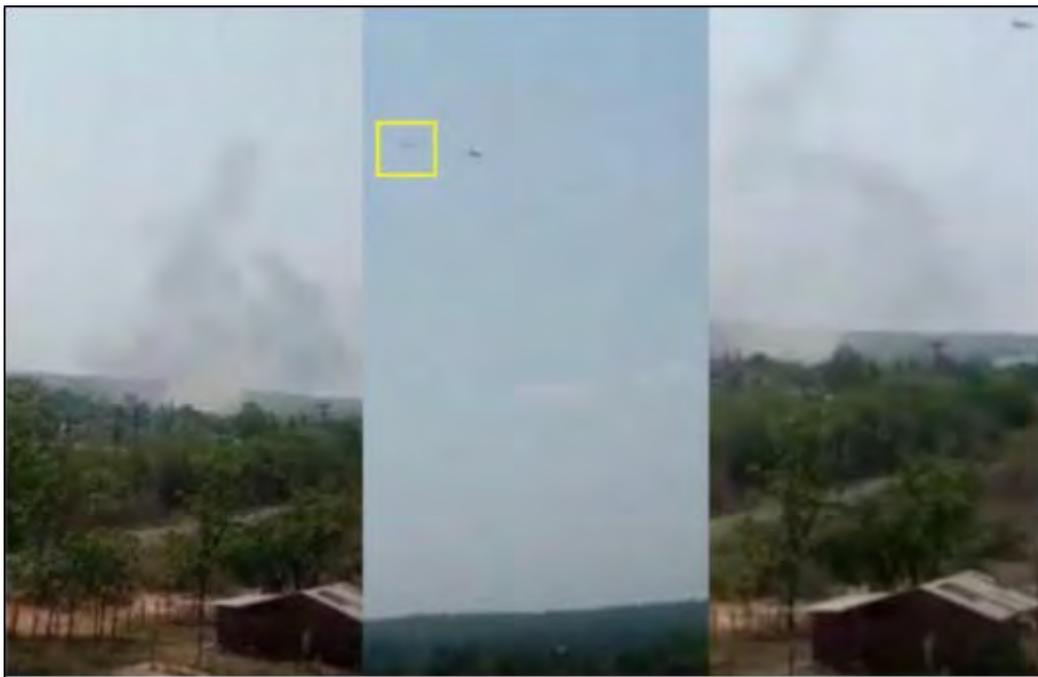
Figure 14: Video footage geolocated by Myanmar Witness to Chaung Ma showing smoke plumes, an aircraft releasing an object - likely ordnance (shown in yellow) - before the sound of an explosion (source redacted due to privacy concerns).

Myanmar Witness identified footage which appears to show two consecutive airstrikes on Chaung Ma village (source redacted due to privacy concerns). The footage shows smoke rising above Chaung Ma village (geolocated, coordinates withheld for privacy). An aircraft is visible (but unidentifiable) and can be seen releasing an object, likely ordnance (shown in the yellow box in figure 14 below), before a large explosion can be heard. The source claimed this event took place on 17 May 2023. The footage corroborates reports from the [Mandalay Free Press](#), and UGC from Facebook and YouTube, which claimed there were two airstrikes on Chaung Ma village on 17 May 2023.

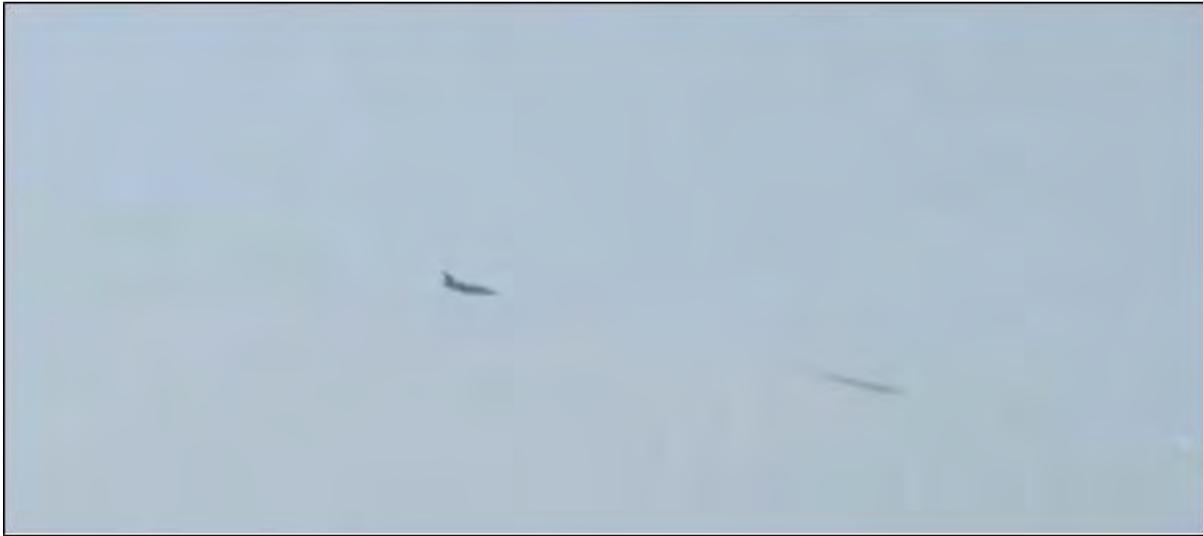
Figure 15: A still image from a video allegedly showing a Myanmar air force (MAF) Q-5 firing towards Chaung Ma on 17 May 2023, geolocated by Myanmar Witness (source redacted due to privacy concerns).

Additional footage reportedly showing the same event was identified, and geolocated by Myanmar Witness to Chaung Ma village (source redacted due to privacy concerns). The footage appears to show an aircraft resembling a Q-5 (an aircraft within the Myanmar air force inventory) firing ordnance (figure 15). The source claimed this took place on 17 May 2023.

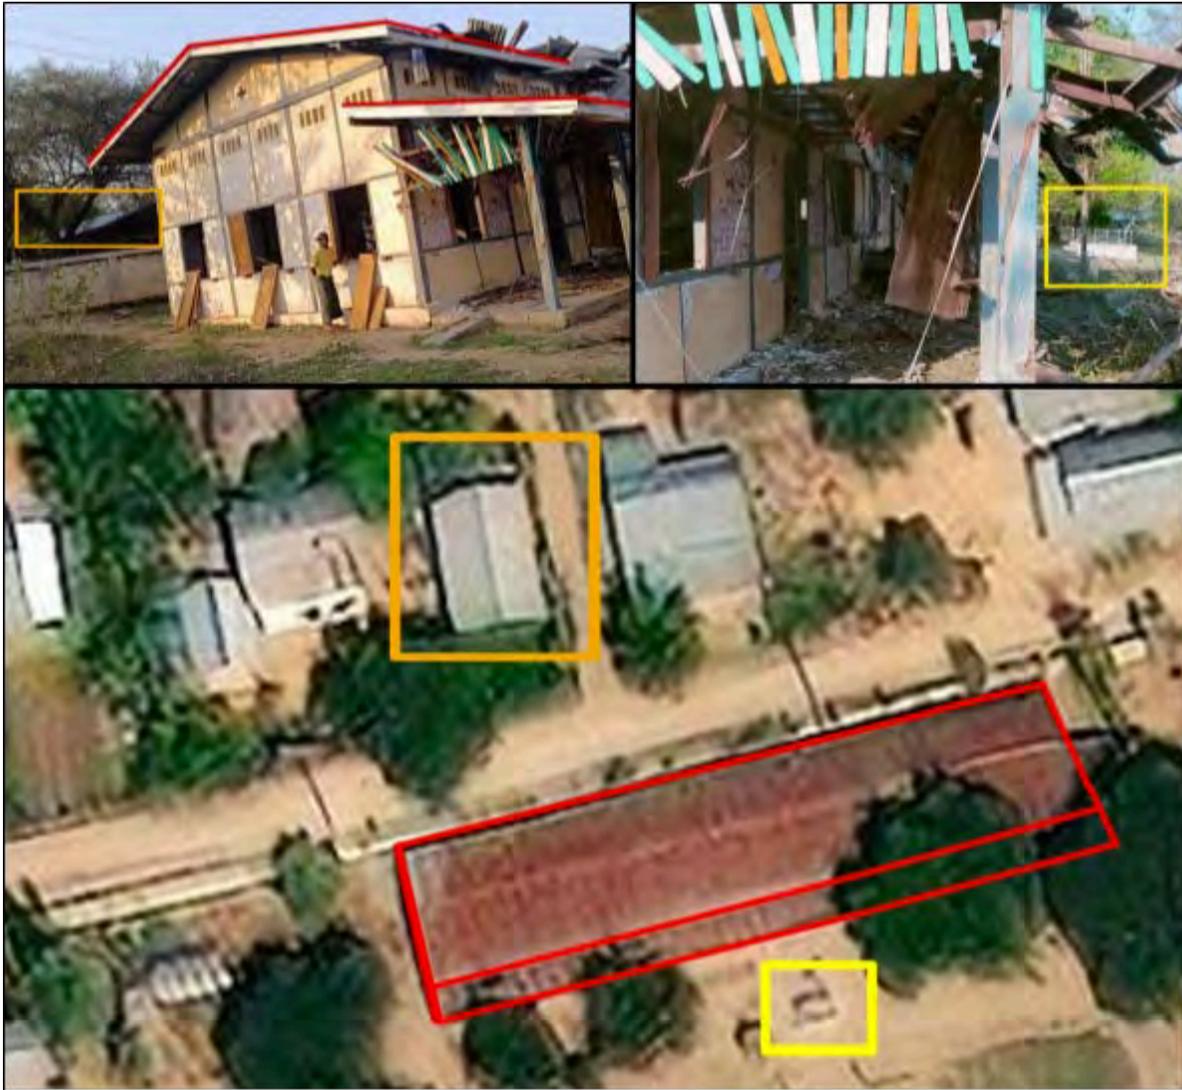
Myanmar Witness assesses that it is highly likely an educational facility in the village was damaged by the airstrikes. [Photos](#) of a destroyed building were geolocated to Chaung Ma village school [2.283743, 94.892570] (figure 16). The images show damage consistent with an airstrike: the roof is damaged and caved in, and the surrounding vegetation is also damaged (figure 17).

Figure 16: Images of Chaung Ma school showing major damage was geolocated by Myanmar Witness to 22.283743, 94.892570 (source: [Mandalay Free Press](#)).

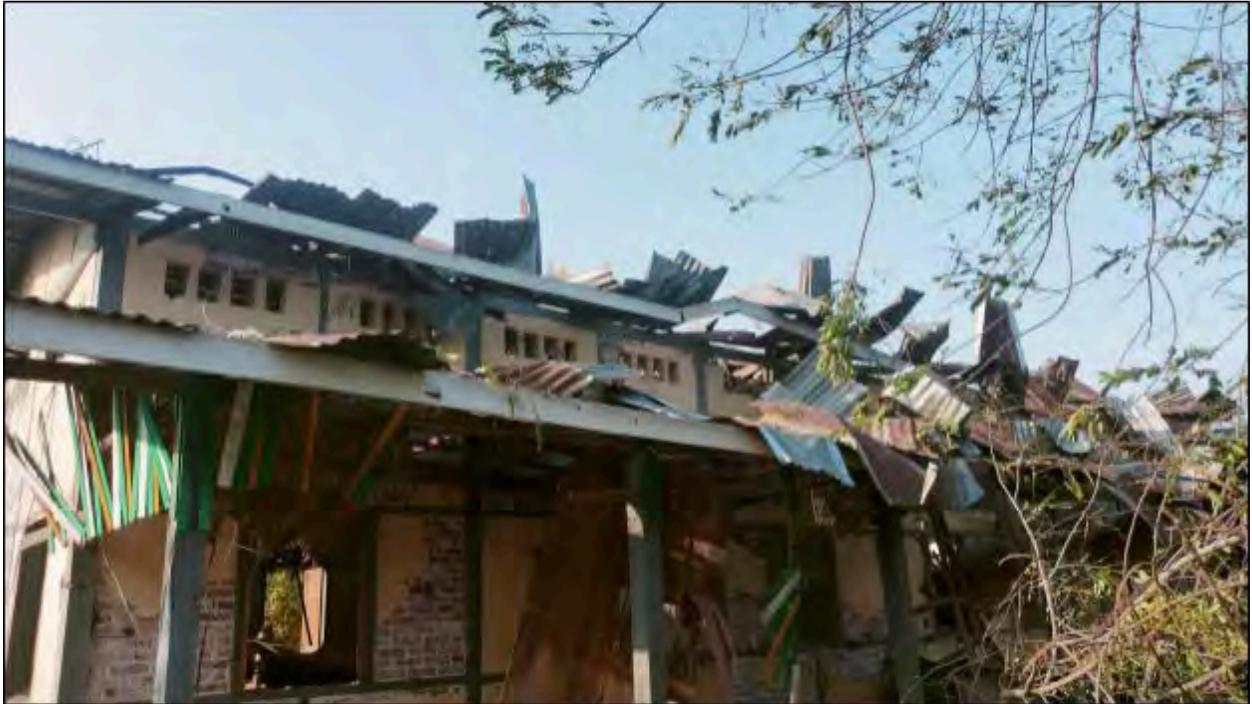
Figure 17: Photos of Chaung Ma school show major damage, with the roof caved in, consistent with an airstrike (source: [Mandalay Free Press](#)).

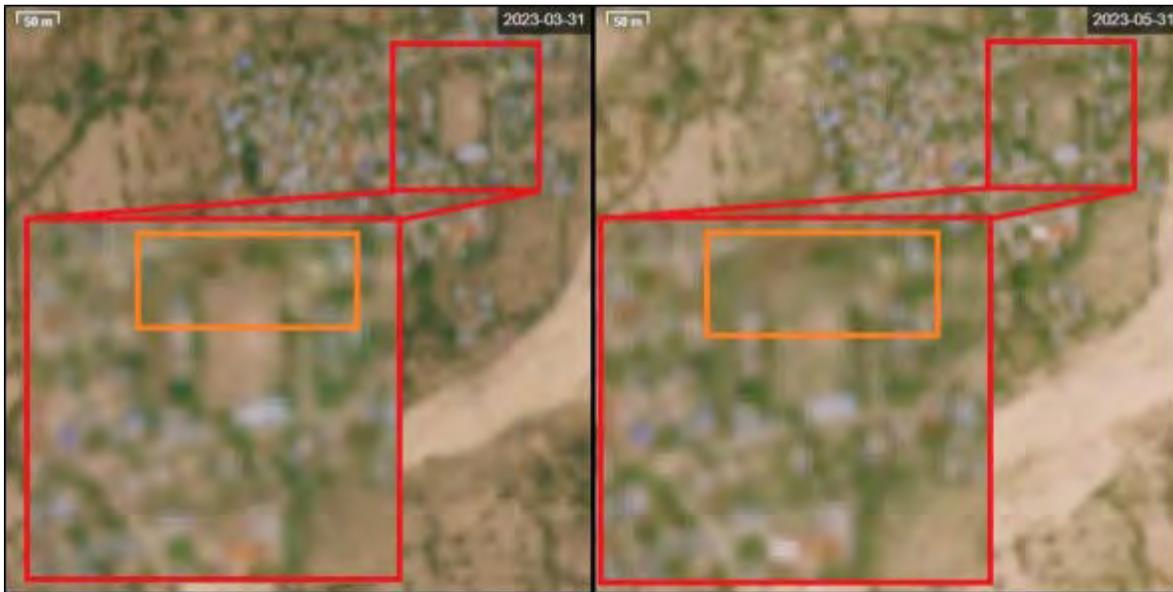
While all sources stated that this event took place on 17 May 2023, Myanmar Witness could not verify the precise date or time using open-source research skills. Using Sentinel-2 imagery, between 31 March 2023 and 31 May 2023, ground changes are visible in the Chaung Ma village school compound, potentially indicating the loss of a school building. While this time gap is very large and does not confirm a specific date of the attack, it does show the school was damaged between April 2023 and May 2023 (figure 18).

Figure 18: Sentinel-2 imagery shows a difference in the ground that could indicate the loss of a school building in the compound (source: Sentinel-2).

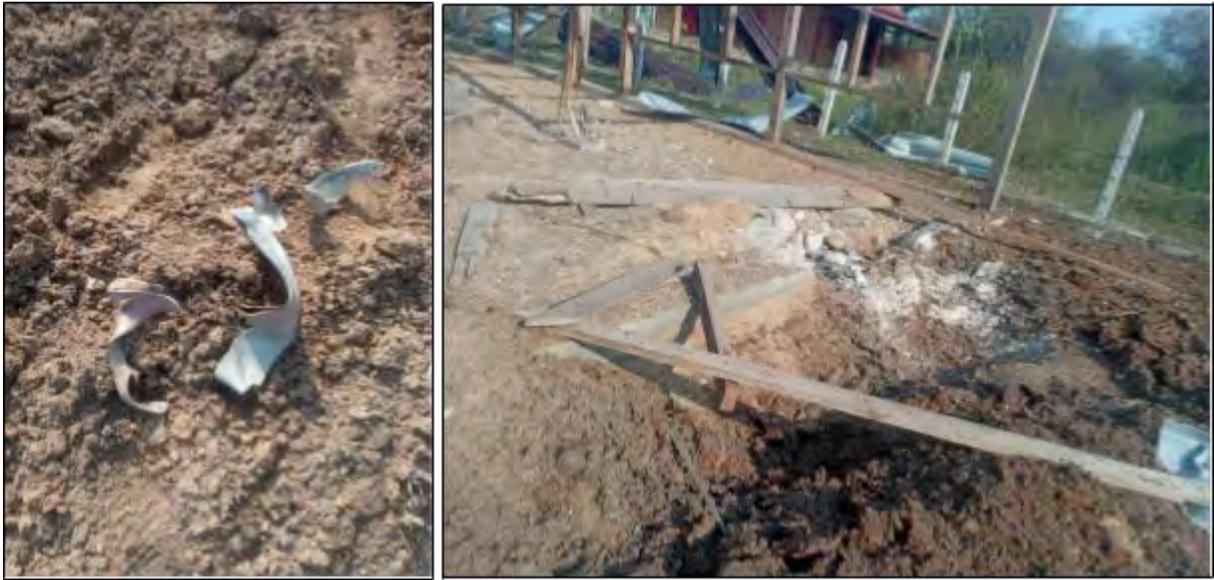
While the debris cannot be positively identified, the source also alleged this event took place on 17 May 2023, and the imagery lends weight to the claim that an airstrike took place in this location (figure 19).

Figure 19: Images posted on social media showing debris and ground pits, geolocated to Chaung Ma village (source redacted due to privacy concerns).

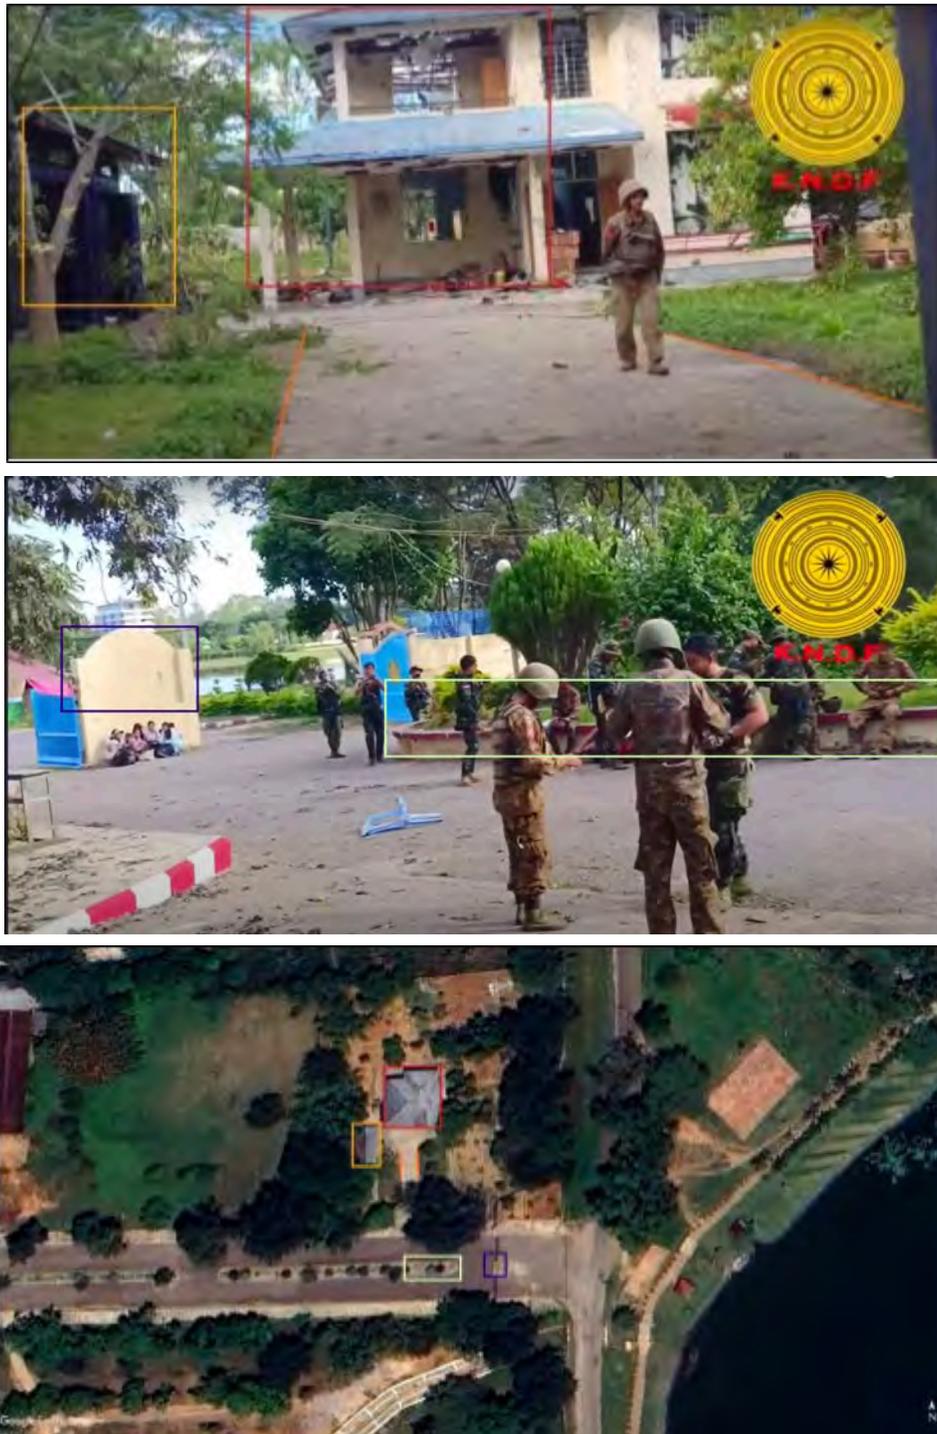
The incident took place at Loikaw University, geolocated by Myanmar Witness at approximately, 19.690611, 97.200791 (see figure 20). The footage shows the University compound is visibly damaged, corroborating claims that clashes took place in the area.

Figure 20: Footage showing destruction in the Loikaw University compound, as well as KDNF personnel, was geolocated to around 19.690611, 97.200791 (source: [Mizzima](#)).

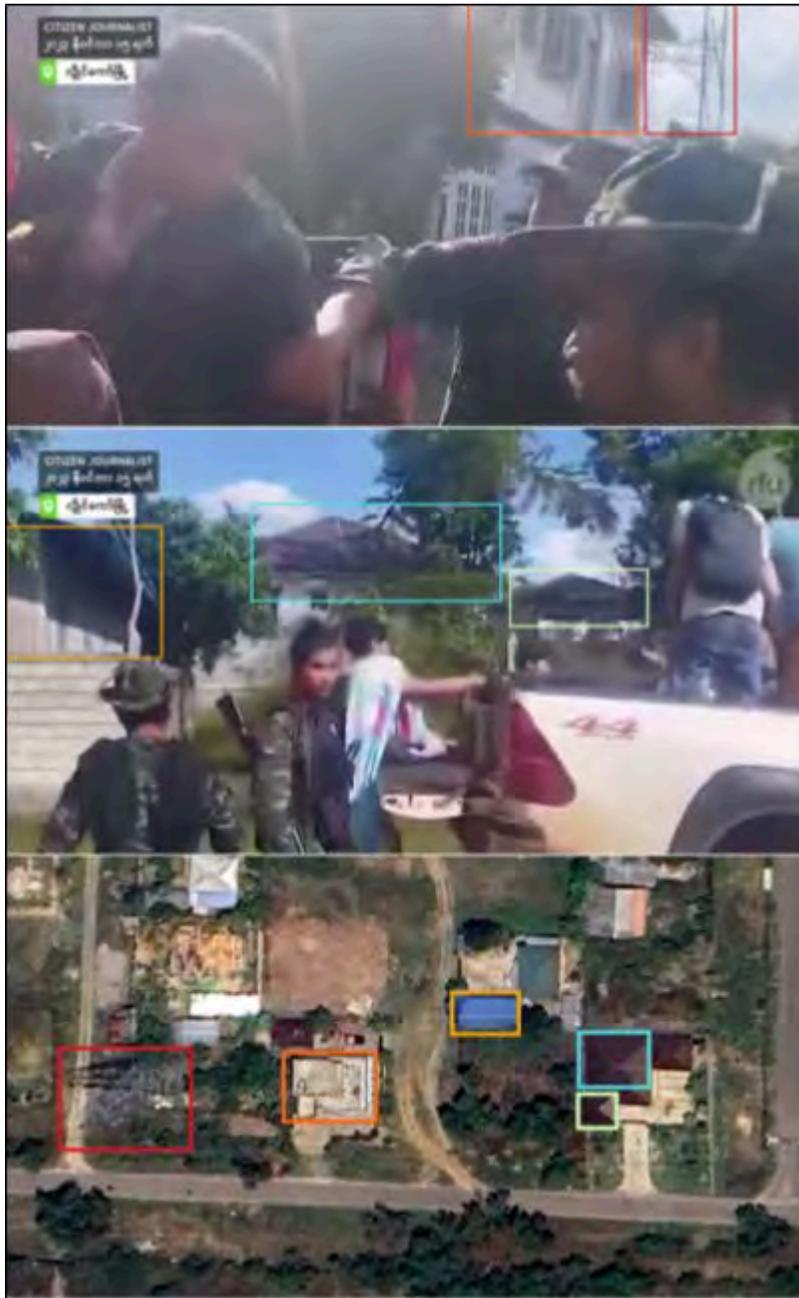
Figure 21: Still imagery from a video shows uniformed and plain-clothed armed individuals consistent with KNDF uniforms assisting civilians out of the Loikaw University compound. Video footage geolocated to 19.698095, 97.195336 (source: [RFA Burmese](#)).

- KNDF personnel assisting civilians, geolocated to Loikaw University;
- the surrender of Myanmar military personnel who had been located within and fighting from the University buildings; and,
- KNDF personnel helping people to [escape](#) from the other side of the University compound, approximately one kilometre away from the video of the military surrenders [19.698095, 97.195336] (figure 21).

Myanmar Witness identified UGC showing KNDF personnel assisting civilians, as well as individuals claimed to be teachers, to leave Loikaw University amid fighting (figure 21).

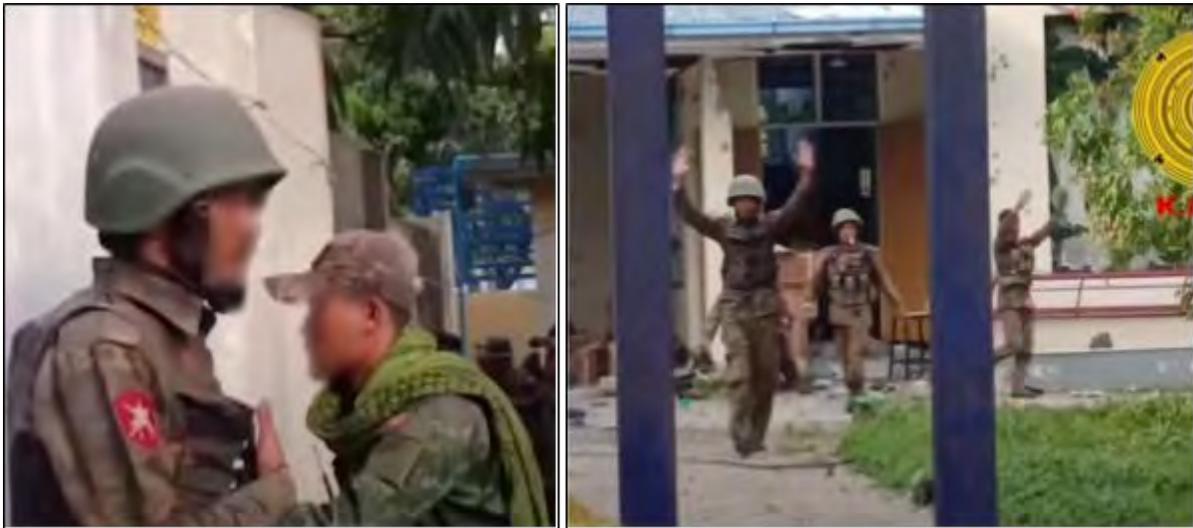
Figure 22: Photos show uninformed individuals consistent with Myanmar armed forces surrendering at Loikaw University (source: [Mizzima](#)).

While Myanmar Witness cannot directly confirm the exact time of the clashes, the available evidence strongly suggests the attack took place over the course of 13-14 November 2024, with the surrender of Myanmar troops occurring on the afternoon of 14 November. The timing of the surrender appears consistent with the evening of 14 November 2023, based on the shadows

and visible damage to the University buildings (see figure 22). This was chronolocated using shadow analysis via Suncalc.

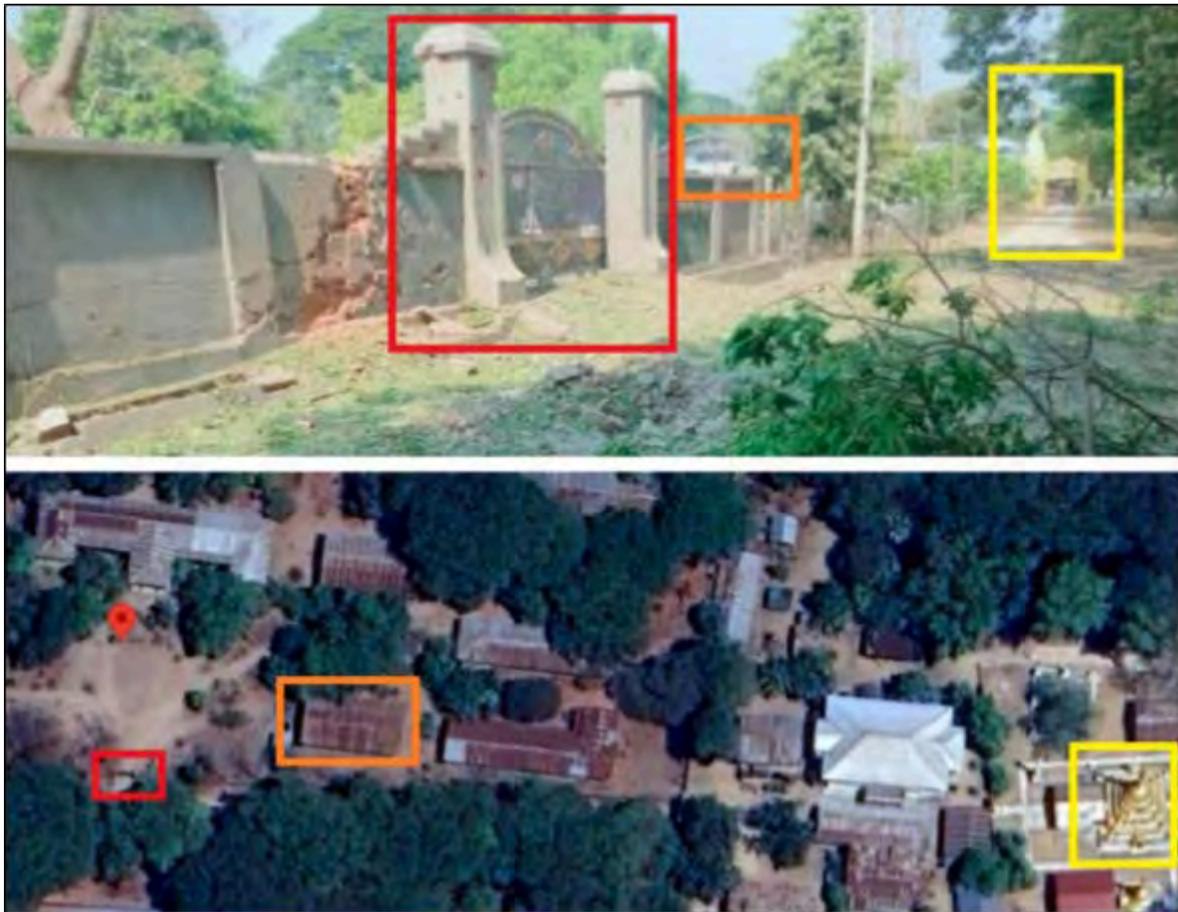
[UGC](#) identified by Myanmar Witness and geolocated to Htan Taw village, show damage to the village compound school buildings and school gates at around 22.730283, 95.306382 (figure 23 and 24). Myanmar Witness classified the visible damage to the school as 'major'.

Figure 23: Geolocation of Ye-u school strike from 9 May 2023, image located at 22.730283, 95.306382 (source: [Myanmar Pressphoto Agency](#)).

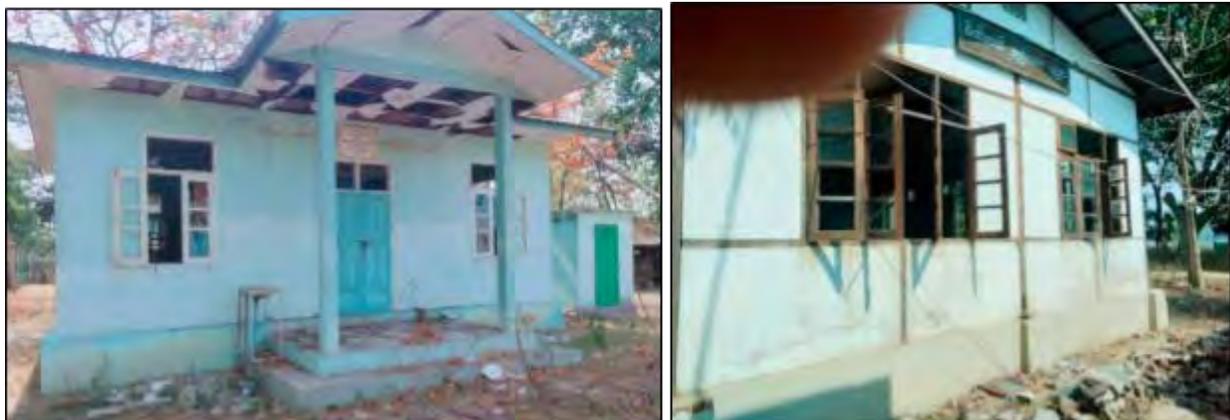
Figure 24: Photos showing damage to Ye-u school at 22.730283, 95.306382 (source: [Myanmar Pressphoto Agency](#)).

The visible damage to the school compound also corroborates the occurrence of an airstrike at the location. The [damage to the school](#) does not appear consistent with fire damage, as there

are no signs of scorching or ash. The building and gate show evidence of impact, with both small and large holes present. UGC indicates significant damage both inside and outside the building. Circular holes in the roof and walls suggest that the damage may have been caused from above or high-altitude sources, possibly by large weapons.

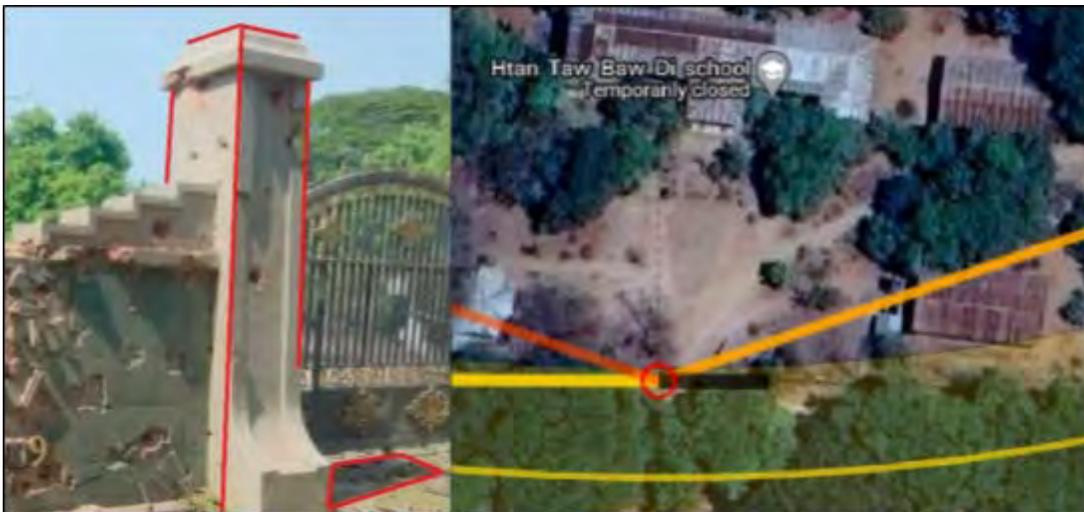
One of the images identified by Myanmar Witness was timestamped at 1456 local time on 9 May 2023. Comparing this image with other pieces of [UGC](#) showing damage to the school gates, it appears that further imagery was taken between 1400 and 1600 local time (figure 25). This was geolocated by Myanmar Witness and chronolocated using shadow analysis via SunCalc.

Figure 25: Chronolocation of images showing the school with visible damage, at 22.730283, 95.306382 (source: [Myanmar Pressphoto Agency](#)).

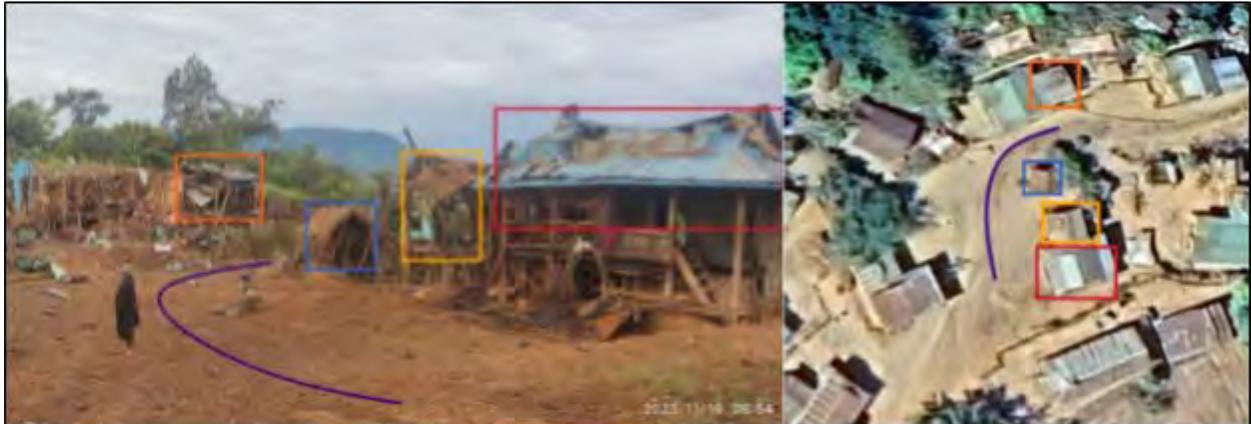
The location of destroyed civilian buildings was verified by matching UGC showing damaged structures with satellite imagery [21.286919, 93.478633] (figure 26, source redacted due to privacy concerns). However, Myanmar Witness is unable to assess if a school was directly affected.

Figure 26: Geolocation of heavily damaged village structures in Walu township at around 21.286919, 93.478633 (source redacted due to privacy concerns).

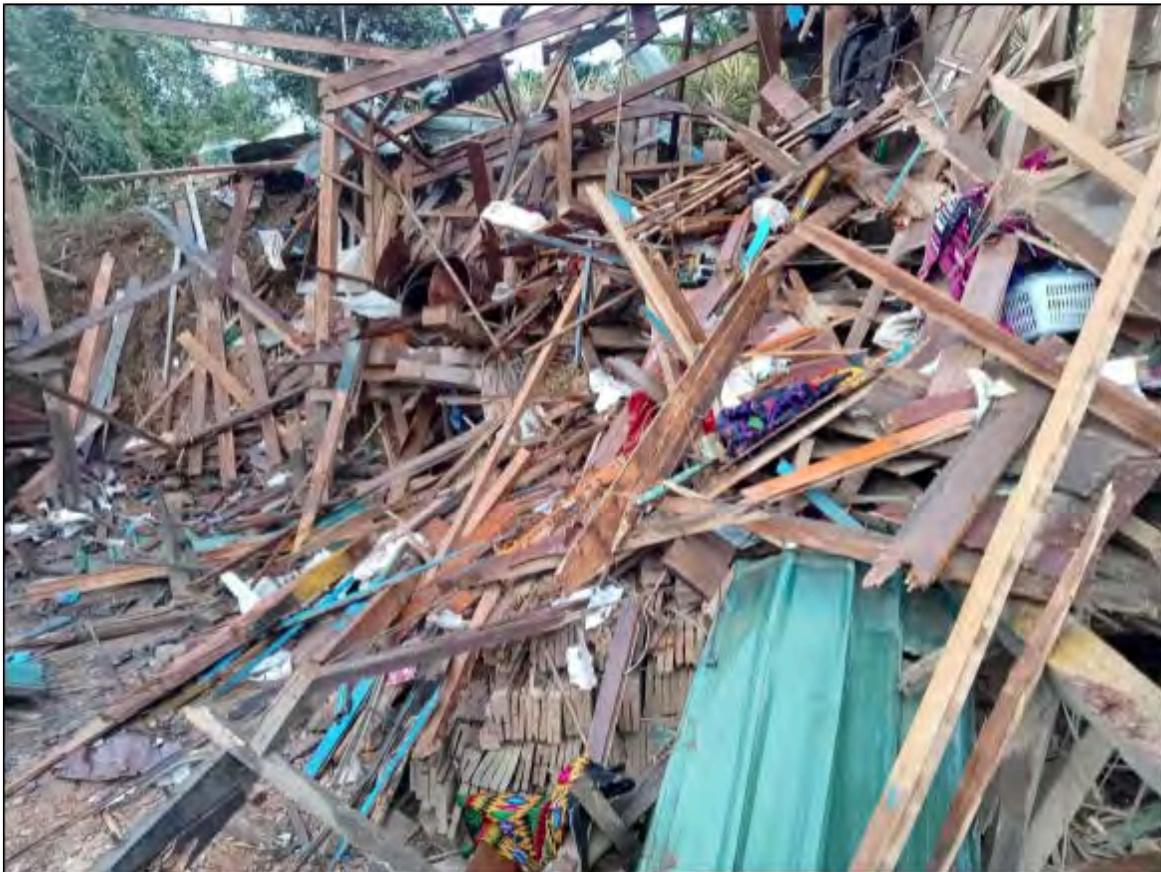
Through analysis of the structural damage evident within the UGC, it is evident that a significant attack, likely aerial, must have occurred to cause the level of destruction seen in the images (source redacted due to privacy concerns). Many wooden planks are broken and roofs have collapsed, adding weight to the claim that an airstrike took place (figure 27).

Figure 27: A photo showing destruction to structures allegedly from the Walu village attack, not geolocated by Myanmar Witness (source redacted due to privacy concerns).

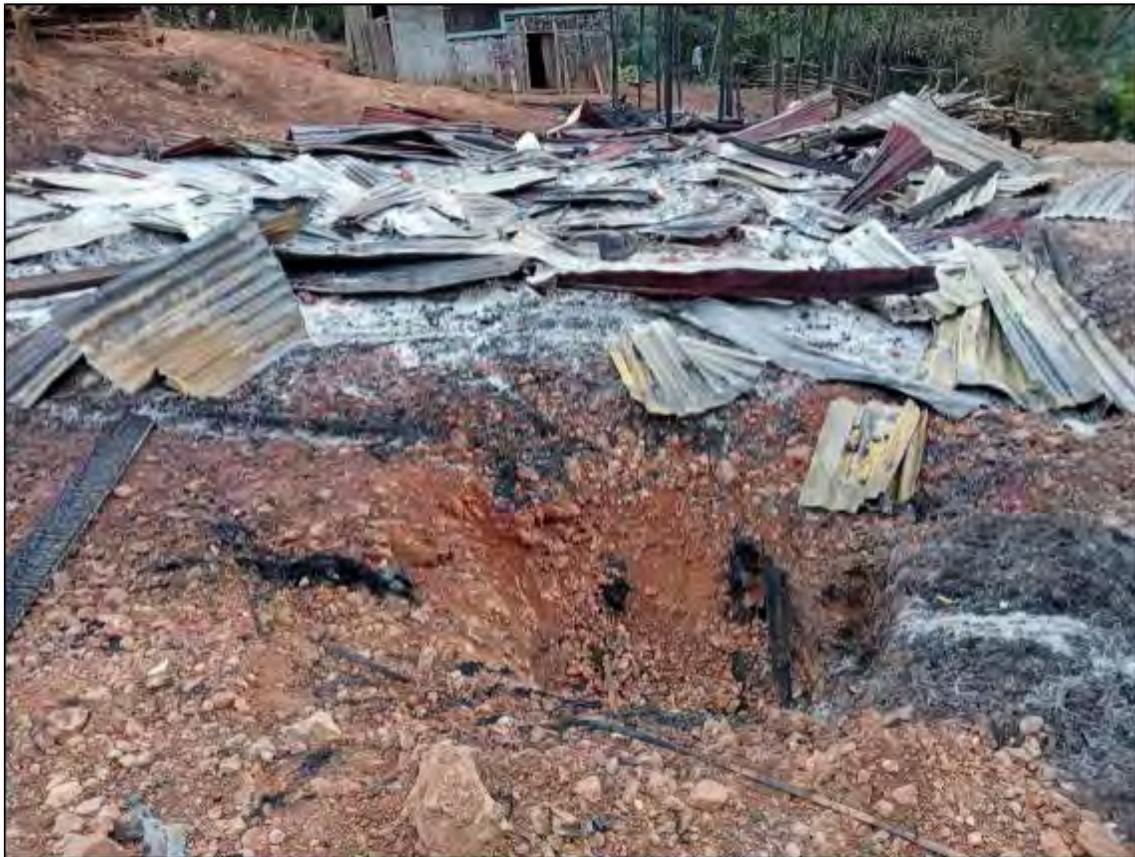
Myanmar Witness identified UGC showing munitions reportedly found at the scene, along with images showing craters in the ground, consistent with the use of heavy weaponry (source redacted due to privacy concerns). While Myanmar Witness could not identify the source of the munitions, these findings appear consistent with claims that there was an attack in the village (see figures 29 and 30).

Figure 29: UGC shows damages to the ground next to a destroyed/burned out structure, not geolocated (source redacted due to privacy concerns).

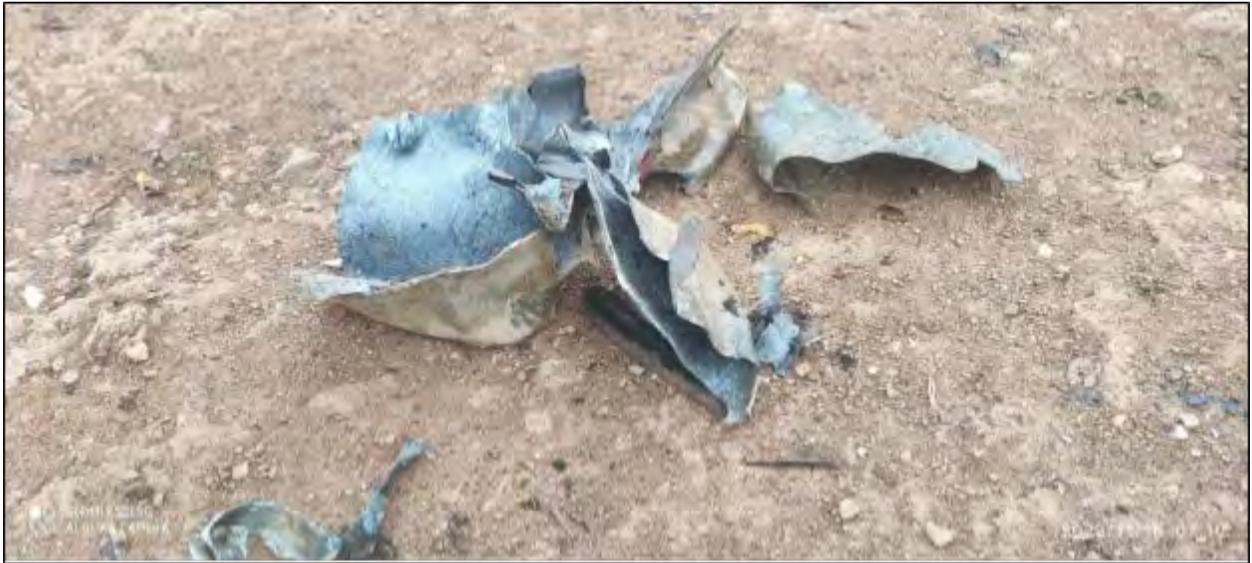
Figure 30: UGC shows munitions allegedly found after the attack, not geolocated. Myanmar Witness could not confirm what these correspond to or geolocate them to Walu village. (source redacted due to privacy concerns).
