NECESSARY AND PROPORTIONATE?

Potential 'Unprovoked' Airstrikes in January 2025

31 March 2025

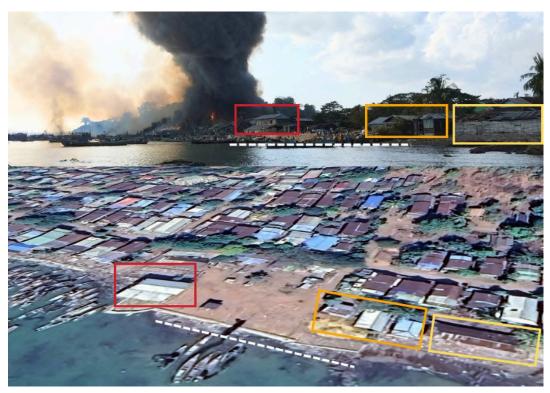
Figure 5: Myanmar Witness geolocated ongoing fires in Kyauk Ni Maw village at around 18.902611, 93.957278 (Source: Arakan Princess Media and Google Earth Pro).

Myanmar Witness verified UGC uploaded by <u>Arakan Princess Media</u> of burning and damaged structures, identified and geolocated to Kyauk Ni Maw village. An image shows the extent of the fire damage across the village at around 18.902611, 93.957278 (figure 5). Additionally, on social media, individuals (source removed due to privacy concerns) shared footage of fires destroying houses and boats. This footage was geolocated to Kyauk Ni Maw at around 18.902618, 93.957786 (figure 6).

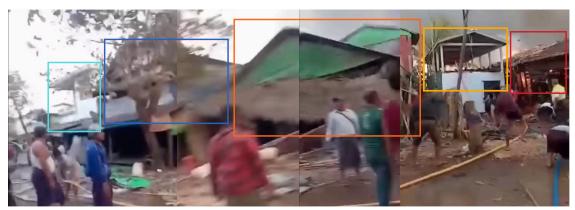
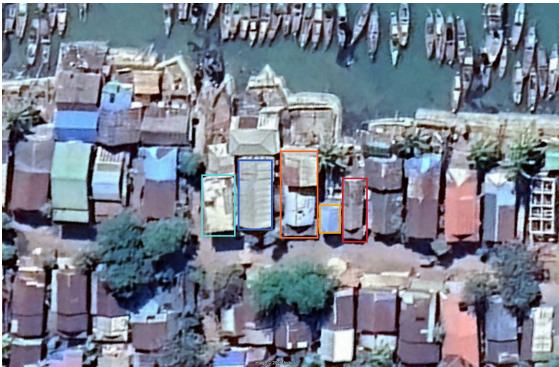
Figure 6: UGC geolocated to Kyauk Ni Maw village at 18.902618, 93.957786, showing fires throughout the village affecting civilian infrastructure and boats in the area (Source: removed for privacy).

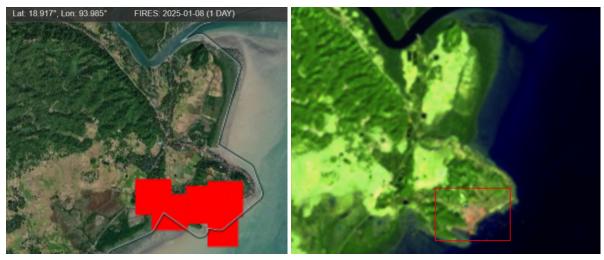
Figure 7: [Left] FIRMS heat activity that was registered in Kyauk Ni Maw village, Ramree Township on 8 January 2025 compared to [right] Sentinel-2 imagery showing fires in Kyauk Ni Maw on 9 January 2025 (Sources: <u>FIRMS</u> and <u>Sentinel-2</u>).

<u>Sentinel-2</u> demonstrates likely damage to the urban structures there between 4 January 2025 and 9 January 2025. Using a false colour (urban) filter on 9 January 2025, <u>Sentinel-2</u> also detected fire in the village visible in the same cluster as FIRMS

on 9 January 2025 (figure 7, right). According to <u>EOS Data Analytics</u>, a false colour filter enhances certain features, such as fires, which would appear orange, while urban areas appear lighter than vegetation. This chronolocation further verifies that the fires likely occurred in the village, between 8-9 January 2025, similar to the timeframe reported.

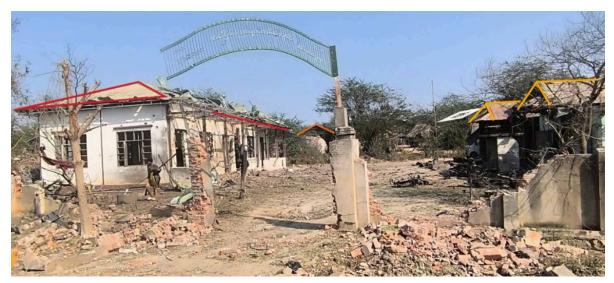
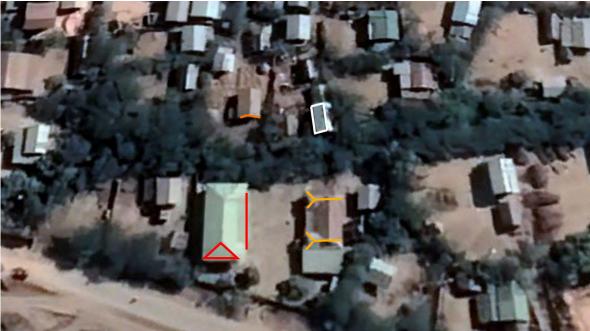
Figure 11: Myanmar Witness geolocated the damaged school to around 21.649348, 95.416413 (Source: removed for privacy and Google Earth Pro).

UGC identified by Myanmar Witness and geolocated to Sin Gut village, demonstrates damage to the village compound school structures and school gates at around 21.649348, 95.416413 (figure 11). Myanmar Witness classified the visible damage to the school as major, rendering this school potentially inoperable due to the damage caused.

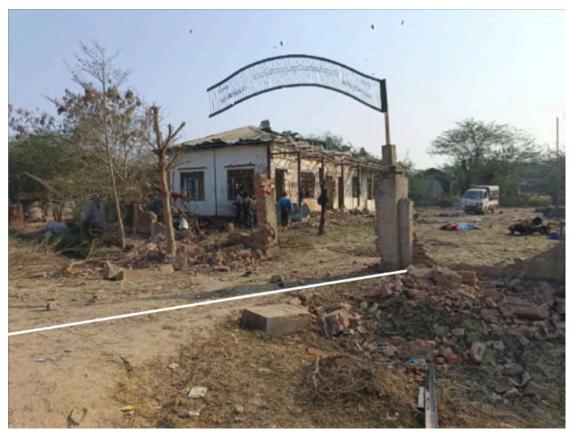
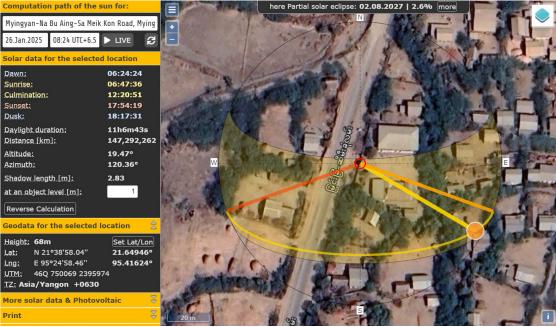
Figure 13: A shadow cast by the Sin Gut Village school gate suggests that the image, if taken on 26 January 2025, was likely taken after 0800 but before 0900 local time (Source: <u>Mandalay Free Press</u> and <u>suncalc.ora</u>).

Myanmar Witness also chronolocated some of the earlier images of the damage to Sin Gut village. The earliest image, determined through <u>Suncalc</u> (shadow calculation from the angle of a shadow in the image of the school sign), is likely from 0800 and 0900 local time on 26 January 2024 (figure 13). This suggests that reporting around the claims about the time of the airstrike by pro and anti military channels are potentially correct, with photos of the destruction being taken an hour or so after the event, and hence chronolocated to slightly later in the day but still close to the timeframe the incident was alleged to have happened.

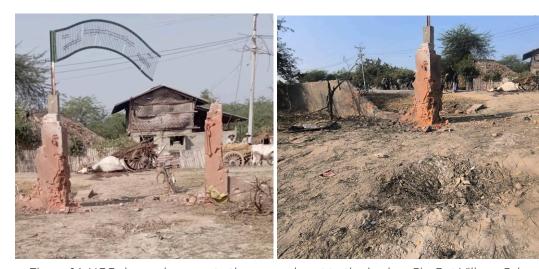
Figure 14: UGC shows damage to the ground next to the broken Sin Gut Village School entrance sign, geolocated to 21.649451, 95.416280 (Source: removed for privacy and <u>People's Spring</u>).

Myanmar Witness identified UGC showing craters in the ground, likely consistent with the use of heavy weaponry or airstrikes. While Myanmar Witness could not identify munitions for analysis, these findings appear to be consistent with claims that there was an attack in the village, possibly caused by heavy weapons or airstrike munitions (figures 14 and 15).

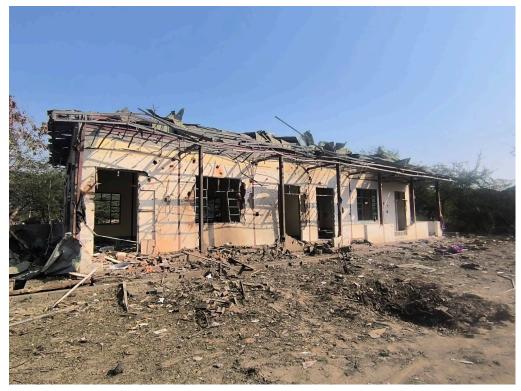
Figure 15: UGC shows damage to the ground next to a destroyed structure, geolocated to 21.649476, 95.416381 (Source: removed for privacy).

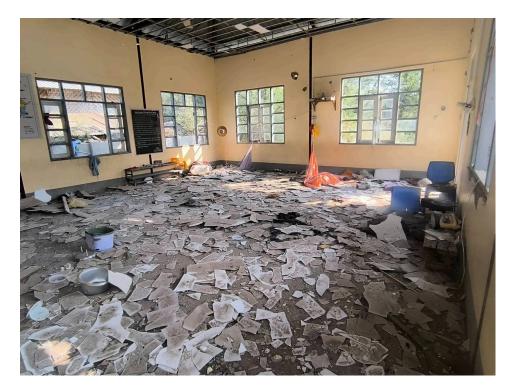
Figure 16: UGC shows damage to the school structure in Sin Gut village that are potentially consistent with claims of an airstrike causing damage in the village (Source: removed for privacy).

The damage to the school does not appear consistent with fire damage, as there are minimal signs of scorching or ash near the structures (figure 16). The building and gate show evidence of impact, with both small and large holes present. UGC (redacted for privacy concerns) collected indicates significant damage both inside and outside the building.

Myanmar Witness assessed damage to the destroyed geolocated structure and determined that this destruction could have been caused by an airstrike. Through analysis of the structural damage visible in the UGC, it is clear that a significant attack likely caused the extensive damage seen in the images of the school compound (source removed due to privacy concerns). It appears that much of the wall is broken and the roofing has collapsed in on itself, adding weight to the claim that an airstrike took place (figure 16).
