CONFLICTING CLAIMS ON A SCHOOL STRIKE

An Analysis Of The Sagaing Airstrike Event

15 May 2025

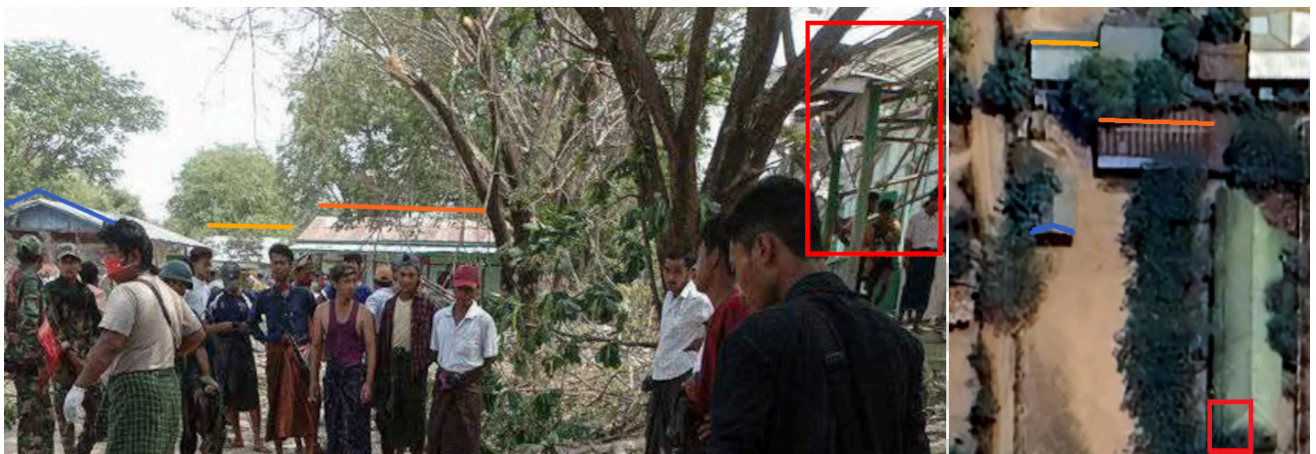
Figure 1: UGC showing people looking at a row of bodies (cropped out due to the graphic nature) gathered on the school compound. In the image [Left], multiple buildings (and the nearby vegetation)

can be seen matching up as per the coloured boxes. [22.650504, 95.209105] (satellite source: © 2025 Airbus/Maxar Technologies via Google Maps) (Source: [Khit Thit Media](#) [GRAPHIC])

Based on open source analysis and UGC analysis emanating from this event, extensive geolocation processes were conducted to Oe Htein Kwin (North) village as the location where the incident occurred. Four separate images were geolocated, two of which are shown below (figure 1 & figure 2).

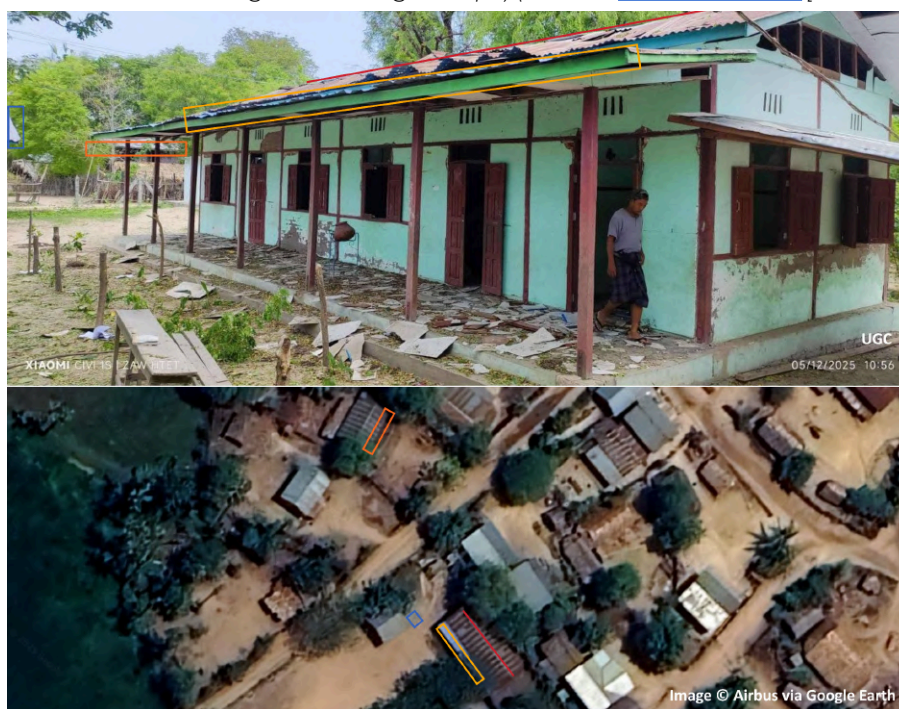
Figure 2: [Top] another damaged school building, in this image, the most notable feature is the two-tiered roof [22.650894, 95.209071] (satellite source: © 2025 Airbus/Maxar Technologies via Google Maps) (source: [Mizzima News](#))

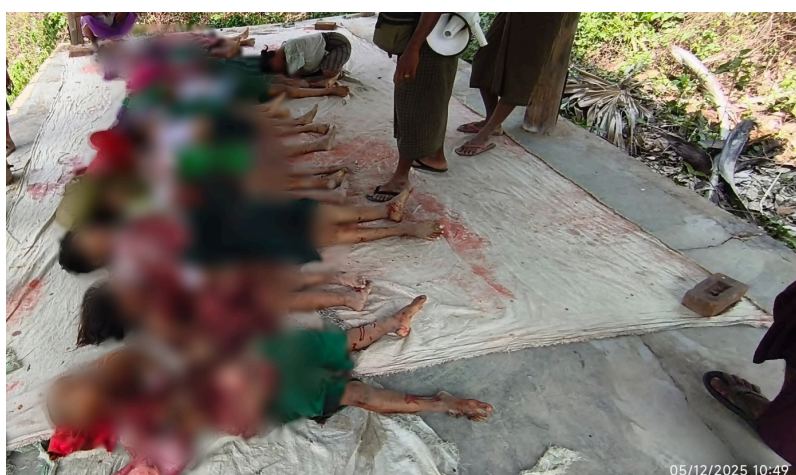
Using images from a source that shared many of the more graphic visuals (Redacted due to privacy), Myanmar Witness confirmed the presence of up to 16 separate bodies in the footage (figure 4). Additional unidentified body parts were also observed, suggesting the total body count could be higher. However, this remains unconfirmed at the time of writing, due to a lack of UGC showing further details. The available imagery shows victims with extremely graphic injuries, including extensive bleeding, lacerations, and partial or potentially full-body mutilation. This type of bodily damage is consistent with that typically seen in large, violent events involving heavy weapons or airstrikes.

Figure 4: Blurred example of the images analysed. The timestamp fits the 12 May 2025 narrative, giving some additional support to the date. (Source Redacted, available upon request)

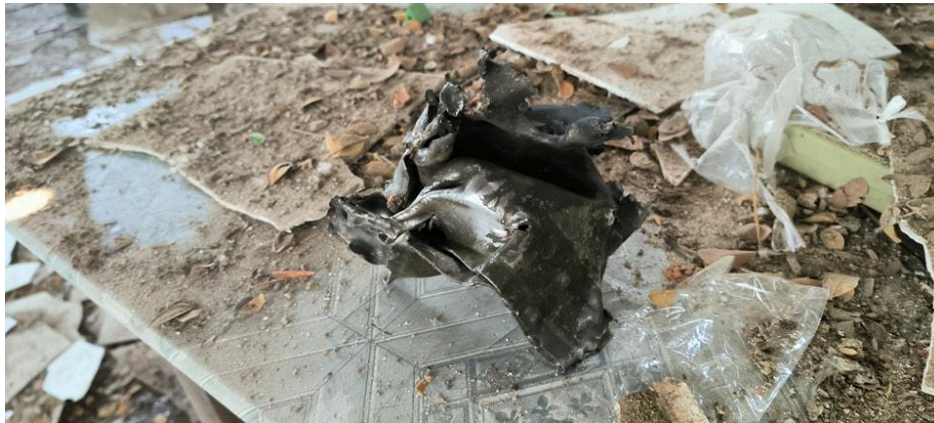
Figure 5: A remnant of munitions within the premises of the destroyed school building. (Source: [\[Local Administration Media\]](#) (မိတ္ထီနိုင်ငံရေး ညှိကိုများ-ဒီပဲယင်း ပကဖ) [GRAPHIC])

Social media posts shared by a local PDF group and a private account on their official Facebook pages purport to show remnants from the alleged airstrike (source redacted due to privacy issues). Myanmar Witness analysed these fragments and determined that the images captured depict two damaged tail fins from an unguided air-delivered ordnance (figures 5 & 6). Despite identifying the type of ammunition, Myanmar Witness is unable to provide an accurate ID of its make and model.

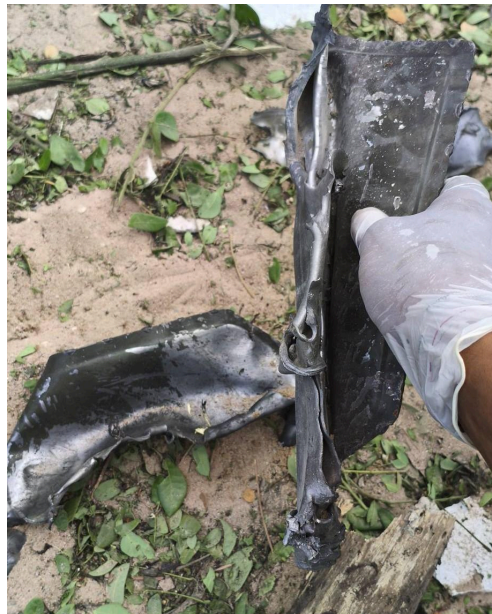
Figure 6: A remnant of munitions within the premises of the destroyed school compound. (Source: redacted, available upon request)

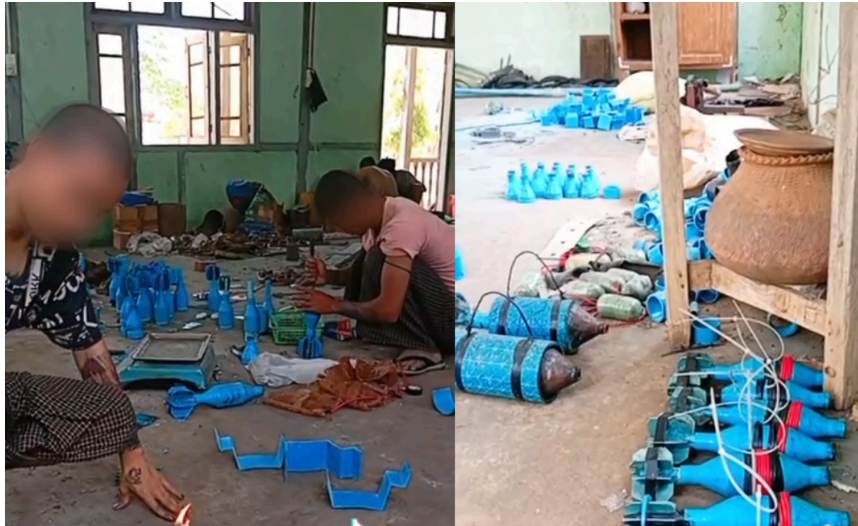
Figure 7: Munition/explosive production at a likely separate school. It appears to be distinct from the UGC of the Oe Htein Kwin (North) school. (source redacted, available upon request)

It has been suggested that the school hit was being used for explosive production. One source included video imagery allegedly showing such activity, thus prompting further analysis. Following review of the video, it is highly unlikely that the site shown in the video is the same as the school involved in the 12 May incident, as none of the UGC from that date match the depicted location. Furthermore, the original TikTok video referenced in the imagery has since been removed (figure 7). The reason for this is unclear, but it could be due to the platform's Terms of Service.
