## REPORTED MAF F-7 AIRCRAFT CRASHES IN PALE, SAGAING

Resistance Claims Shootdown; SAC Blames Malfunction

11 JUNE 2025

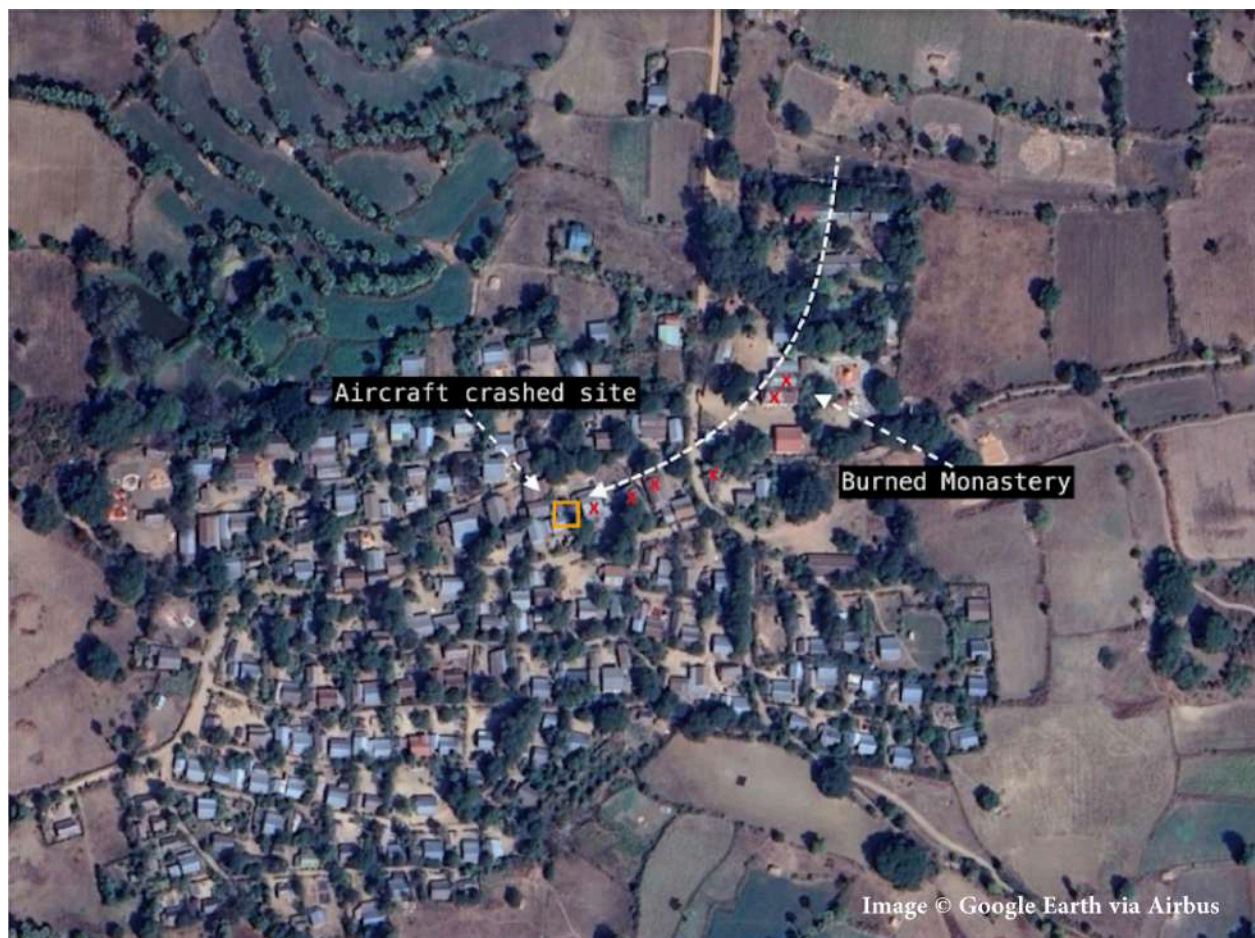
Figure 1: Geolocation of the F-7 aircraft crash site and the burned monastery within the Sa Par Sayt village [21.93375015, 94.76542664] (Source: Google Earth: Airbus 2025)

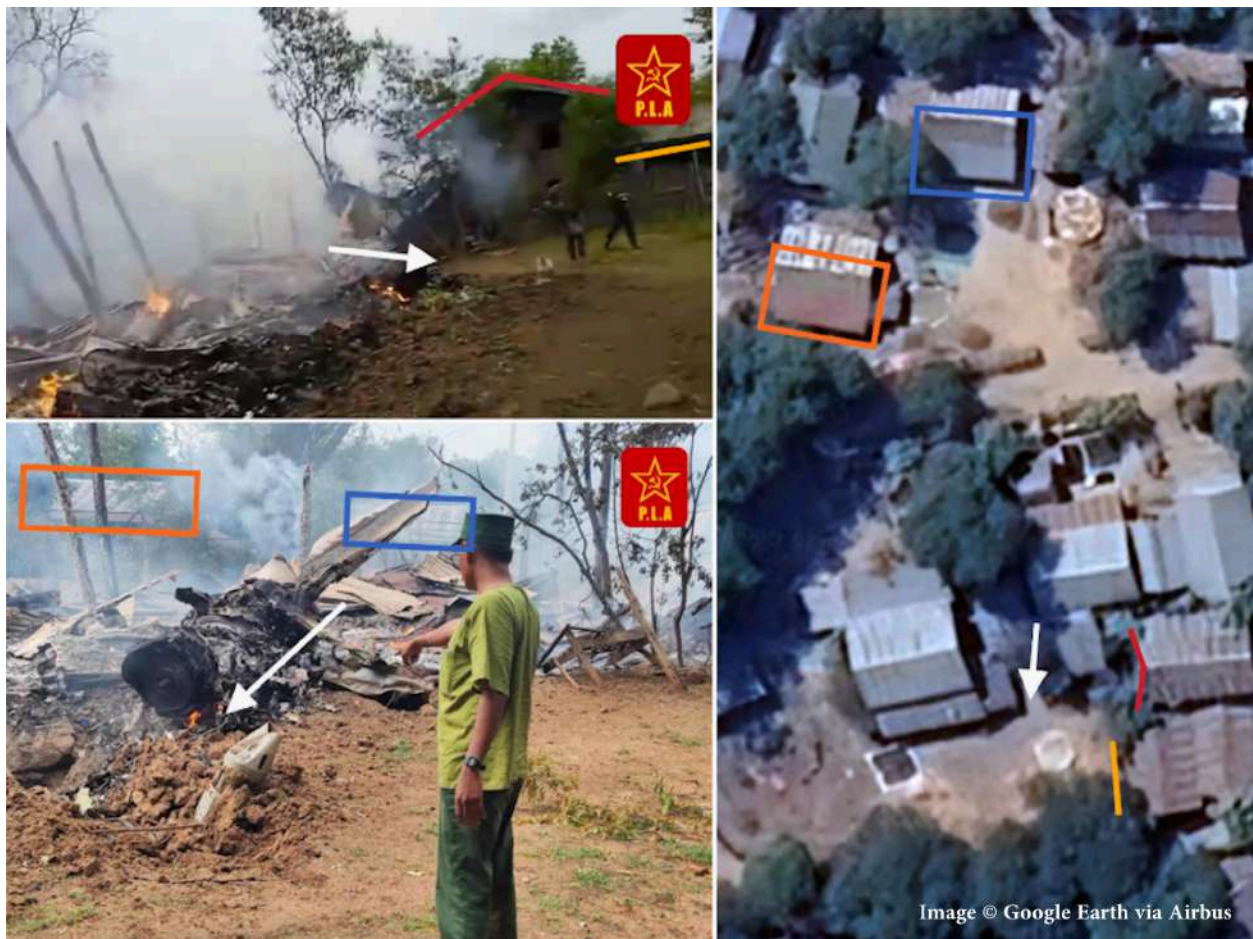
Figure 2: Geolocation of F-7 fighter jet at Sa Par Sayt စပါးစေ့ village [21.933990, 94.765994] (source: [Top Left] [PLA](#); [Bottom Left] [PLA](#), [Right] Google Earth: Airbus 2024)

Myanmar Witness geolocated UGC that appeared online, reported by local media and private accounts. Myanmar Witness geolocated the UGC [posted](#) by PLA and [Khit Thit media](#) at Sa Par Sayt စပါးစေ့ village [21.93375015, 94.76542664] (figure 2). Myanmar Witness also geolocated that there were additional fires that occurred within the same village inside a monastery at [21.934478, 94.766930] (figure 3). Some private accounts (source redacted due to privacy concerns) also claimed that the aircraft was coming toward Zee Hpyu Kone village (ဇီးဖြူကုန်း) [21.96026993, 94.71855164], bombed the village, and then crashed at Sa Par Sayt on its return to base. However, Myanmar Witness has not been able to fully verify these claims due to insufficient UGC and media reporting.

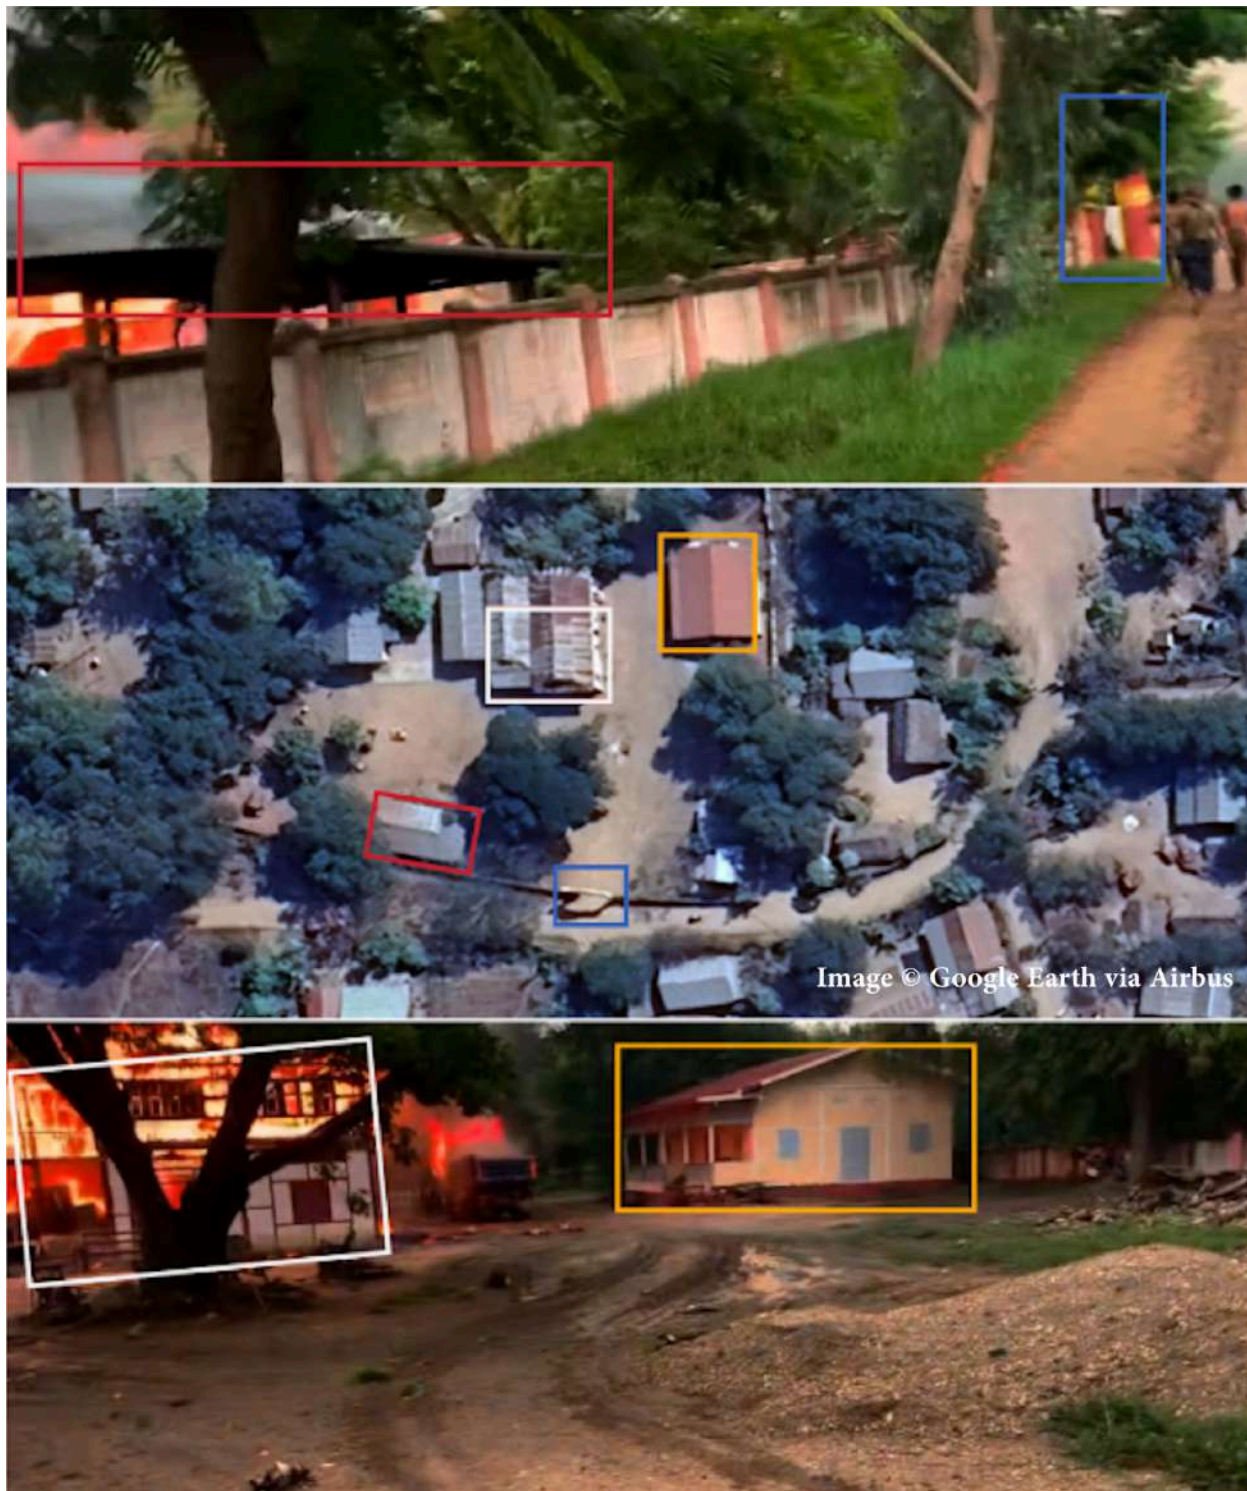
Figure 3: Geolocation of the fire that broke out at the monastery in Sa Par Sayt village [21.934478, 94.766930] (Source: [Burma VJ](#) and Google Earth: Airbus 2024)

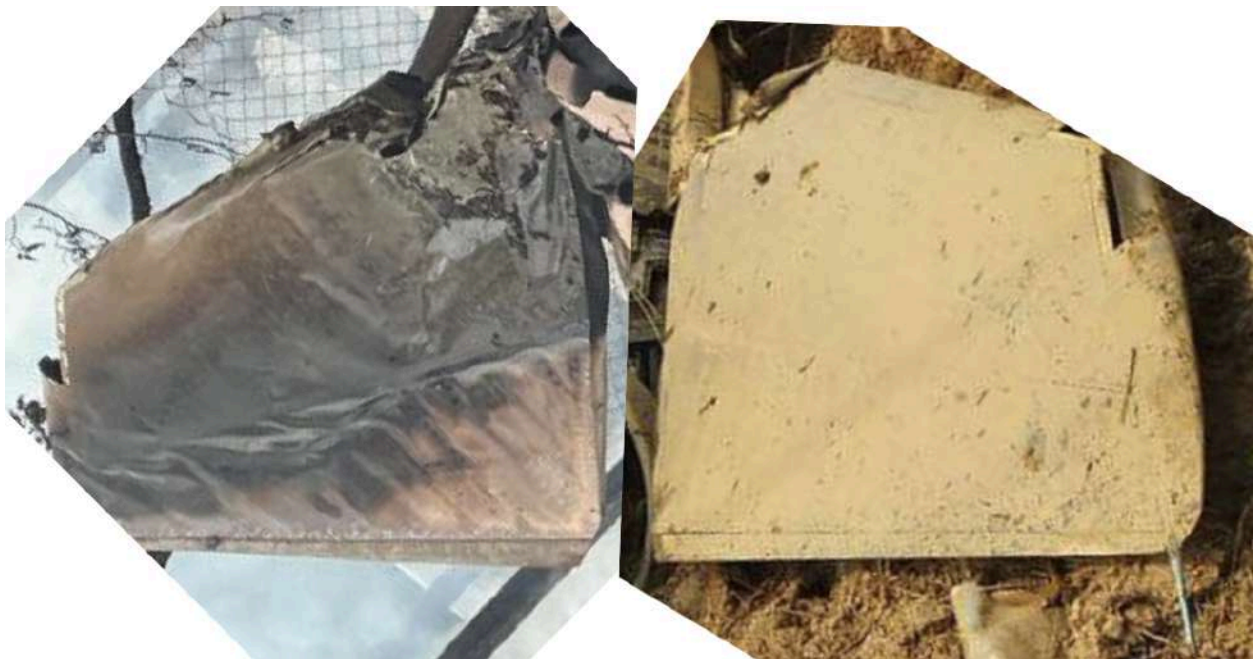
Figure 4: [Left] Myanmar Witness analysed components of the crashed aircraft from UGC, comparing with components [Right] of an F-7 crashed in 2018 (source: [Left] [PLA](#) and [Right] [Coconuts Yangon](#))

Myanmar Witness has analysed the components of the aircraft visible in several pieces of UGC. Such components—reviewed by Myanmar Witness—include the aircraft’s left horizontal stabiliser (figure 4), the rudder (figure 5), part of its landing gear (figure 6) and the canopy (figure 7). Based on this examination and following a comparative visual analysis, Myanmar Witness has determined these debris to be originally part of a Chinese-manufactured Chengdu F-7 fighter jet of the MAF, also confirmed by the unique livery pattern. This aircraft was also carrying equipment normally arming the F-7 in MAF service, such as an auxiliary external fuel tank, 30mm rounds for its internal cannon, and at least one pod for unguided rockets (figures 8 and 9). Additionally, given the peculiar pattern of rivets on the retrieved damaged canopy, Myanmar Witness was able to ascertain that this aircraft is of the single-seater variant (the MAF also operates the double-seater variant of the same model). Myanmar Witness is unable to confirm if the aircraft was damaged in flight or crashed as a result of an engineering malfunction. However, there have been previous cases of ageing MAF models, and among these the F-7, crashing due to malfunctions.

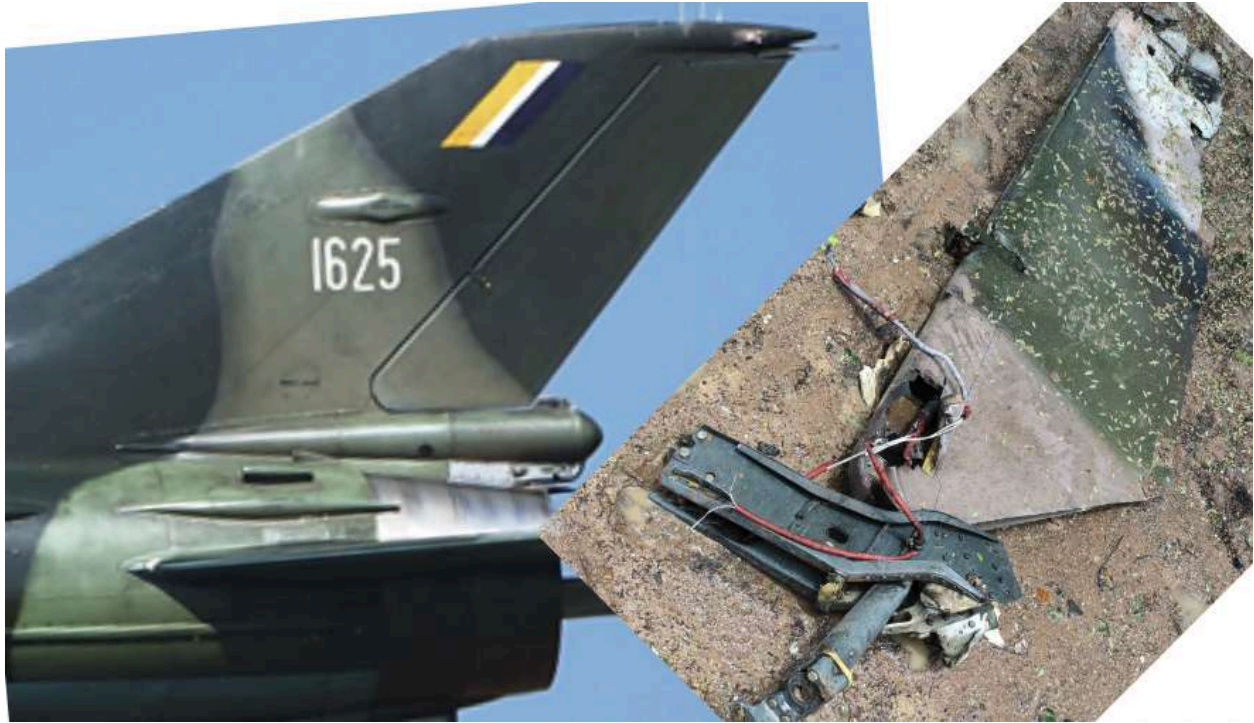
Figure 5: [Right] Myanmar Witness analysed components of the crashed aircraft from UGC, comparing it with the tail section [Left] of MAF F-7 tail number 1625 (sources: [Left] [PLA](#) and [Right] [Airliners](#))

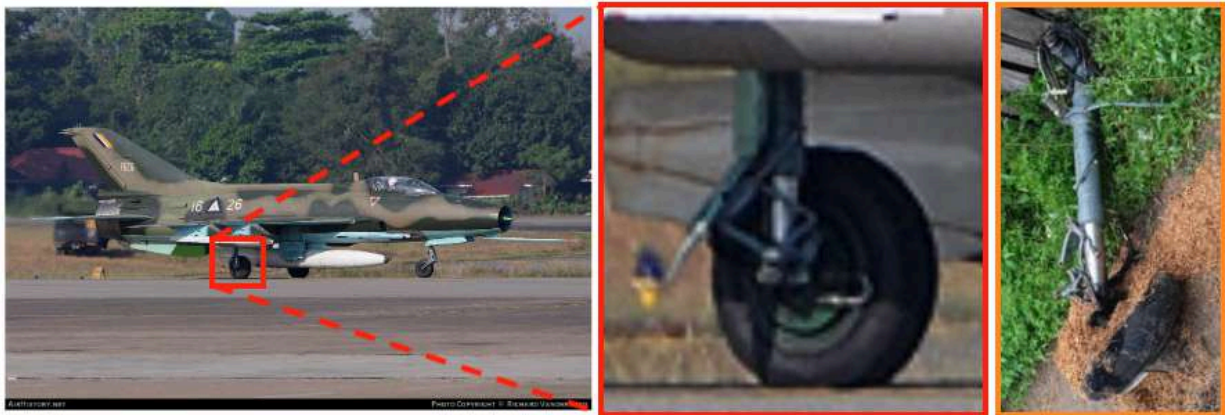
Figure 6: [Right] Myanmar Witness analysed components of the crashed aircraft from UGC, comparing it with [Left] the tail section of MAF F-7 tail number 1626 (sources: [Right, in orange] [PLA](#) and [Left, and zoomed-in section, both in red] [airhistory.net](#))

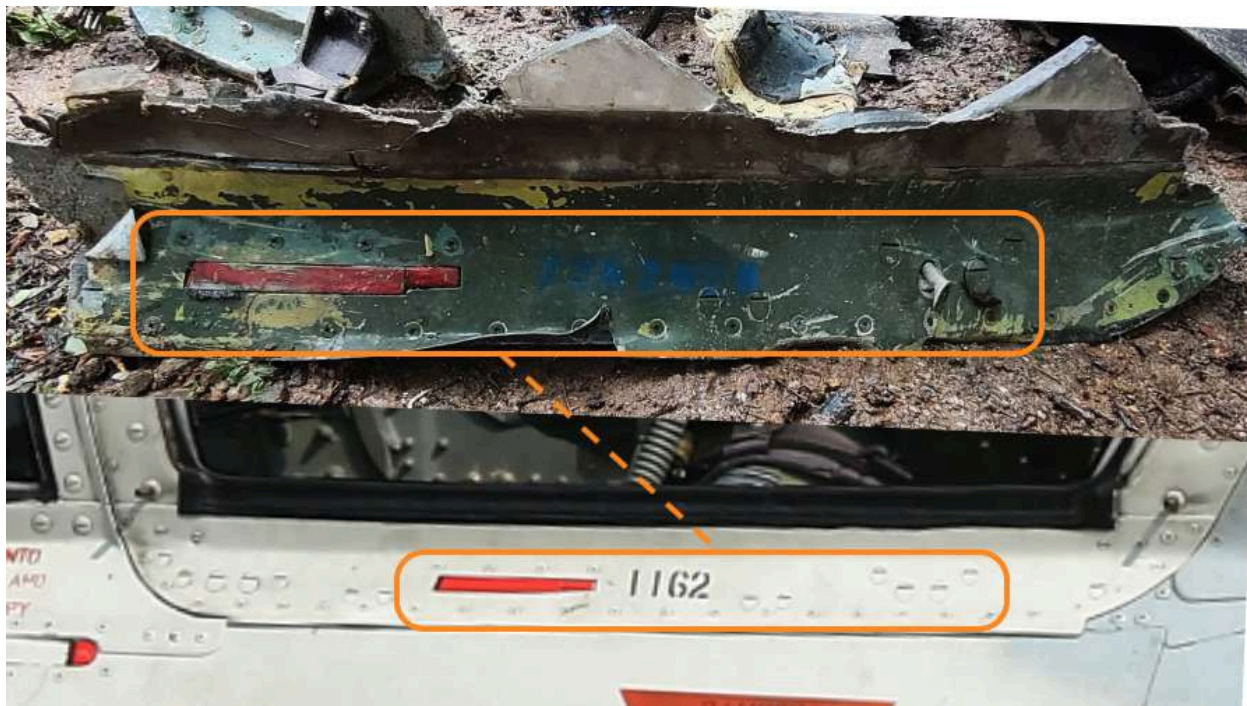
Figure 7: [Top] Myanmar Witness analysed components of the crashed aircraft from UGC, comparing it with the canopy [Bottom] of Bangladesh Air Force F-7 (sources: [Top] [PLA](#) and [Bottom] [Wikimedia Commons](#))

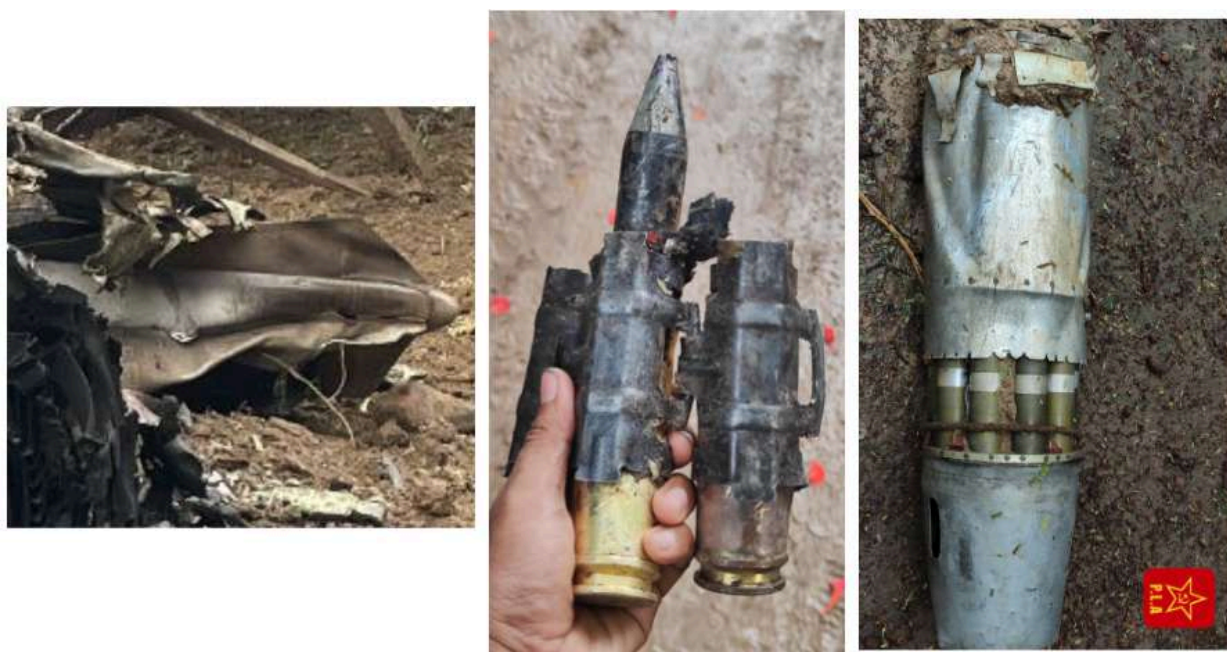
Figure 8: Myanmar Witness analysed components of the crashed aircraft from UGC, identifying [Left] 1x auxiliary external tank fuel, [Centre] 2x 30mm rounds for aircraft cannon, [Right] 1x pod for unguided rockets (sources: [Left] [Mandalay Free Press](#), [Centre] [PLA](#) and [Right] [PLA](#))

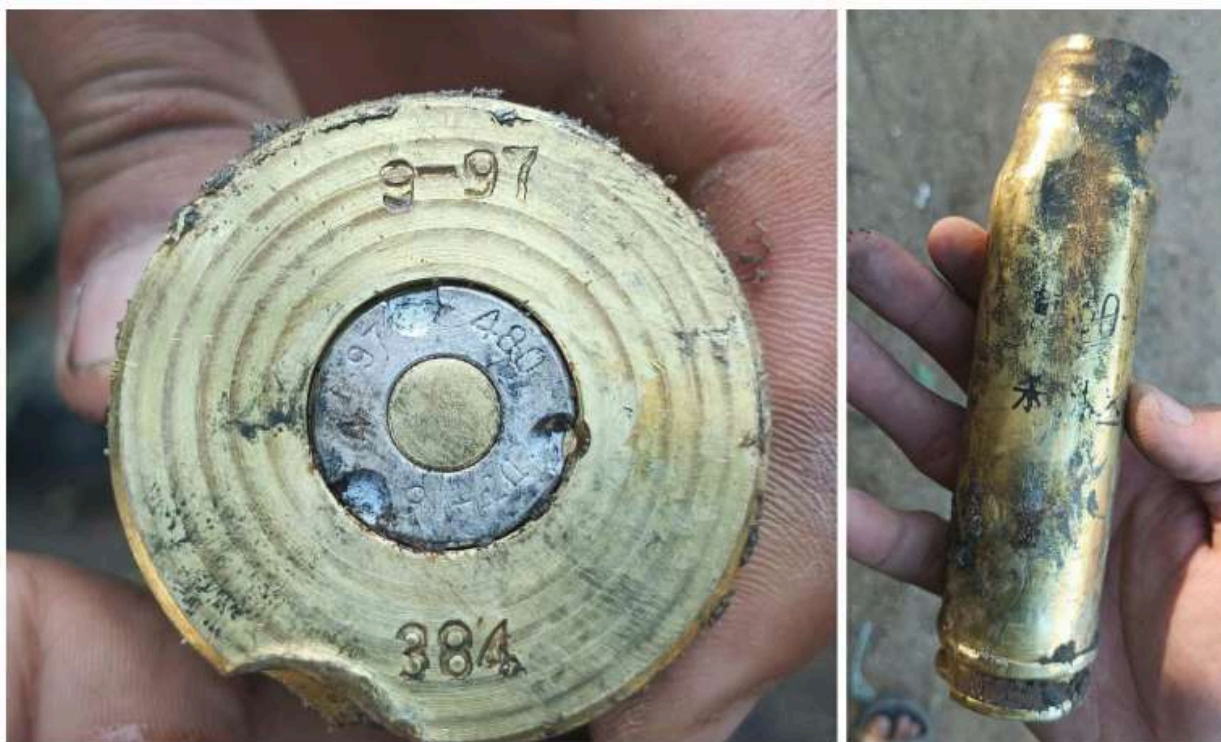
Figure 9: Myanmar Witness analysed equipment at the site of the crashed aircraft from UGC, identifying 1x 30mm round for aircraft cannon. Markings on the headstamp [Left] and shell casing [Right] suggest that this casing was manufactured or assembled in the People's Republic of China in 1997 (Source redacted due to privacy issues)

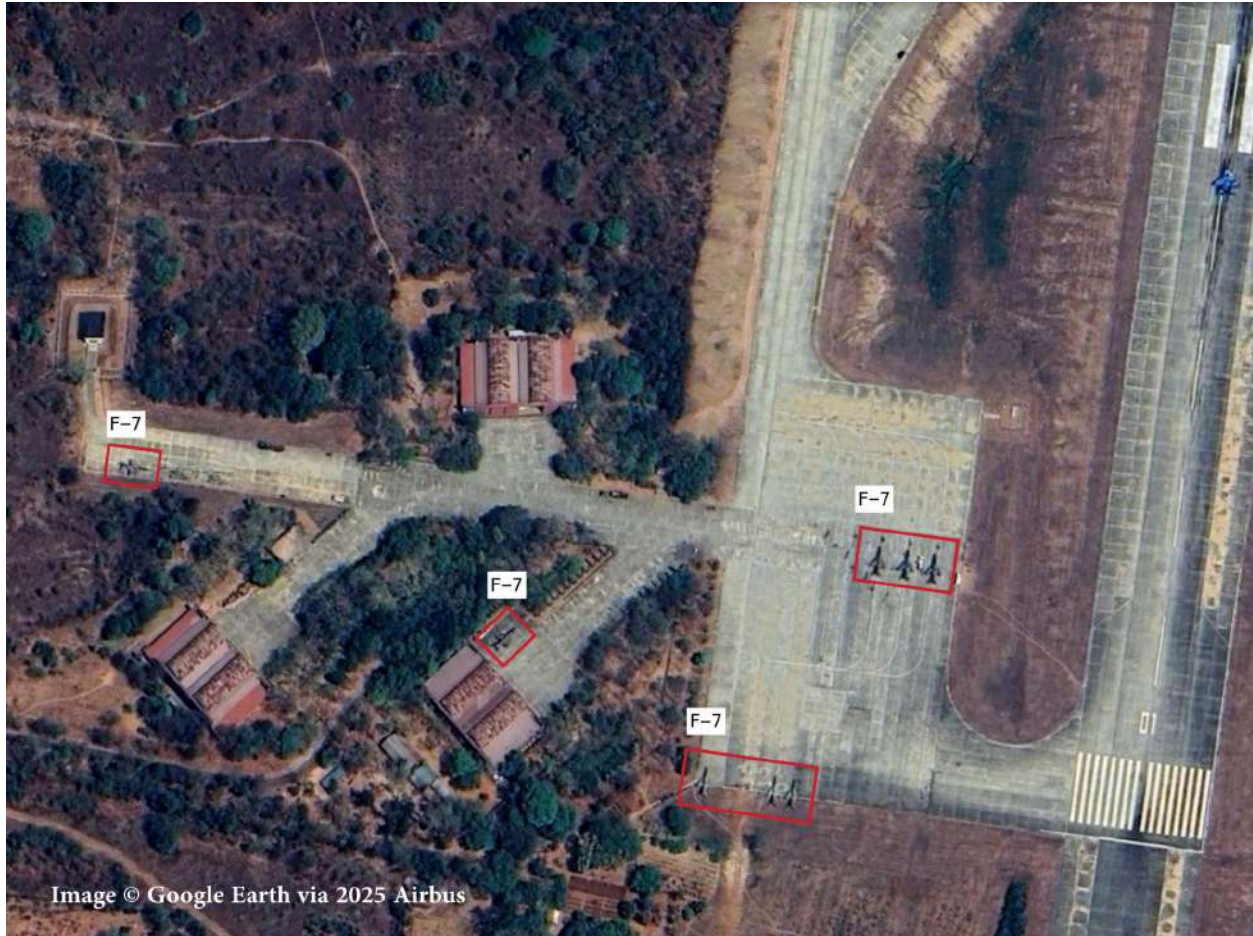
Figure 13: Location of Magway airbase with the presence of eight F-7 spotted near tarmac on 6 March 2025 imagery [20.143415, 94.964550] (Source: Google Earth Pro: 2025 Airbus)

Myanmar Witness also examined Google Earth imagery of the Magway Airbase and spotted F-7 aircraft stationed on the tarmac on imagery dated 2 March 2025 - three months before the reported crash, which is also consistent with Myanmar Witness's aircraft identification (figure 13).
