AIRSTRIKES ON RELIGIOUS BUILDINGS: CASE STUDIES FROM MAGWAY AND SAGAING REGIONS

An Analysis Of The 25 And 26 February 2025 Airstrikes On
Religious Sites

31 March 2025

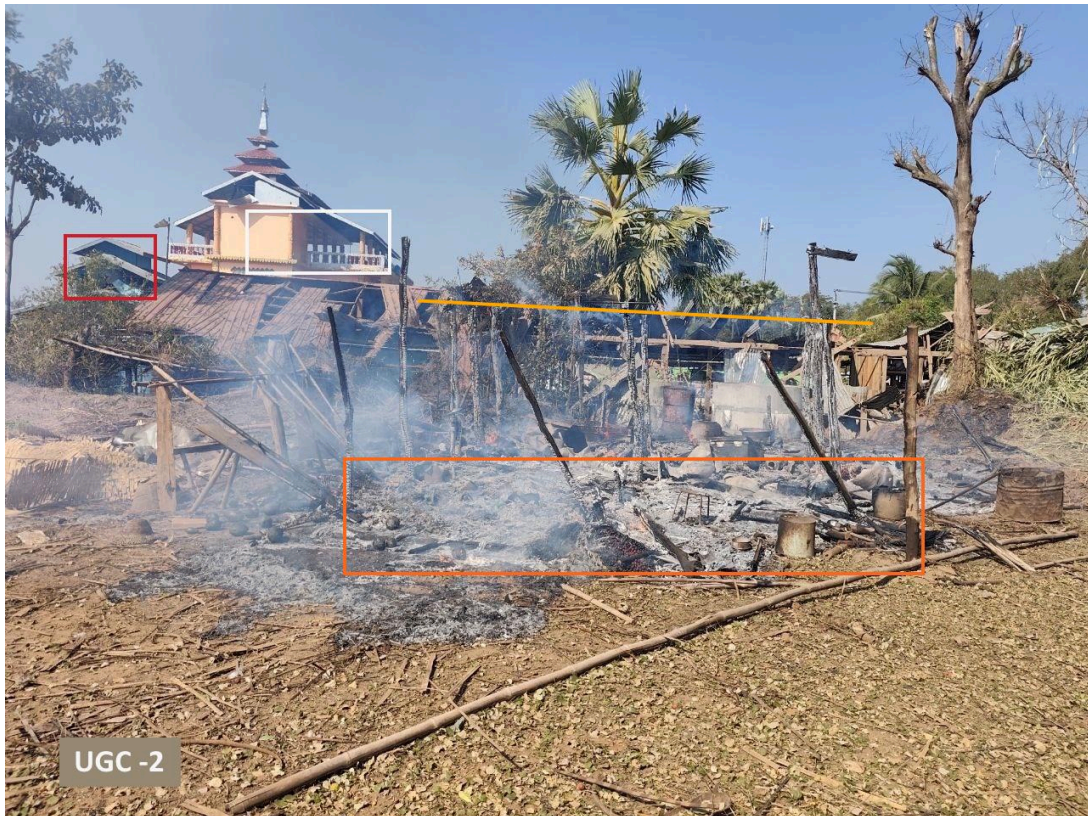
Figure 4 - An image of a destroyed building geolocated to [21.650608, 94.651880], reportedly the kitchen area (source: [MFP](#))

Moreover, Myanmar Witness cross-checked this information with satellite imagery and geolocated the damaged building to coordinates [21.650608, 94.651878], approximately nine metres east of the pagoda compound (figure 6).

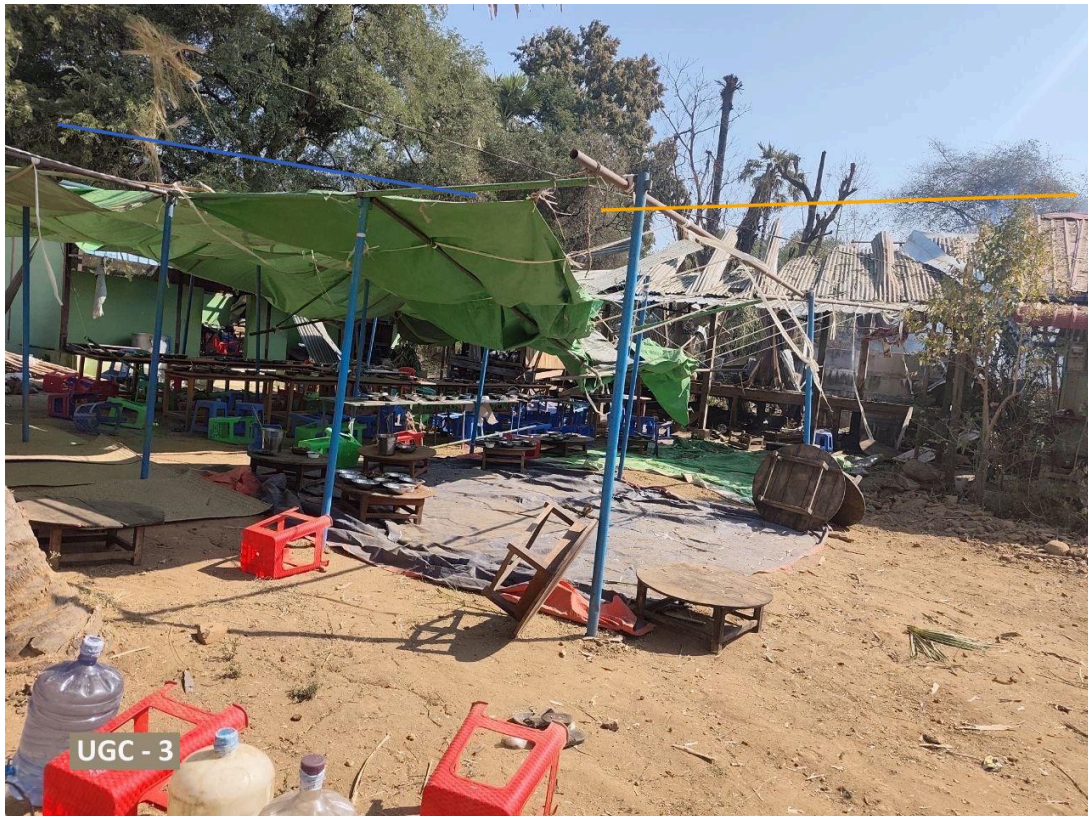
Figure 5 - An image of the damaged temporary tent reportedly used for the guest reception [21.650688, 94.651651]. (source: [MFP](#))

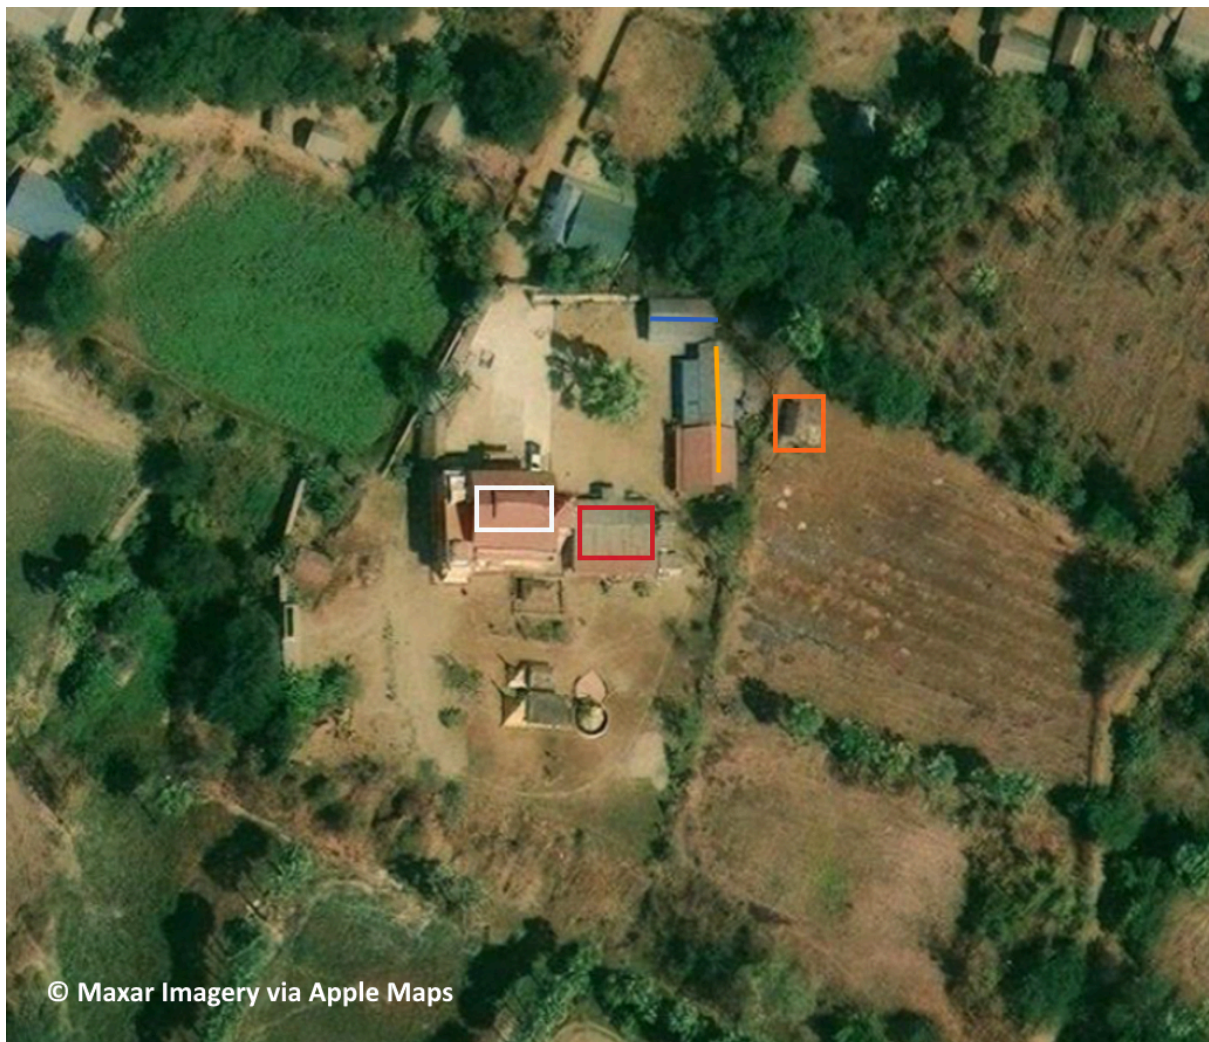
Figure 6- Visualisation of satellite imagery showing the location of UGCs posted by MFP, with geolocated points labelled UGC 1 [21.650608, 94.651880], UGC 2 [21.650608, 94.651880], and UGC 3 [21.650688, 94.651651] (source: Maxar (vivid))

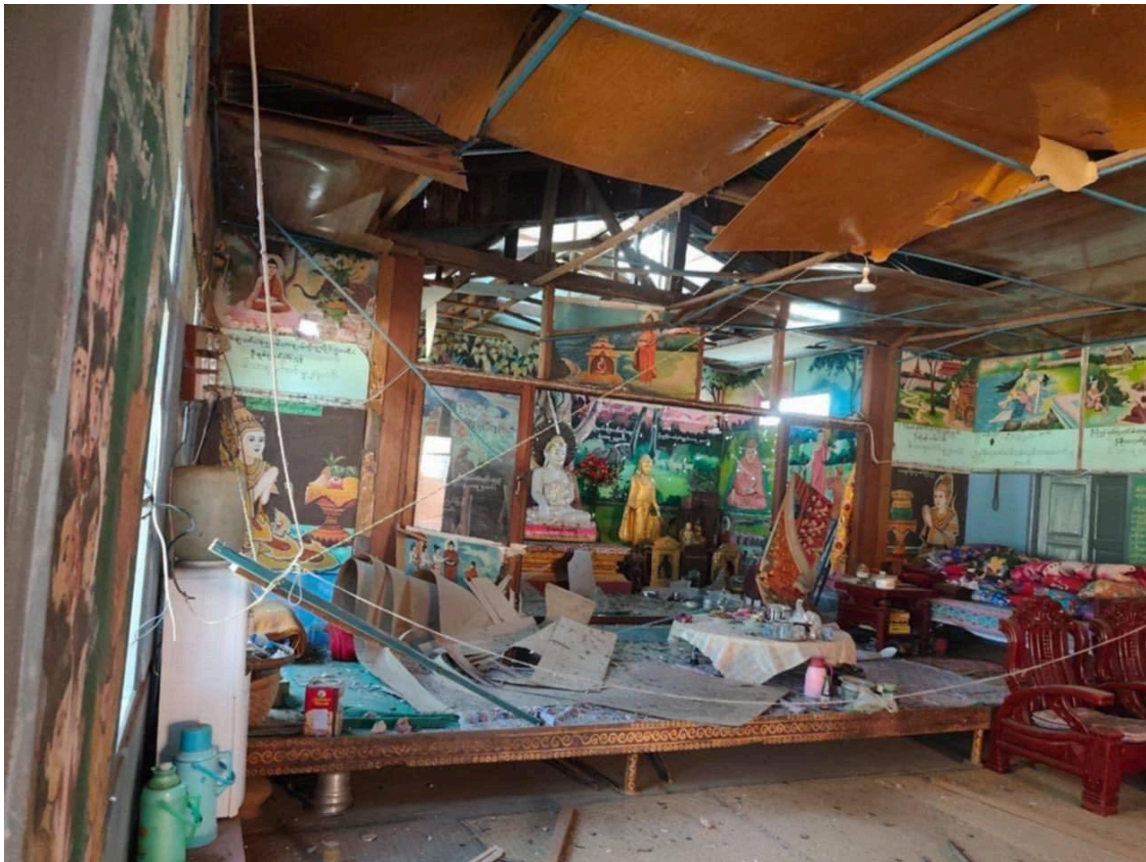
Figure 7: An image showing damage to a guest reception area, reportedly where food was being served. The building appears to be the main monastery (source: [People's Spring Post](#))

Additional imagery, also uploaded on the same day as the reported incident, shows damage to a [guest reception area](#), where food was reportedly being served to attendees (figure 7).

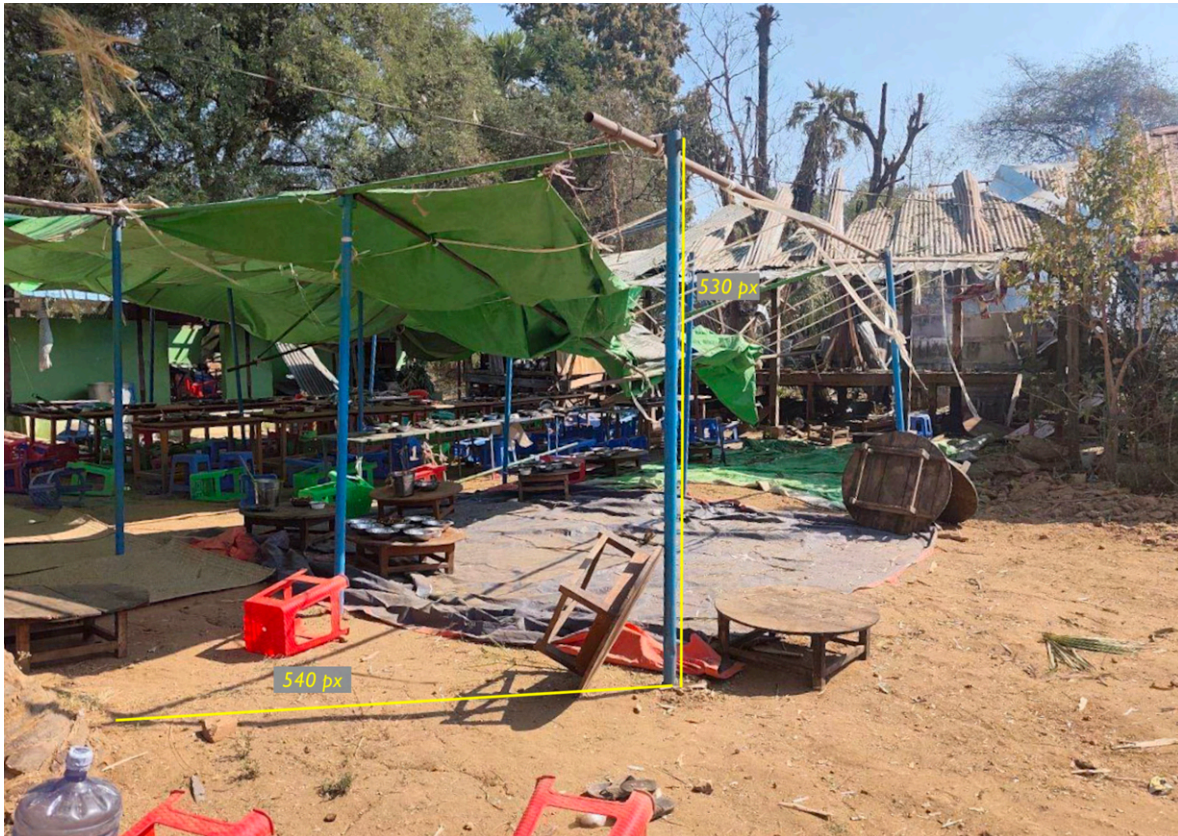
Figure 9: Shadow analysis using Suncalc suggests the UGC image was taken around 10:22 on 25 February 2025, aligning with reports of the airstrike happening at around 10:00 local time (source : [People's Spring Post](#))

To estimate the time of the UGC imagery showing the destroyed buildings (figure 9), Myanmar Witness cross-referenced the data using [Suncalc](#) (figure 10). This tool analyses sunlight angles to approximate the time an image was taken. By appropriately comparing height and shadow length in the UGC (figure 9) with [Suncalc](#), Myanmar Witness determined that the image was likely taken at approximately 10:22 on 25 February 2025. This timeframe is consistent with reports stating that the airstrike happened around 10:00 local time.

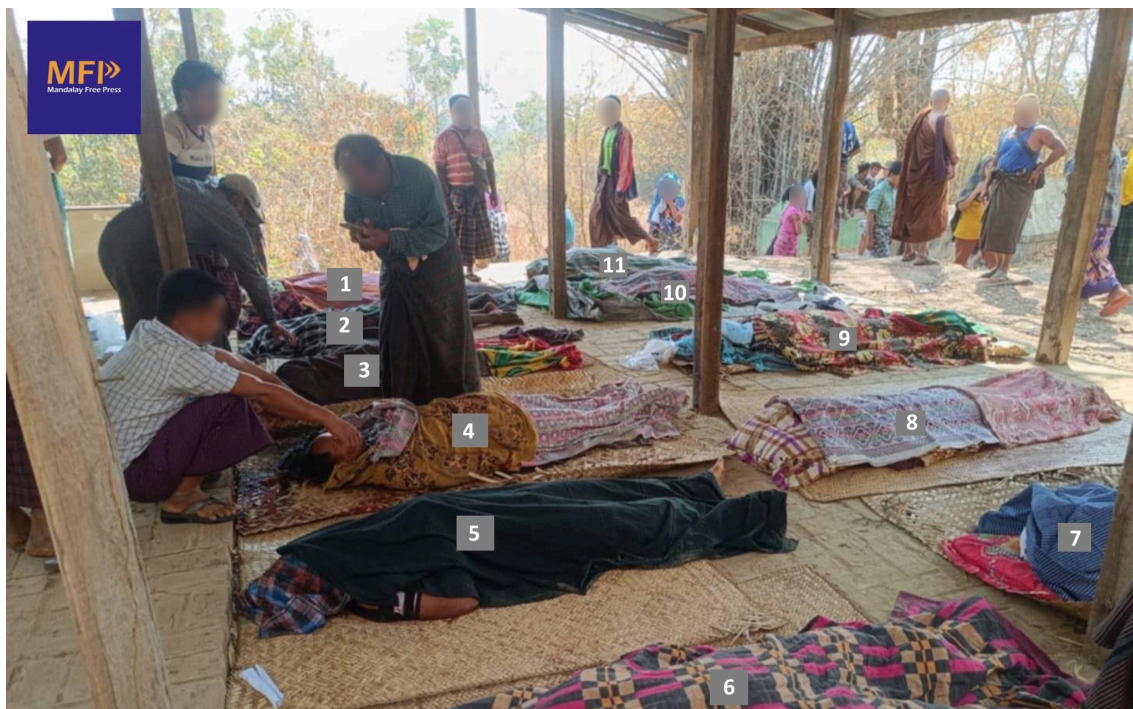
Myanmar Witness analysed available [UGC](#) and counted 11 bodies covered with blankets and clothing (figure 12). However, the imagery lacks any distinct or notable characteristics that allow for precise geolocation. While one analysis suggests that the bodies were located west of Son Kone at approximately [21.653069, 94.650080], this conclusion is disputed due to conflicting information.

Figure 12: An image showing that 11 dead bodies could be counted in the UGC posted by MFP on social media (source: [MFP](#))

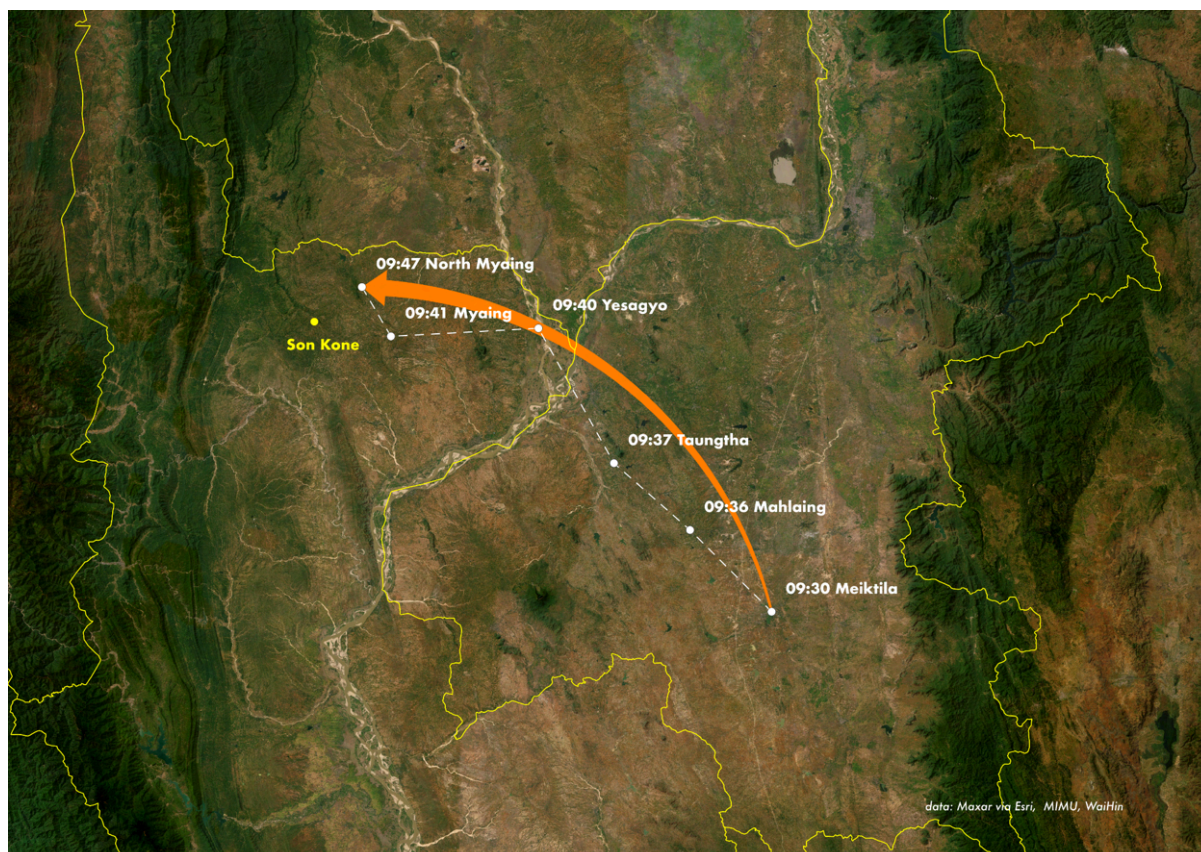
Figure 13: Reconstruction of the reported aircraft trajectory via Telegram channel messages (sources redacted due to privacy concerns).

According to the air route monitoring channel WaiHin on Telegram, an aircraft took off from Shante Airbase near Meikhtila at 09:00 local time, heading west. This flight path was tracked through four townships, confirming that the aircraft passed over Myaing town, located east of Son Kone village, at 09:47 local time (figure 13). This aligns with media reports that the airstrike occurred around 10:00 local time, thus making it highly likely that this aircraft was involved in the incident.

Time	Messages
09:30 local time (25 Feb 2025)	A FTC-2000G Jet Fighter from Shante Tale Base (Meiktila) flew west.
09:36 local time (25 Feb 2025)	A jet fighter from Meiktila Air Base flew north over the northern part of Mahlaing township.
09:37 local time (25 Feb 2025)	A jet fighter from Meiktila Air Base flew northwest over Taungtha township.
09:40 local time (25 Feb 2025)	A jet fighter from Meiktila Air Base flew northwest over Yesagyo township.
09:41 local time	A jet fighter from Meiktila Air Base flew northwest over Myaing township.

(25 Feb 2025)	
09:47 local time (25 Feb 2025)	A jet fighter from Meiktila Air Base was seen circling at a location in the northern part of Myaing Township.

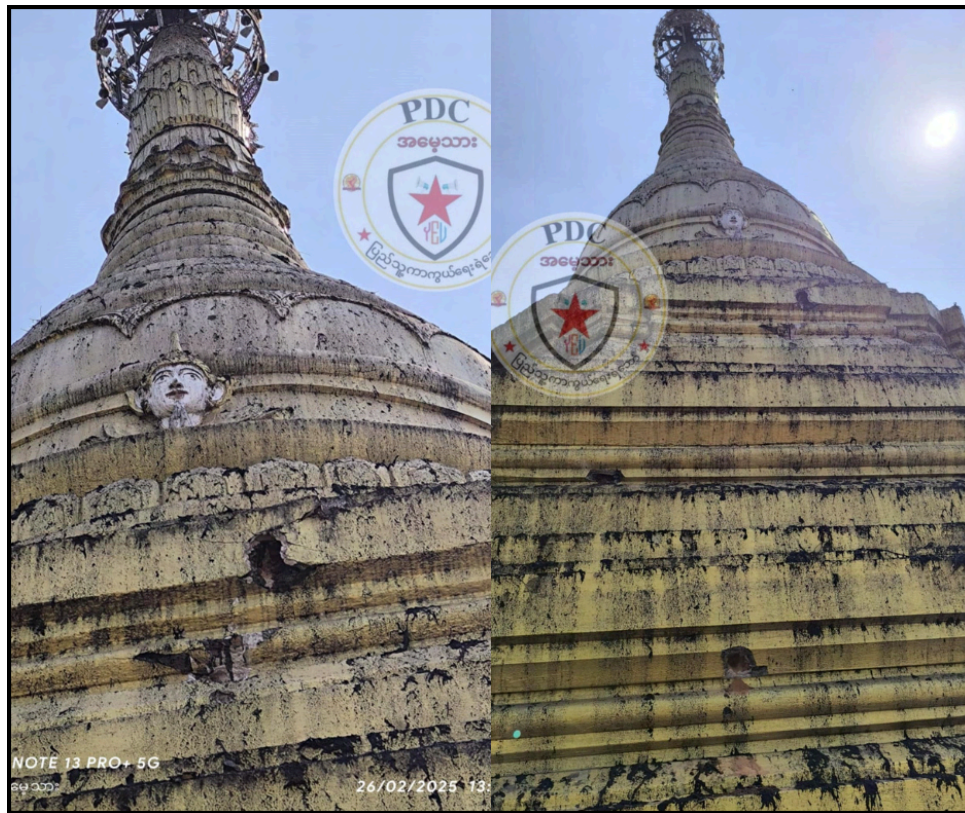
Figure 16: A UGC image of a damaged temple, located at [22.799783, 95.349656], Phaung Taw Oo temple in Me Oe village, Ye U Township. (Source: [Khit Thit Media](#))

township, Sagaing region, was reportedly hit during an alleged airstrike on 26 February 2025. According to the local PDF group, a bomb was allegedly detonated in a small lake next to the Buddhist temple compound, with shrapnel reportedly causing damage to surrounding structures (figure 16).

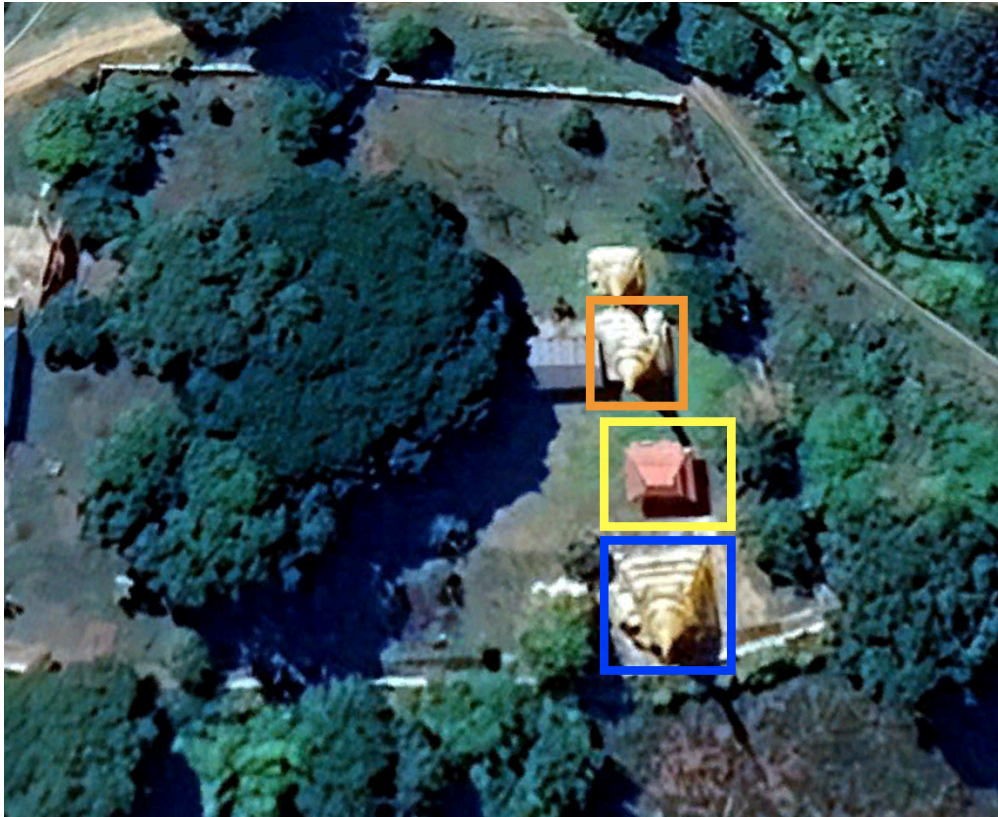
Figure 17: Google Earth imagery showing the location of Phaung Taw Oo temple in Me Oe village, Ye U Township, with the red-roof building between the two temples at coordinates [22.799683, 95.349645] (source: Google Earth)

Myanmar Witness analysed various images depicting the incident and geolocated them to Phaung Taw Oo Pagoda Hill at Me Oe village [22.799683, 95.34964] (figure 17). By cross-referencing satellite imagery with available UGC, the following elements have been geolocated:

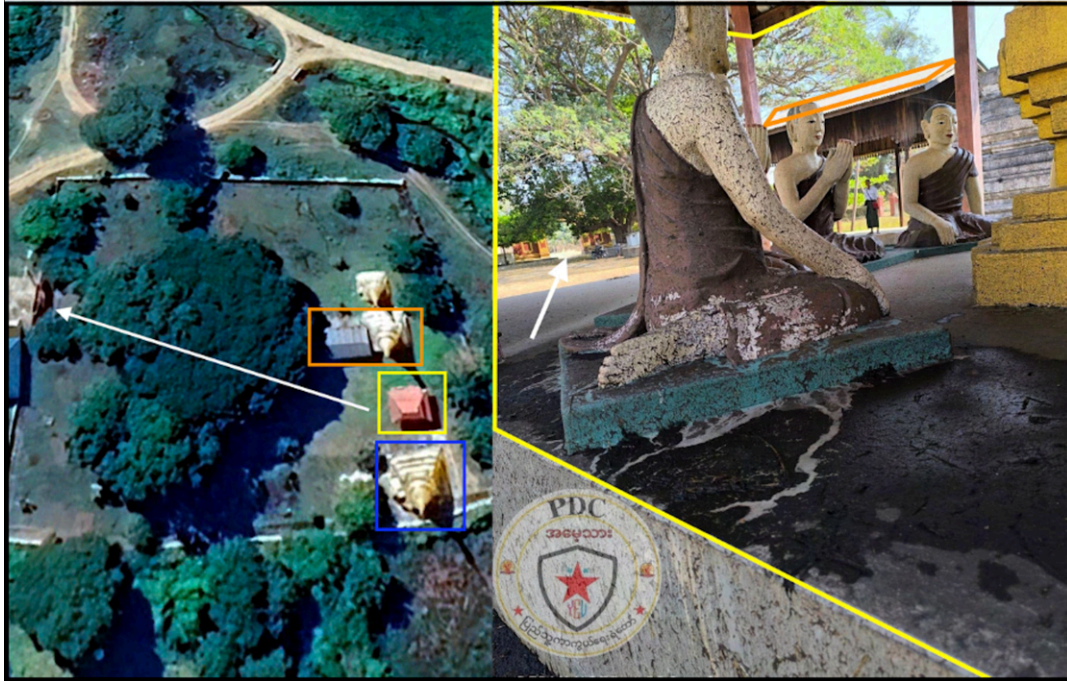
Figure 19: [Left] Google Earth imagery highlights the building with a red roof between the two temples and an arrow pointing to a building. [Right] damaged area shown in UGC imagery located at [22.799683, 95.349645], Phaung Taw Oo temple in Me Oe village, Ye U Township (Source: Google Earth and [Khit Thit Media](#))

- A damaged pagoda with an apparent ammunition impact (figure 18)
- The precise location of the pagoda that was reportedly hit (figure 19)

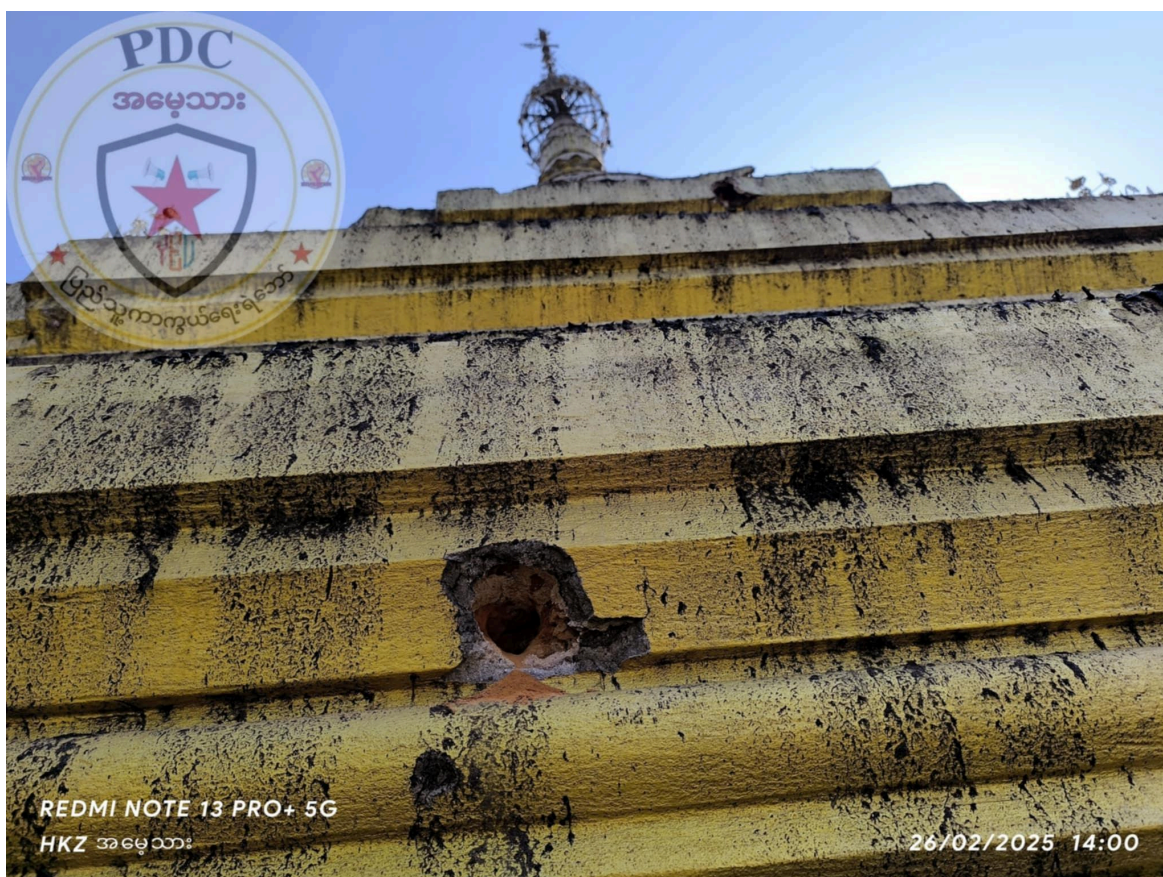
Figure 20: UGC uploaded on the same day as the reported attack, containing timestamps, supports the event occurring on or before 26 February 2025 (Source: [Khit Thit Media](#))

[Khit Thit Media](#) reports that the airstrike happened on 26 February 2025 at 11:00 local time. While Myanmar Witness cannot independently verify the exact time, UGC uploaded on the same day contains timestamps (figure 20), confirming the incident happened on or before 26 February 2025.

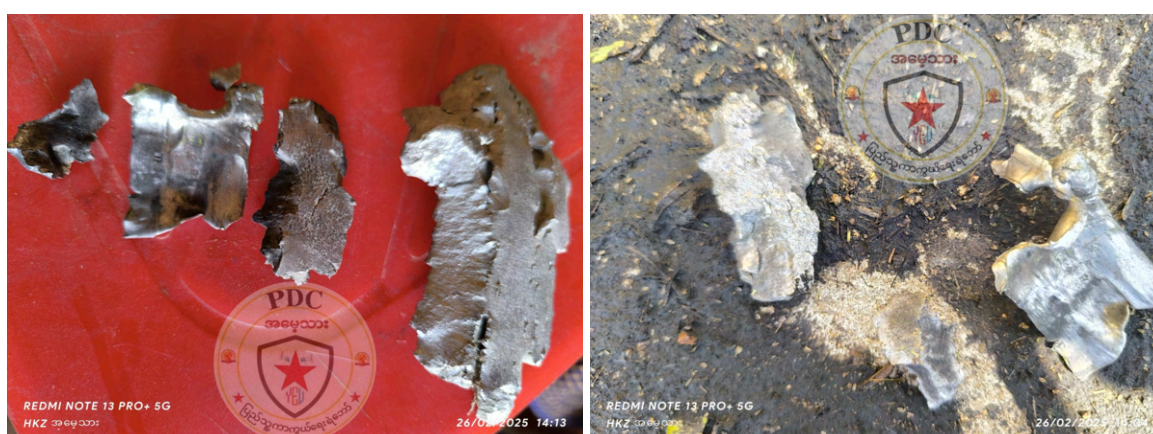
Figure 21: Images of remnants. Despite some sources claiming the MAF dropped two 100-pound bombs, the indistinct fragments in UGC make it impossible to verify the weapon type or confirm an airstrike (source redacted due to privacy issues)

While the damage and the fragments can be [visible in UGC](#), the footage lacks visibility of the remaining munition fragments, making it impossible to verify the airstrike conclusively. However, imagery of the damaged pagoda does not indicate an ammunition impact, suggesting that an explosion did occur at the site. Myanmar Witness has high confidence in the exact location but cannot verify the precise cause or whether the incident was an airstrike or another form of heavy weaponry.

Although sources such as Khit Thit Media and People's Defense Comrade claimed that the MAF dropped two 100-pound bombs, the fragments visible in UGC (figure 21) are indistinct, making it impossible to verify the type of weapon used. Myanmar Witness does not have sufficient confidence to determine whether the fragments are remnants of an airstrike or heavy weaponry.
