SUDAN WITNESS FLASH REPORT

WFP/UNICEF convoy attack near Al Koma

12 June 2025

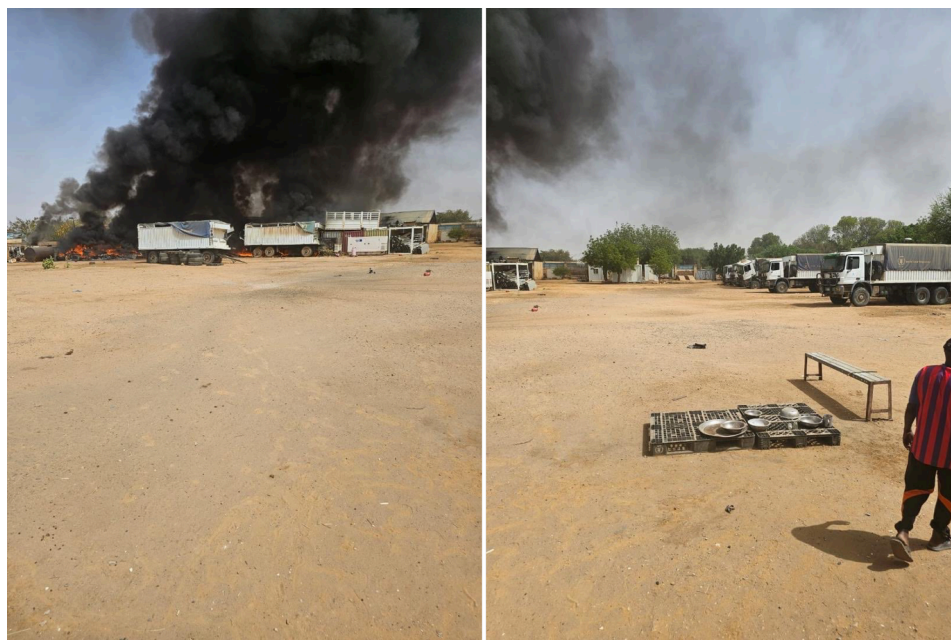
CIR verified fire damage to a WFP facility in El Fasher from an incident that likely happened on 29 May, following a statement from UN spokesperson [Stéphane Dujarric](#) on 30 May that the WFP premises in El Fasher were hit and damaged by repeated shelling from the RSF. CIR verified images posted by Mini Minawi—leader of the pro-SAF Joint Force—to X on 29 May, showing fire and dark smoke inside a WFP compound in El Fasher (figure 2), approximately 200m to the north of the airport. The post date of the images and analysis of satellite imagery from Planet and Sentinel-2 indicates the incident occurred between 28 and 29 May, while Maxar satellite imagery shows damage to the facilities. On 2 June, [Dujarric](#) confirmed that the incident happened on 29 May, “causing significant damage to a key humanitarian hub”.

Figure 2: Fires inside a WFP compound in El Fasher on 29 May. WFP trucks are seen in the right image. [13.62798,25.330975] (source: [X](#))

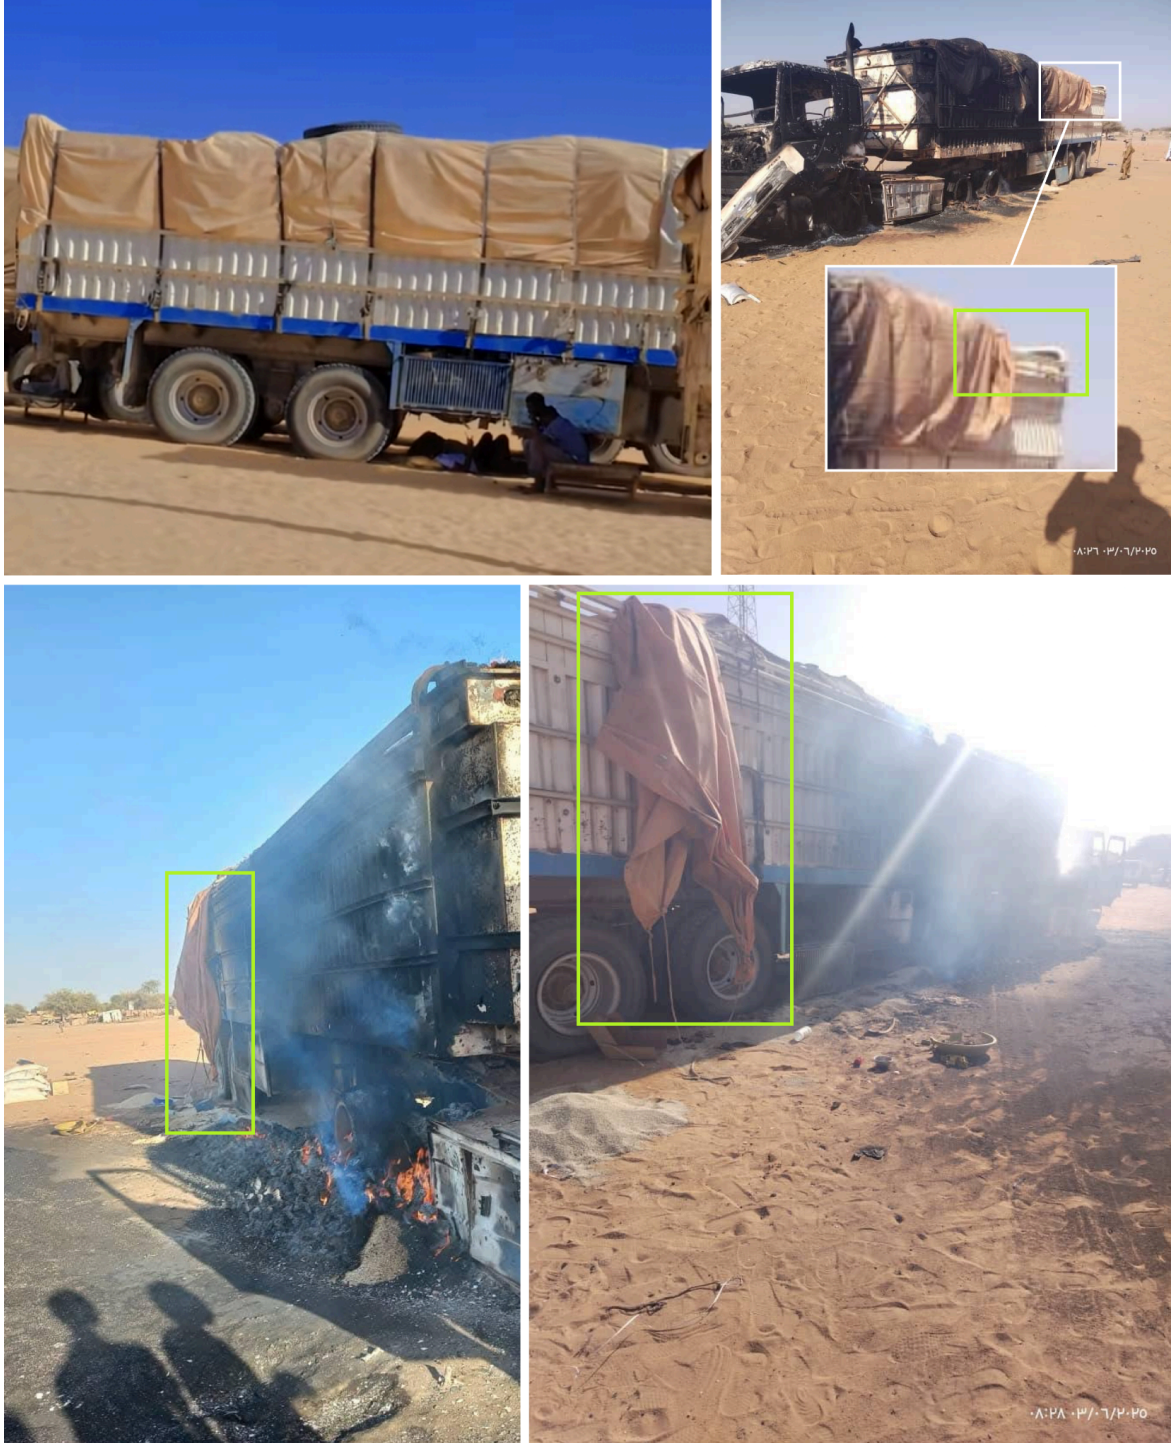
The fourth truck with damage that was likely parked next to Truck F, and the third truck that was destroyed by fire (Truck A), is seen parked behind Truck F in the convoy video posted on 31 May (figure 4, 5). By 3 June, Truck A was observed smouldering approximately 200 meters to the west. The front section—adjacent to Truck F in the 31 May video—sustained heavy fire damage, while the rear section, where the tarpaulin had been removed, showed no signs of fire damage (figure 5). The footage suggests the tarpaulin was potentially removed in an attempt to save the humanitarian aid after the truck caught fire.

Figure 5: Cropped video still showing what appears to be Truck A parked behind Truck F in a video posted on 31 May (top left), and pictures showing truck A in the morning of 3 June, destroyed by fire and with the tarpaulin removed on one side. [13.95967, 26.02186] (sources: TikTok (top left) Facebook (bottom), Facebook (top right))

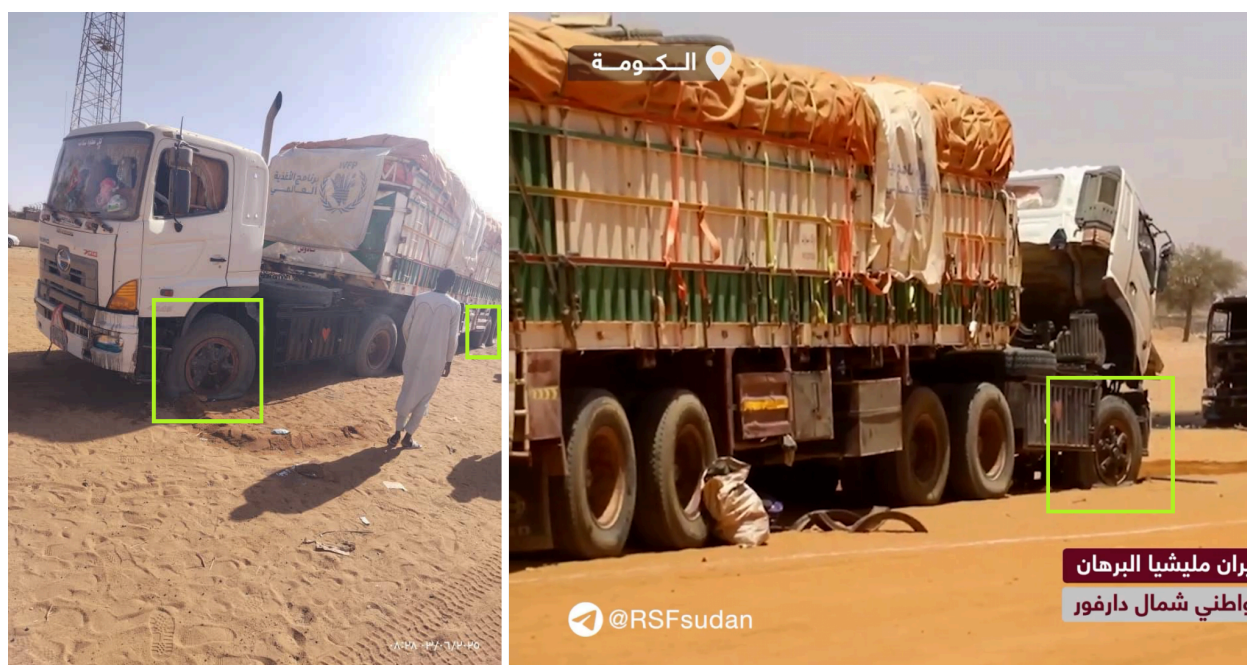
CIR identified another truck with burst tyres in the footage posted on 3 June (Truck B), seen parked at the front of the convoy in the footage posted on 1 and 2 June (figure 4).

In the aftermath footage, both of Truck B's front tyres are flat, in addition to one tyre at the back of the trailer (figure 6).

Figure 6: Photo captured in the morning of 3 June (left) and cropped video still from a video claimed to have been recorded on 5 June (right) (source: Facebook, Telegram)

CIR was neither able to confirm the seizure of the convoy nor any looting. In particular, one Truck (B) was observed with flat tyres while likely parked at the front of the convoy, some distance from the fire and potential impact, meaning the tyre damage was less likely caused by the potential blast or heat. The available footage shows signs that could indicate looting, such as some damaged packaging and one truck with removed tarpaulin. However, most of the trucks in the available footage and satellite imagery appear still covered and untouched. Further, the damaged packaging and removed tarpaulin could also be explained by an attempt to save trucks and aid from further damage. It should however be noted that CIR confirmed the trucks were removed from the site on 7 June. CIR also confirmed the presence of fighters in RSF uniform in Al Koma one day before the incident, as explained at the start of this report, in relation to the airstrike on the market on 1 June.
