MYANMAR WITNESS

A project by

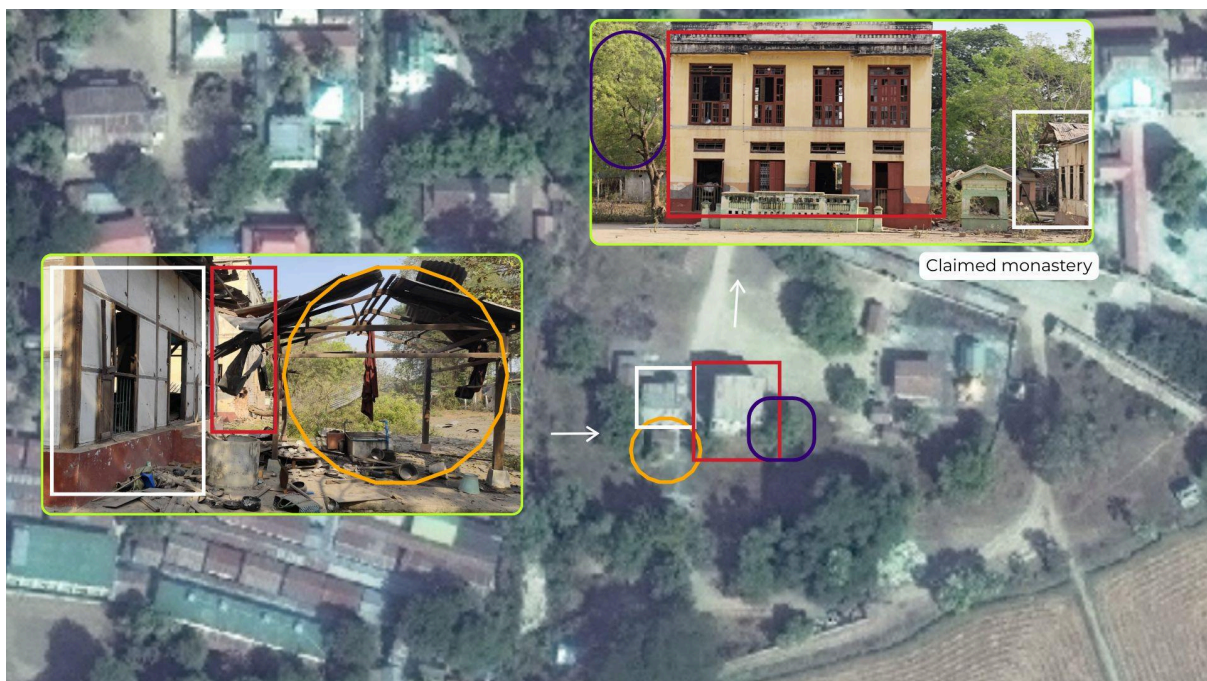
Figure 1: Myanmar Witness geolocated the monastery tied to the Seik Khun incident and cross-referenced with UGC (Sources: Satellite imagery © 2025 Vantor, UGC [Red Peacock](#) via Facebook).

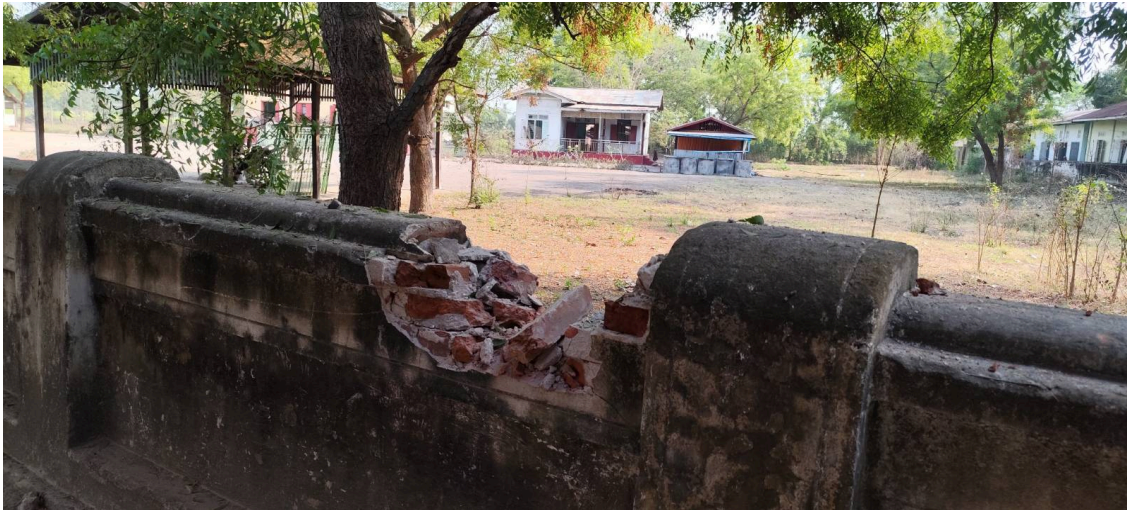
Figure 2: Myanmar Witness geolocated images of damaged walls at the compound at [22.55850], 95.583812]. (Sources: [Red Peacock](#) via Facebook).

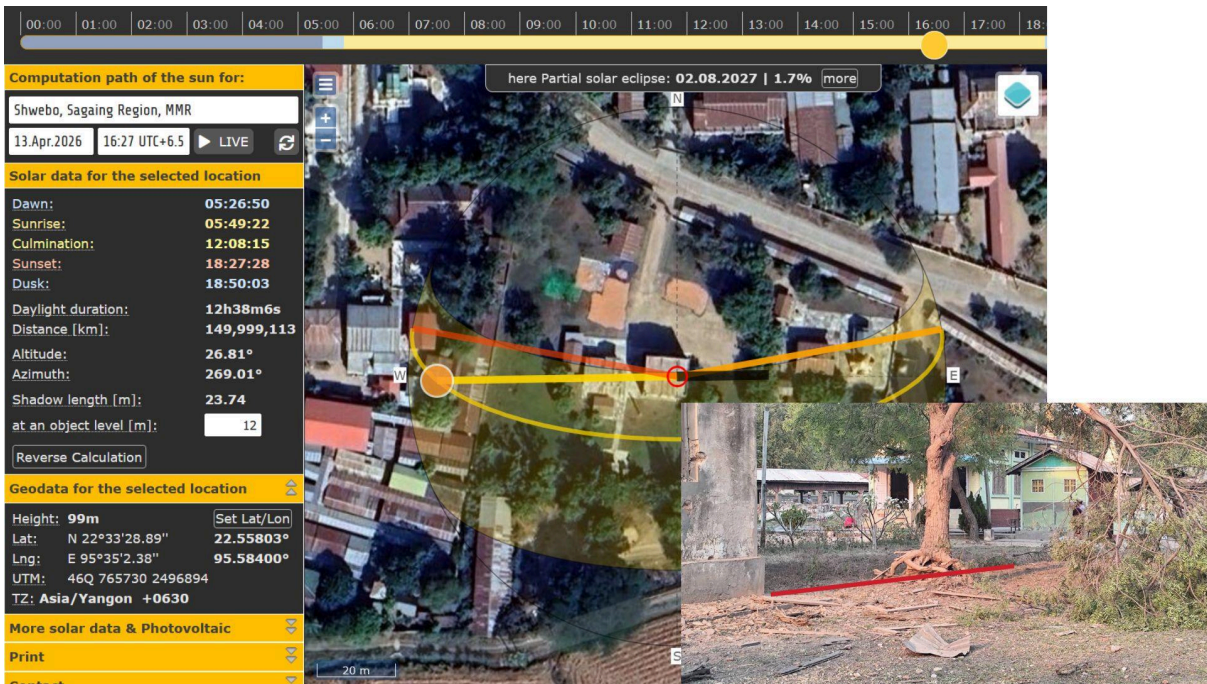
Figure 3: Myanmar Witness carried out a shadow analysis using SunCalc on UGC, which dates the aftermath imagery between 16:00 and 17:30 local time on 13 April 2026. While this aligns with reports that the incident took place on 13 April 2026, Myanmar Witness cannot conclusively verify that the airstrike occurred on that date. (Sources: [Suncalc.org](https://www.suncalc.org/), [Bottom Right] [Red Peacock](#) via Facebook).

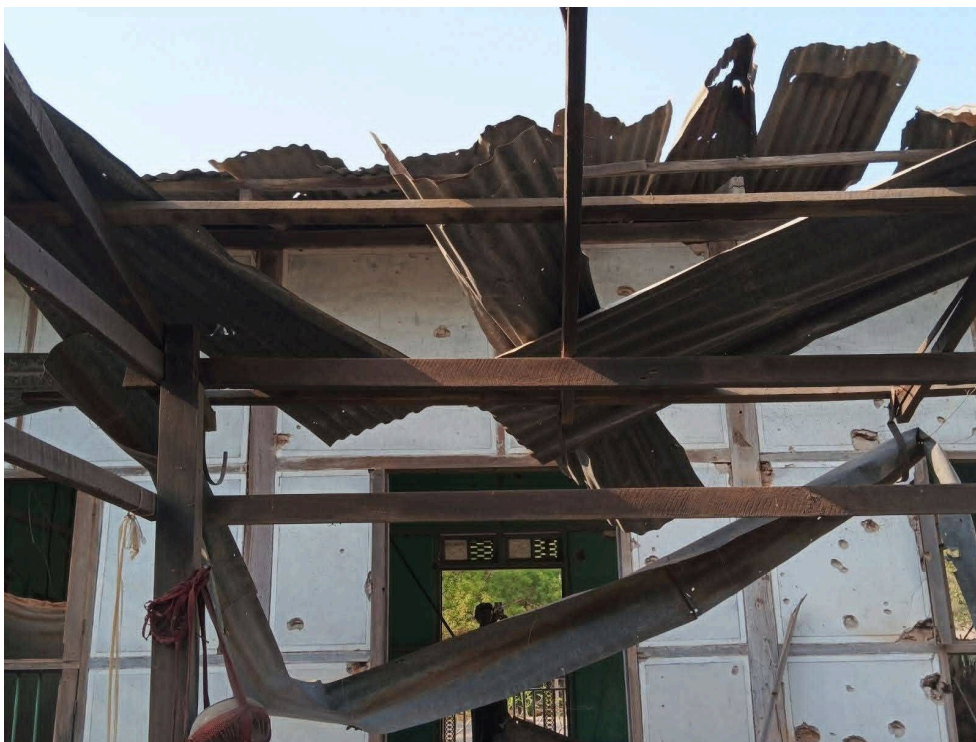
Figure 5: Myanmar Witness analysed the roofing of the external area at [22.557952, 95.583810], which shows indications of a potential aerial attack, due to the inversion of the roofing structure. (Source: redacted).

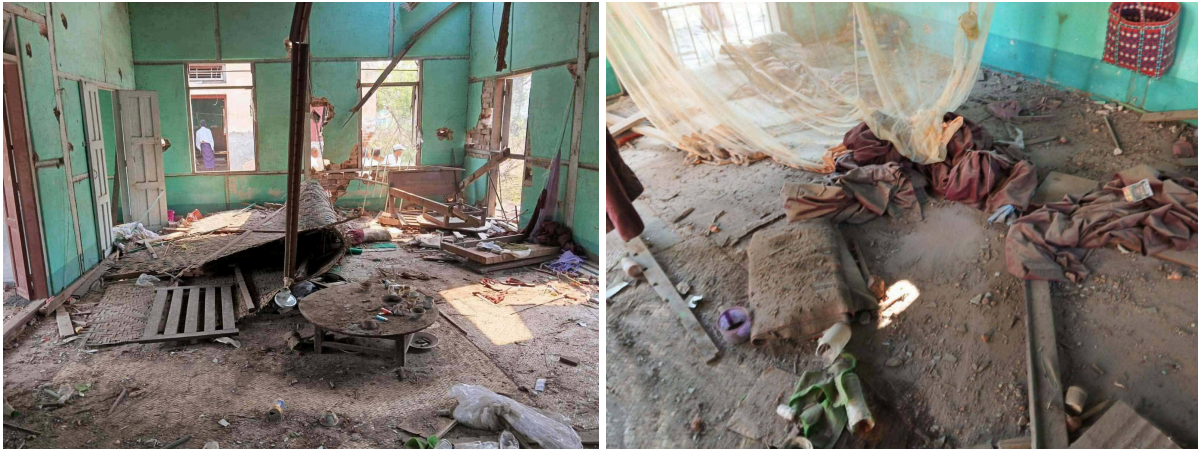
Figure 6: UGC reportedly from the Seik Khun incident demonstrates damage to the inside of a building [22.558029, 95.583815], tea tables and robes are observed among the debris (Source: [Karen People's Voice](#) via Facebook).

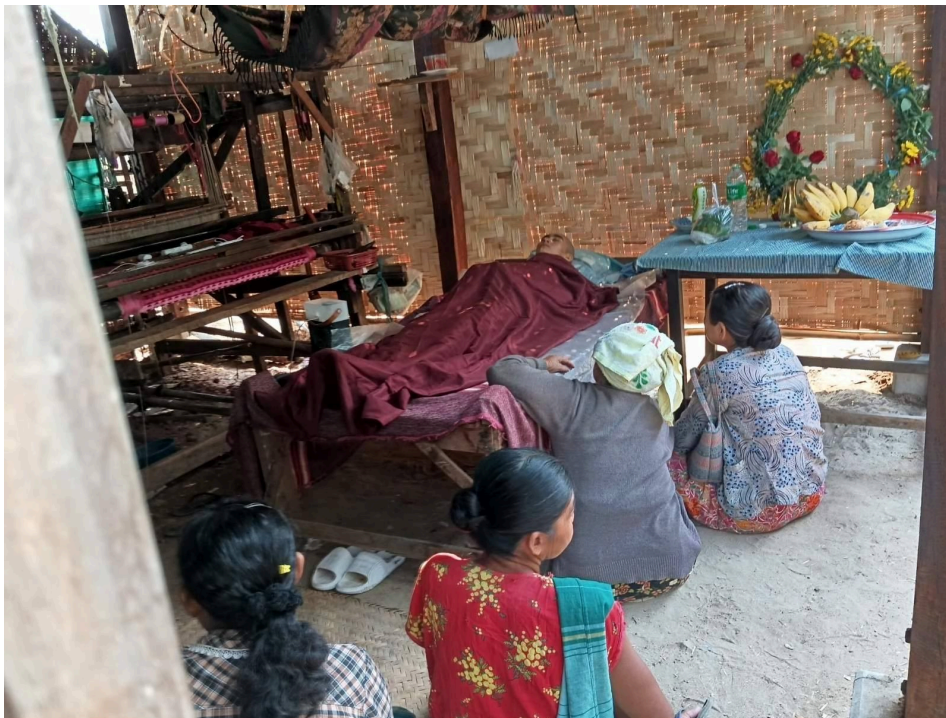
Figure 7: Myanmar Witness analysed an image of an allegedly deceased monk, which was published after the reported incident. (Source: [Mandalay Free Press](#) via Facebook).

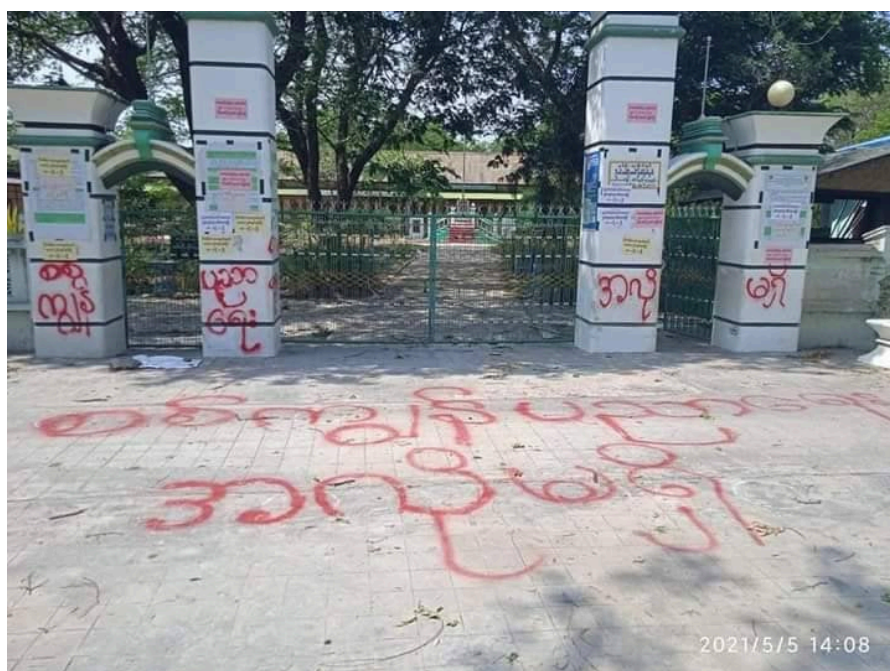
Figure 8: Myanmar Witness geolocated UGC of protest graffiti on the walls of Seik Khun Basic Education High School at around [22.547349, 95.584420] (source: [Myanmar Now](#)).

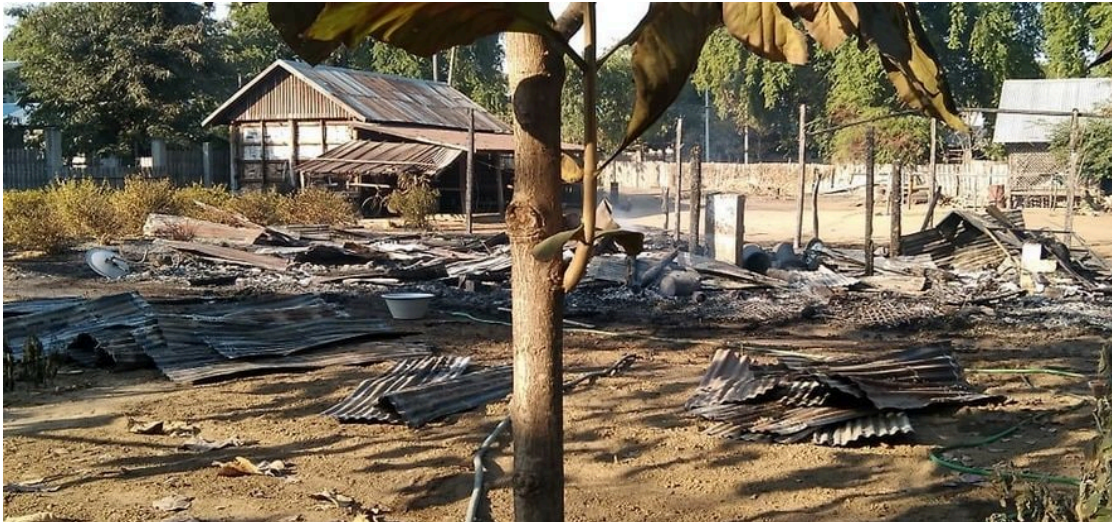
Figure 9: Myanmar Witness identified images alleged to have been associated with the DVB report of Myanmar military setting fires to civilian homes in Seik Khun in February 2022. Myanmar Witness has been unable to geolocate these videos at the time of reporting. (Source: redacted for privacy).

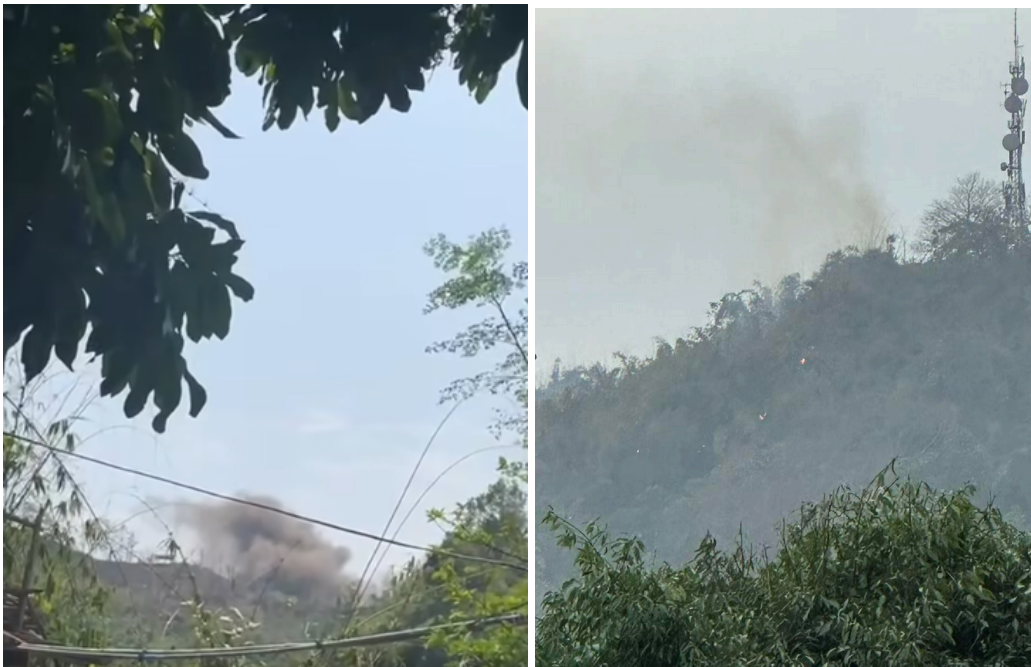
Figure 11: UGC claiming to be from the incident in Hpakant Township on the eve of Thingyan. (Source: [Left] [Mizzima](#), [Right] [Kachin News Group](#)).
