## SHWE KOKKO: A CRACKDOWN UNDER SCRUTINY

Examining Inconsistencies In Myanmar Military's  
Reported Demolition Campaign

10 August 2026

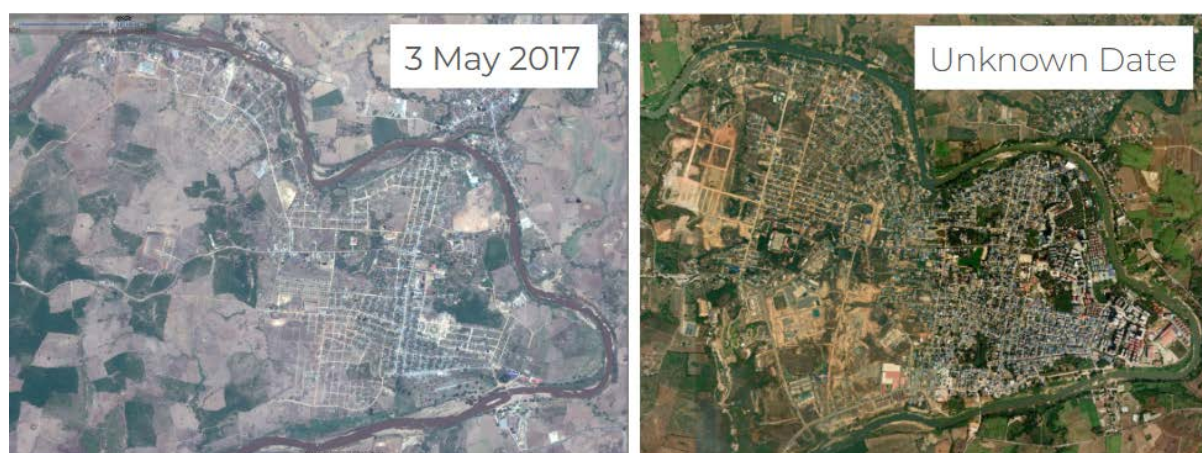
Figure 4: [Left] 3 May 2017 satellite imagery compared to early 2026 satellite imagery [Right] shows an expansion of Shwe Kokko (satellite imagery source 2017: © CNES / Airbus, Unknown date: © Apple Maps, 2026, Maxar Technologies).

Satellite imagery shows that Shwe Kokko grew rapidly between 2017 and early 2026, becoming a large developed area spanning approximately 8-9 square kilometres (figure 4). This figure does not include related developments nearby, including a water park, farm, shooting range, and a golf course under construction.

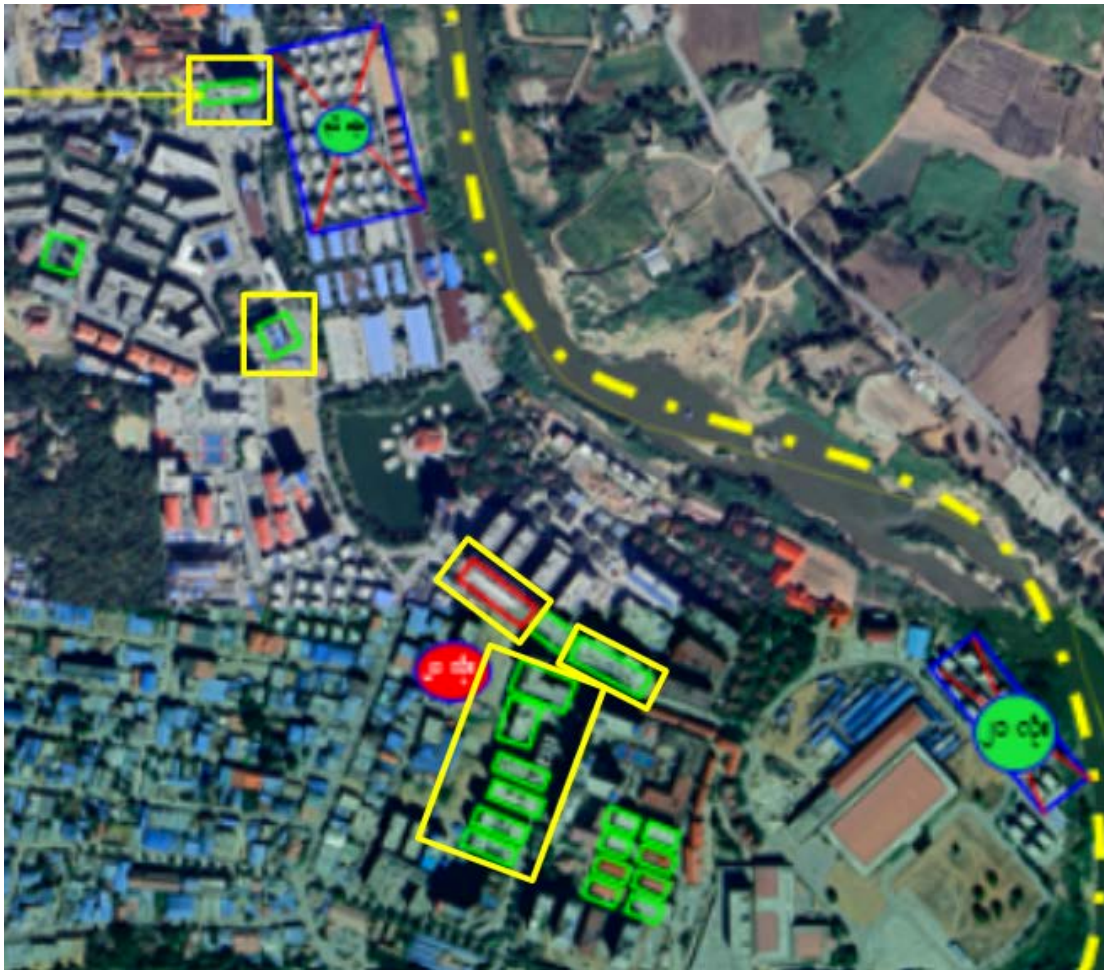
Figure 6: A zoom-in view from the state-provided map of the demolished buildings, showing which ones were not geolocated during demolitions. This was the last provided map to viewers on 22 July 2026 (source: [GNLM](#)).

The state-reported [map](#) shown in figure 6 is a zoomed-in version shared on 22 July 2026. The yellow boxes highlighted indicate which buildings were reported to be demolished, but were not confirmed by Myanmar Witness to be taken down.

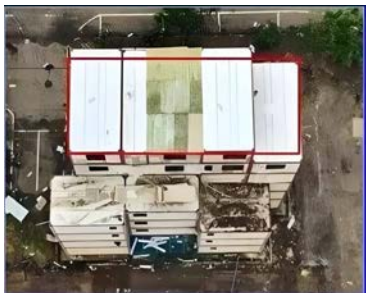
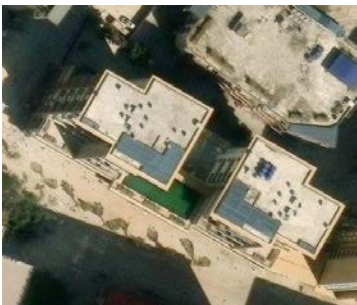
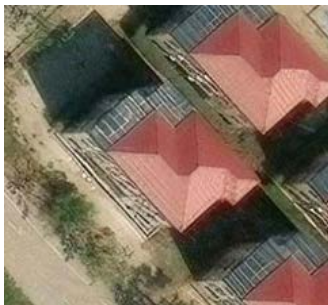
| Date & Given Image | Reported Location | Geolocation |
|---|---|---|
| <p>3. <a href="#">8 July 2026</a></p> | <p>[16.816602, 98.541897]</p> <p>Reported to be a six- storey building</p> | <p>[16.814752, 98.546393]</p> <p>Counted only four storeys</p> |

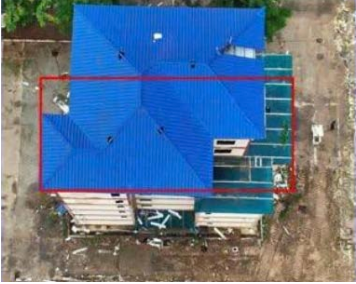
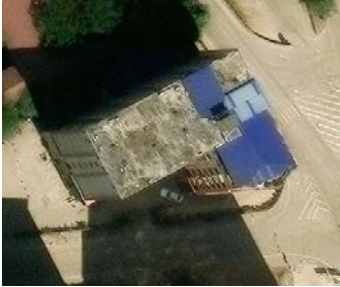
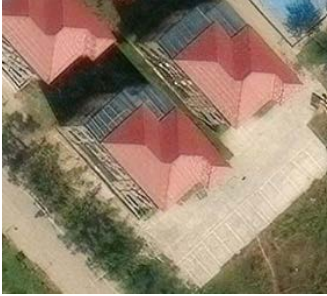
| <p>4. <a href="#">10 July 2026</a></p> | <p>[16.819900, 98.53849]</p> <p>Reported to be an eight-<a href="#">storey</a> building</p> | <p>[16.814571, 98.546572]</p> <p>Counted only 4 storeys</p> |

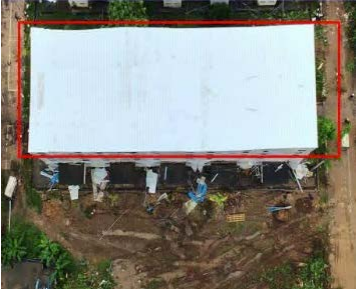
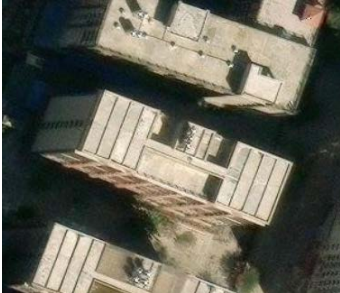
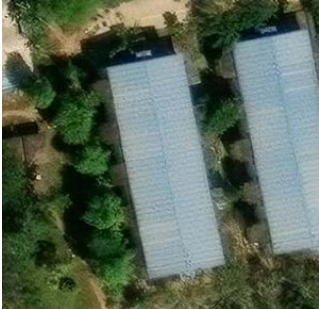
| <p>6. <a href="#">14 July 2026</a></p> | <p>[16.815123, 98.541020]</p> <p>Reported to be a 12-storey building</p> | <p>[16.820846, 98.538977]</p> <p>Counted only two storeys</p> |

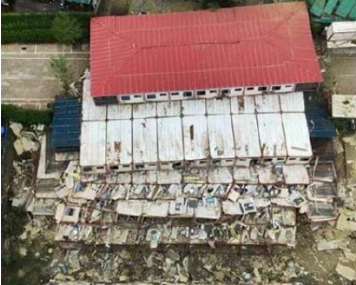
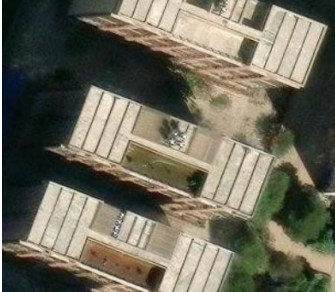
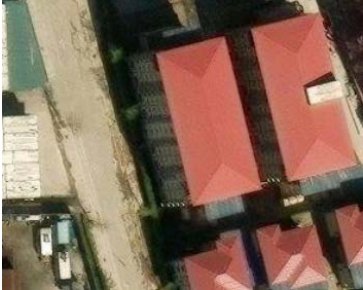
| <p>7. <a href="#">16 July 2026</a></p> | <p>[16.814852, 98.540762]</p> <p>Reported to be a 12-storey building</p> | <p>[16.817851, 98.538413]</p> <p>Counted only seven stories</p> |

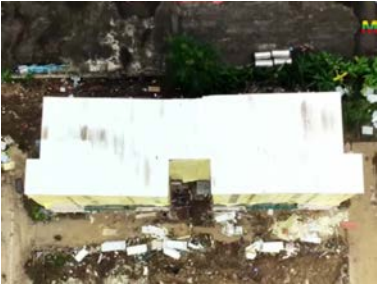
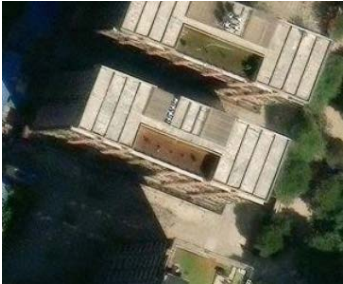
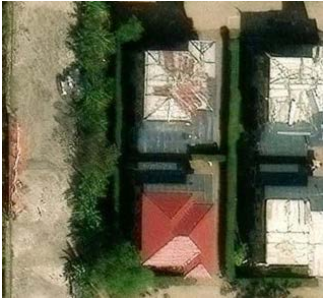
| <p>8. <a href="#">19 July 2026</a></p> | <p>[16.814610, 98.540803]</p> <p>Reported to be a 12-storey building</p> | <p>[16.821149, 98.538964]</p> <p>Two buildings, counted as only three storeys each</p> |

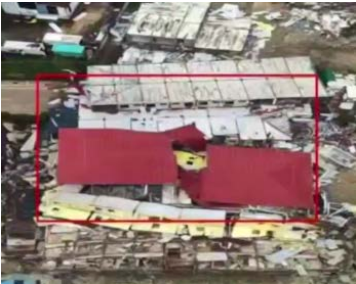
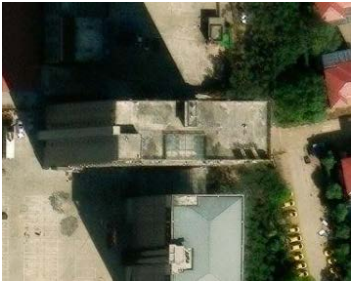
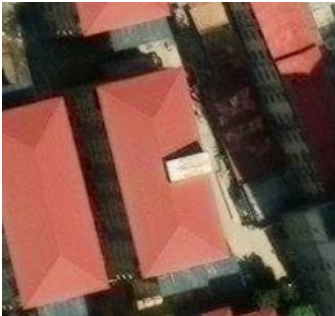
| <p>9. <a href="#">22 July 2026</a></p> | <p>[16.822437, 98.538102]</p> <p>Reported to be a 17-storey building</p> | <p>[16.817899, 98.538639]</p> <p>Counted only seven storeys</p> |

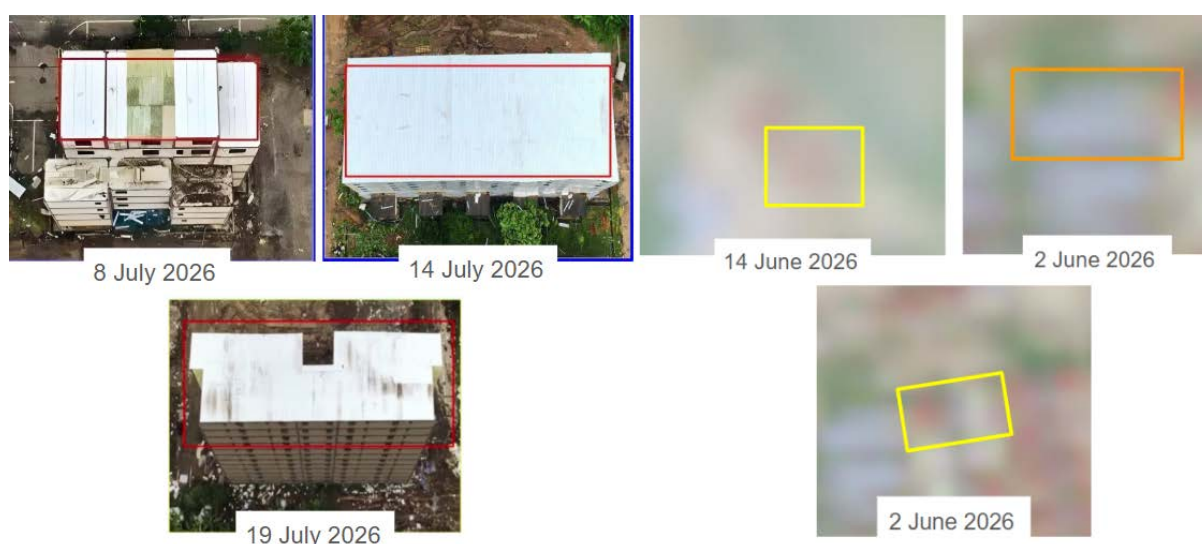
also appeared roofless in state-shared footage. However, Sentinel-2 imagery from [2 June](#) and [14 June](#) 2026 shows that two of these buildings still had roofs shortly prior to the planned demolition. (figure 7).

Figure 7: [Left] Three images showing no roofs (Sources: 8 July 2026 [东南亚大事件](#), 14 July 2026 [【妙瓦底论坛】妙瓦底新闻 | 亚太新闻 | 缅甸新闻](#), 19 July 2026 [MRTV](#)); [Right] Low-resolution Sentinel-2 imagery showing original rooftops (sources [2 June](#) 2026 [Top], [2 June](#) 2026 [Bottom], and [14 June](#) 2026).

This finding suggests that several buildings have been altered before their demolition; however, Myanmar Witness cannot verify when or why the roofs were removed, but it certainly reduces the clarity of the state's messaging around this crackdown.

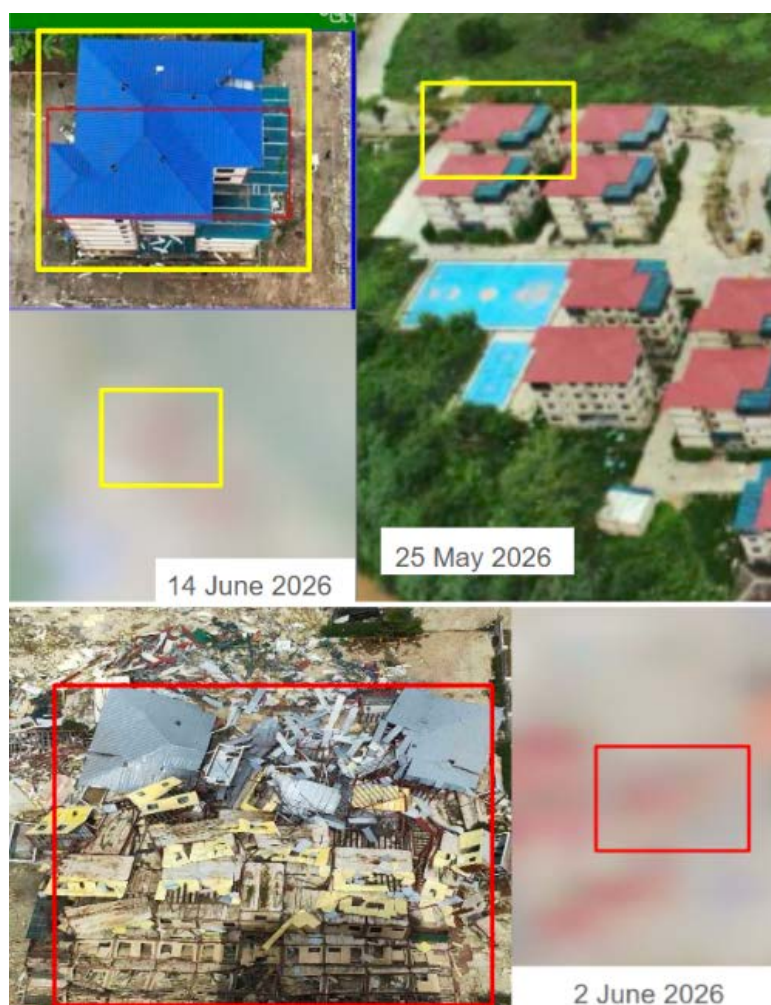
Further discrepancies were also visible in at least two building demolitions where the roof colour (or material) depicted in state footage did not match satellite imagery. On 10 July 2026, a villa with a [blue roof](#) was shown being demolished with explosives. Using satellite imagery, Myanmar Witness confirmed that as of early June 2026, no villa in Shwe Kokko had a blue roof (figure 8). Myanmar Witness geolocated this demolished villa to [16.814565, 98.546576]. However, in all available [satellite imagery](#), the roof of this building is red.

Similarly, on 26 July 2026, state-reported imagery showed a building with a [grey roof](#), but geolocation placed the demolition at [16.818302, 98.538524], where high-resolution satellite imagery shows a red roof as of [25 May 2026](#). Additionally, low-resolution Sentinel-2 imagery confirms this building was red-roofed on [2 June](#) 2026, after the demolition series began.

Figure 8: {Top Left} A building showing a blue roof [16.814571, 98.546572] (source: [东南亚大事件](#)); {Bottom Left} A building showing a grey roof [16.818305, 98.538523] (source: [GNLM](#)); {Top Right} Imagery from 25 May 2026 showing the blue roofed building location having a red roof (source: [GNLM](#)); {Middle Left} Sentinel-2 imagery showing the blue roofed location as still having a red roof on 14 June 2026 (source: [Sentinel-2](#)); [Bottom Right] Sentinel-2 imagery showing the grey roofed building location having a red roof on 2 June 2026 (source: [Sentinel-2](#)).

Myanmar Witness has been unable to confirm why these roofs appear to have changed in the weeks before the demolitions. It should be noted, however, that the state-provided map outlining the demolition plans and the specific buildings to be destroyed does not align with the geolocated buildings shown in the footage. The state map placed the blue-roofed villa at [16.819900, 98.53849], but Myanmar Witness's geolocation identifies the demolished building at [16.814565, 98.546576]. Additionally, on 26 July 2026, the state map puts the grey-roofed building at [16.817283, 98.540866] while geolocation confirms the demolished building at [16.818302, 98.538524] (figure 9).

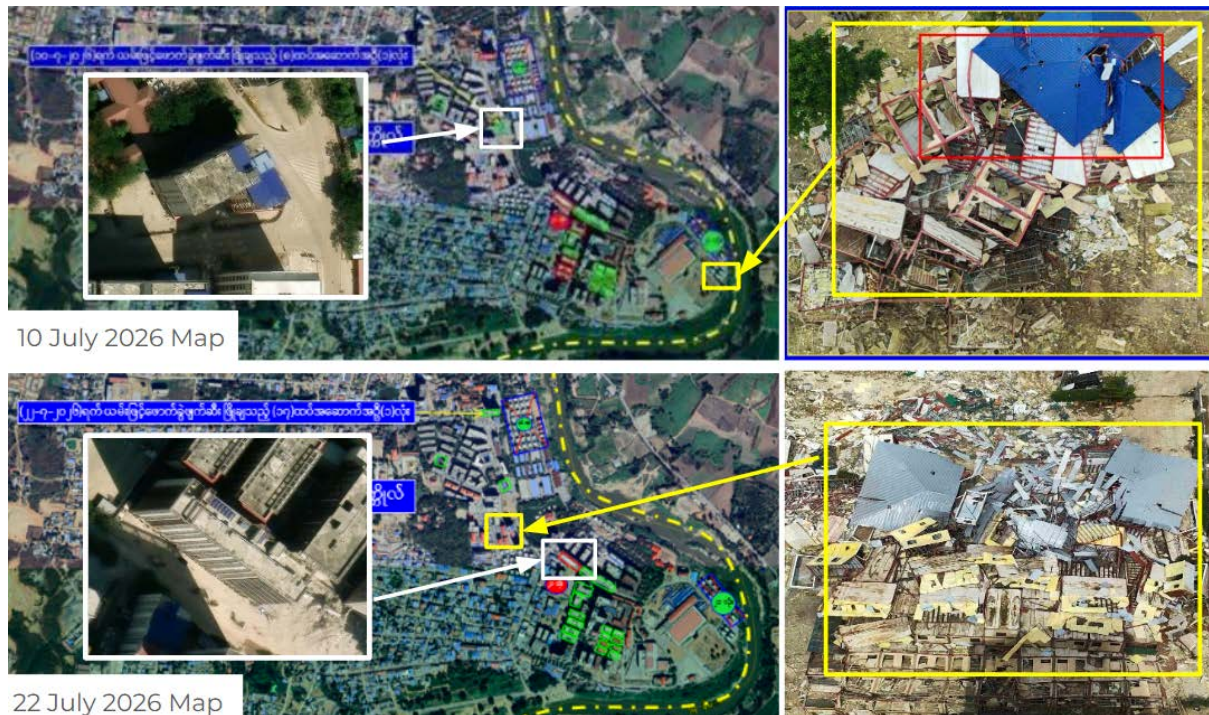
Figure 9: [Top Left] A 10 July 2026 state-provided map showing the location where the state media reported the blue roofed building location (white box) [16.819900, 98.53849] (map source: [妙瓦底论坛](#) | [妙瓦底新闻](#) | [亚太新闻](#) | [缅甸新闻](#)) (satellite image source: © Apple Maps, 2026, Maxar Technologies); [Top Right] Image of the blue roofed villa with an arrow indicating its geolocation on the state map (source: [GNLM](#)); [Bottom Left] A 22 July 2026 state-provided map showing the final demolition location (white box) [16.819900, 98.53849] (map source: [GNLM](#)) and (satellite image source: © Apple Maps, 2026, Maxar Technologies); [Bottom Right] Image of the grey roofed building with an arrow indicating its geolocation on the state map (source: [GNLM](#)).

Therefore, these types of mismatches- the roof removals, differences in colours, and map locations suggest that the state's visual presentation of the demolitions does not consistently match the buildings that are actually shown being destroyed.

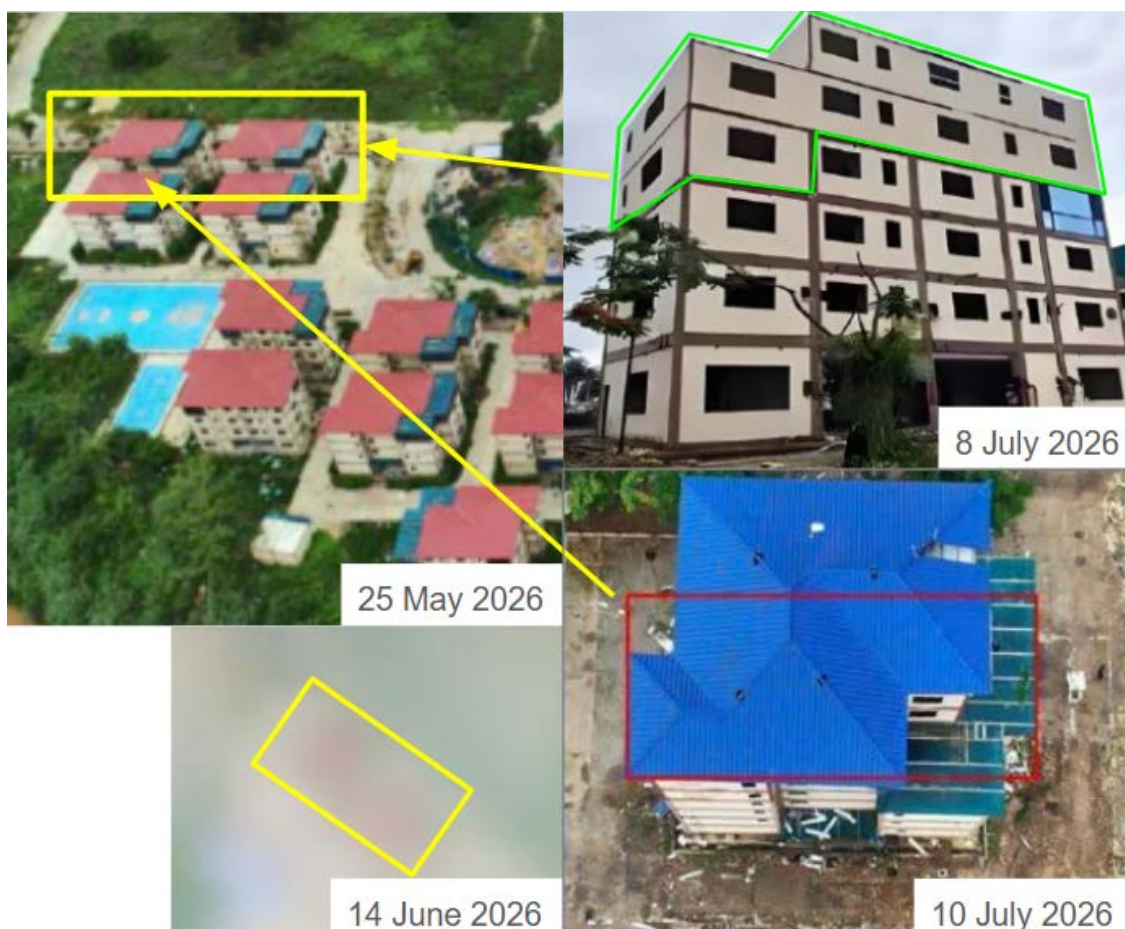
On [8 July](#) 2026, a villa [16.814752, 98.546393] was shown in demolition footage as having six visible storeys; however, earlier imagery from [25 May](#) 2026 shows the building had four levels (figure 10). On [10 July](#) 2026, another nearby blue-roofed villa also appears to be presented as taller than in earlier imagery, with six storeys. State media reported the villa to be an eight-storey building. In both cases, low-resolution Sentinel-2 imagery from 14 June 2026 still shows red roofs, indicating that the buildings' appearance also changed before demolition. The green line shown in figure 10 below highlights the part of the 8 July demolished villa that appears to have additional storeys.

Figure 10: [Top Right] Image of the 8 July 2026 building with a green outline highlighting the appearance of additional storeys [16.814752, 98.546393] (source: [东南亚大事件](#)); [Bottom Right] Image of the blue roofed villa from 10 July 2026 [16.814565, 98.546576] (source: [东南亚大事件](#)); [Top Left] Zoomed-in imagery of the 8 and 10 July 2026 buildings with both showing red roofs (source: [GNLM](#)); [Bottom Left] Sentinel-2 imagery from 14 June 2026 showing red roofs on both buildings (source: [Sentinel-2](#)).

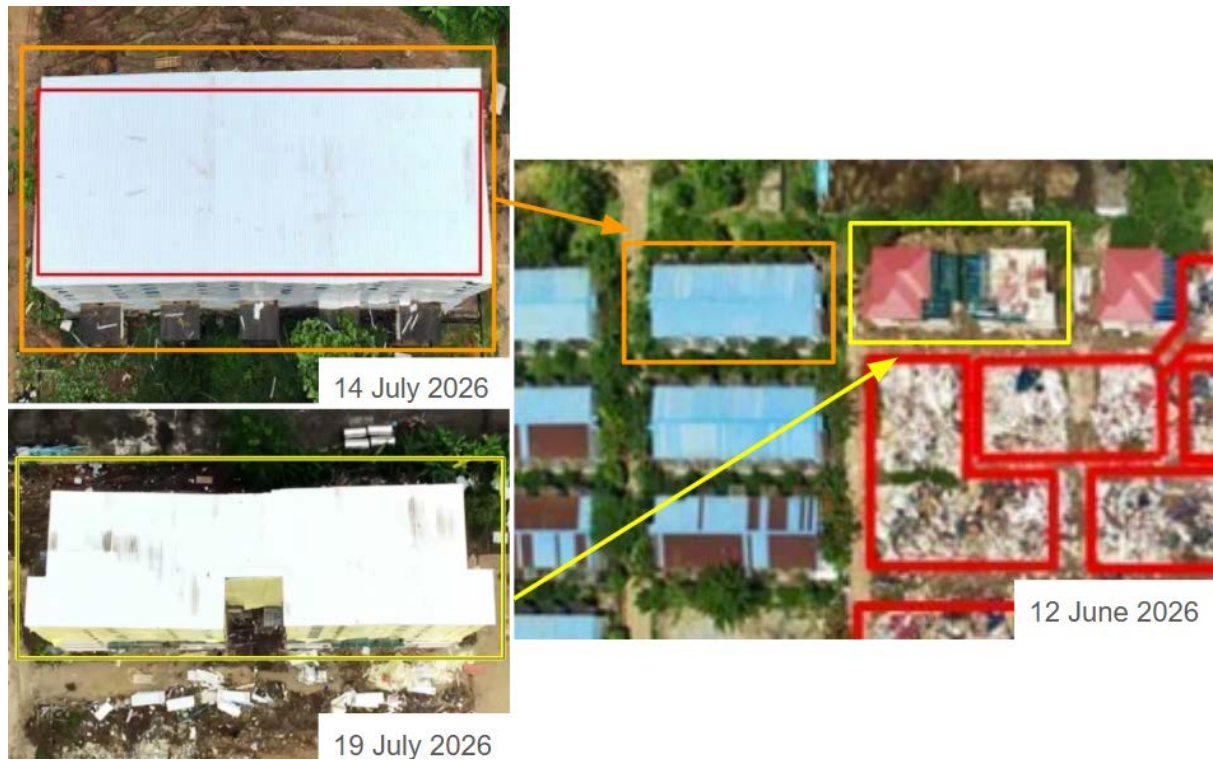
On [14 July](#) 2026 and [19 July](#) 2026, additional buildings were reported to be higher than the geolocated structures. The first structure was reported as a 12-storey building, but again appears to be much lower according to satellite imagery. The second was also reported as a 12-storey building, but in fact it was geolocated to two separate three-storey buildings.

Figure 11: [Top Left] Image of the 14 July 2026 building showing no roof and a taller build [16.820846, 98.538977] (source: [妙瓦底论坛](#) | [妙瓦底新闻](#) | [亚太新闻](#) | [缅甸新闻](#)); [Bottom Left] Image of the 19 July 2026 building showing a taller build [16.821149, 98.538964] (source: [MRTV](#)); [Right] Zoomed-in imagery of the two buildings showing original roofs from 12 June 2026 (source: [妙瓦底论坛](#) | [妙瓦底新闻](#) | [亚太新闻](#) | [缅甸新闻](#)).

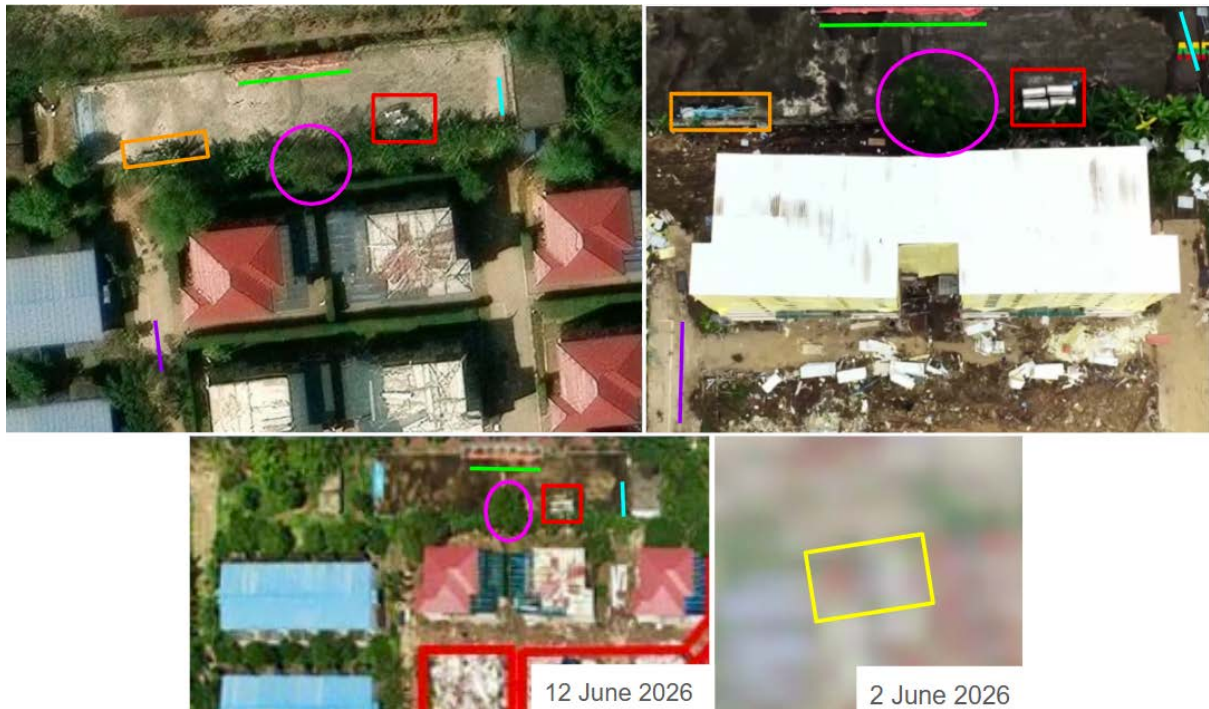
The [19 July](#) 2026 demolition is one of the clearest examples of this type of discrepancy. There was very little information shown around the location in the demolition footage, including nearby buildings. Importantly, state footage depicted the site as one tall singular building, but Myanmar Witness's geolocated imagery identified it as two separate buildings, with a much lower profile. Sentinel 2 imagery dated 2 June 2026 supports this and shows that the two structures were clearly distinct at that time (figure 12).

Figure 12: Geolocation of the 19 July 2026 building [16.821149, 98.538964]; [Top Right] Image of the 19 July 2026 building (source: [MRTV](#)); [Top Left] Satellite imagery showing the geolocation work [source: © Apple Maps, 2026, Maxar Technologies]; [Bottom Left] Zoomed-in imagery of the geolocated location from 12 June 2026 (source: [妙瓦底论坛](#) | [妙瓦底新闻](#) | [亚太新闻](#) | [缅甸新闻](#)); [Bottom Right] Sentinel-2 imagery showing original rooftops for both buildings on 2 June 2026 (source: [Sentinel-2](#)).

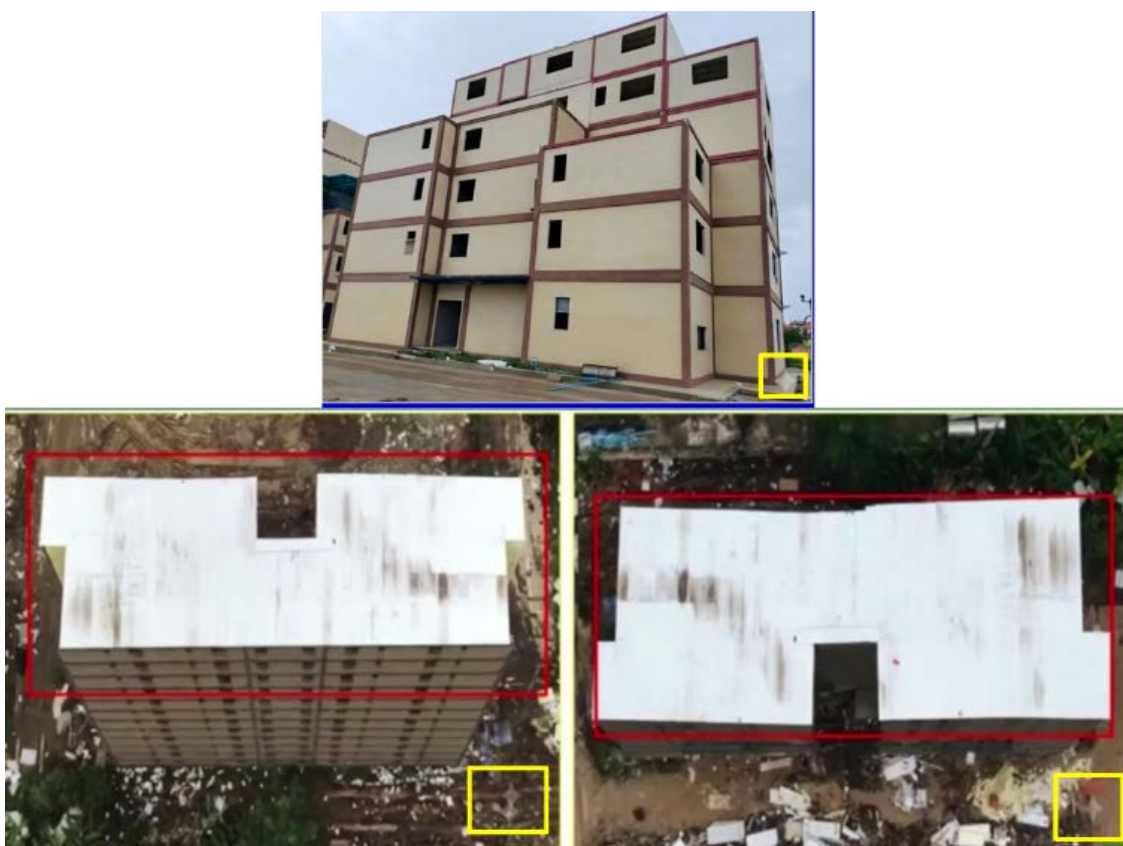
The state media also shared images that showed signs of AI manipulation (figure 13). Three images, connected to the [8 July](#) and [19 July](#) 2026 demolitions, in fact displayed a Gemini watermark and also tested positive for Google's SynthID. SynthID is essentially an invisible watermark embedded by AI image tools, from providers including Google and OpenAI, to indicate that an image was altered or generated by AI. Four additional images from three separate demolition days were also tested for AI use because they stood out as too tall compared to what was observed in satellite imagery, or the surroundings appeared potentially off in some way. All four images tested positive for SynthID.

Figure 13: [Top] Image showing the 8 July 2026 building with a yellow box highlighting the Gemini watermark [16.814752, 98.546393] (source: [Ministry of Information](#)); [Bottom] Two images showing the 19 July 2026 building with yellow boxes highlighting the Gemini watermark [16.821149, 98.538964] (source: [MRTV](#)).

Taken together, these findings suggest that the state made some effort to alter visual material used to present the Shwe Kokko crackdown before publication. So while the evidence shows these alterations, it is difficult to determine the exact reason or intent behind these observed discrepancies.
