## AIRSTRIKE IN KYAUKTAW, RAKHINE STATE

Expanded Verification Assessment and Analysis of Damage  
and Civilian Impact

2 October 2026

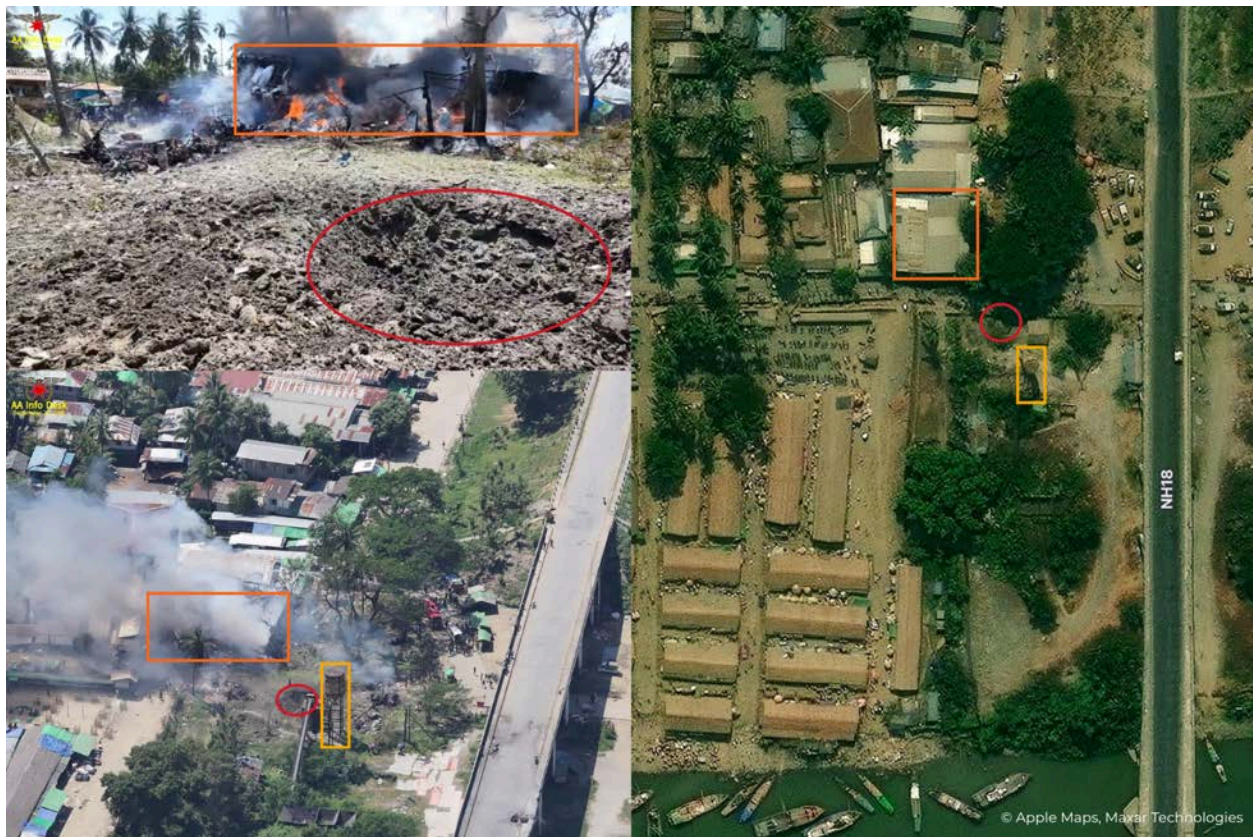
Myanmar Witness geolocated the incident by cross-referencing different satellite imagery, including Google Earth Pro, Planet and Sentinel, to near Kacchappanadi Bridge and India Market (according to Google Maps labels) at [20.833724, 92.984405], Kyauktaw Town, Kyauk Taw Township, Rakhine State. Historical satellite imagery shows frequent visible crowding in the area and supports the assessment that the incident occurred in a civilian and commercial area (figure 2).

Figure 2: The geolocation of the crater and burning location at [20.833729, 92.983821] (Source: [Left] AA Info Desk, removed due to graphic concerns, [Right] Apple Maps)

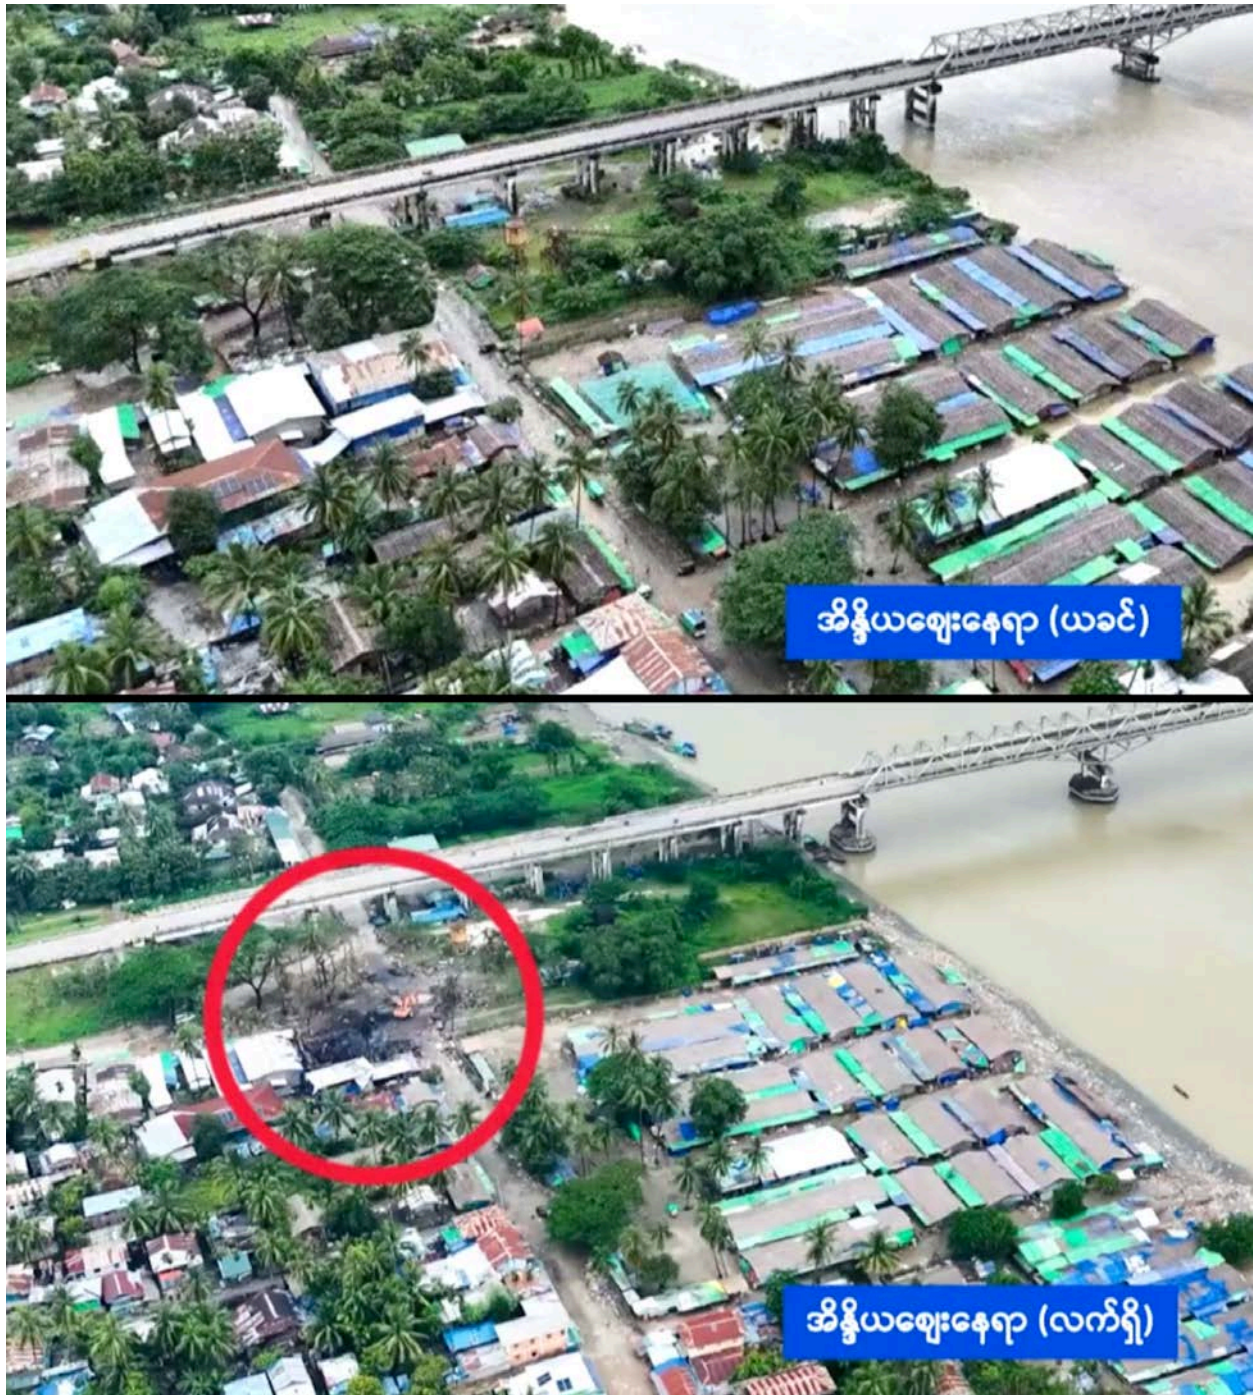
Figure 3: AA Info Desk released an image highlighting the incident area with before-and-after images [20.833729, 92.983821] (Source removed due to graphic concerns)

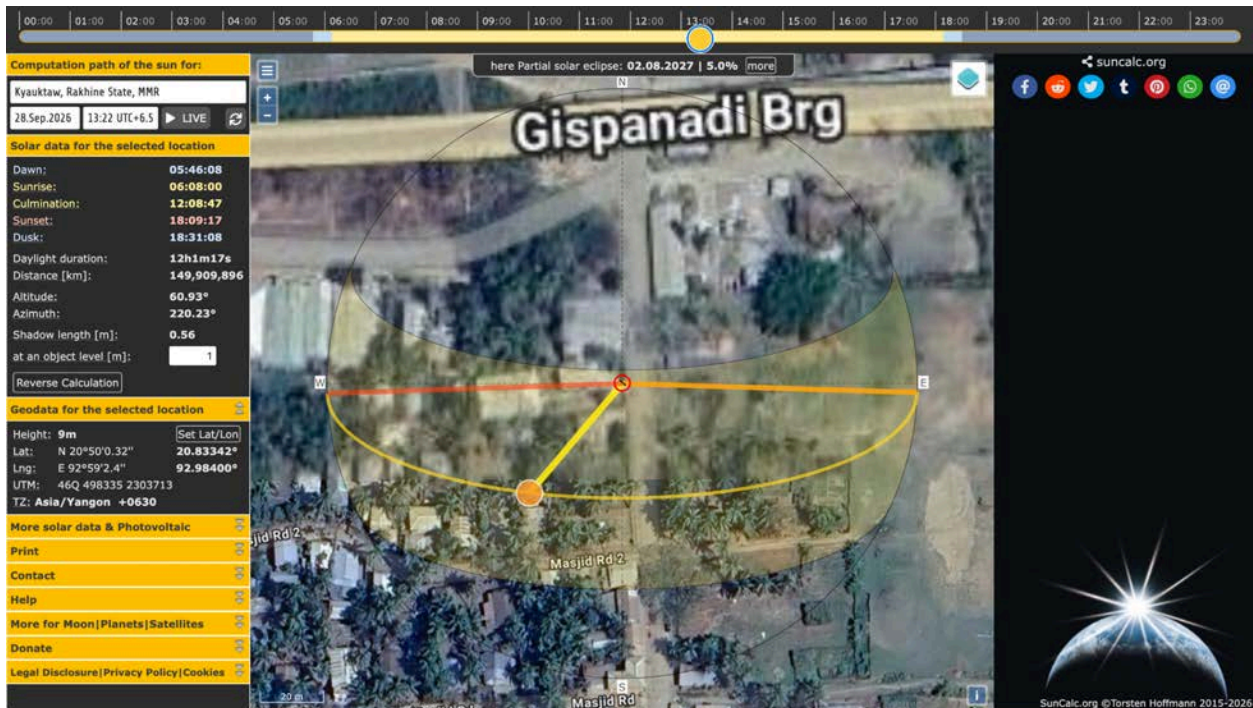
The direction of the shadows, using SunCalc, suggests that if the image was captured at the geolocated location on 28 September 2026, it was likely recorded between approximately 12:42 and 13:22 local time (figure 5). This estimation is later than the initial 12:10-12:14 local time reported for the strikes. This difference could be down to uncertainty in the shadow analysis or because the image was taken after the strikes; therefore Myanmar Witness does not treat this analysis as a final confirmation of the incident date or exact time.

Figure 5: Shadow-based chronolocation assessment using SunCalc. The satellite view is SunCalc's map basemap, used to model expected shadow direction; it is not incident satellite imagery. (Source: [Top] [SunCalc](#) (12:42) [Bottom] [SunCalc](#) (13:22))

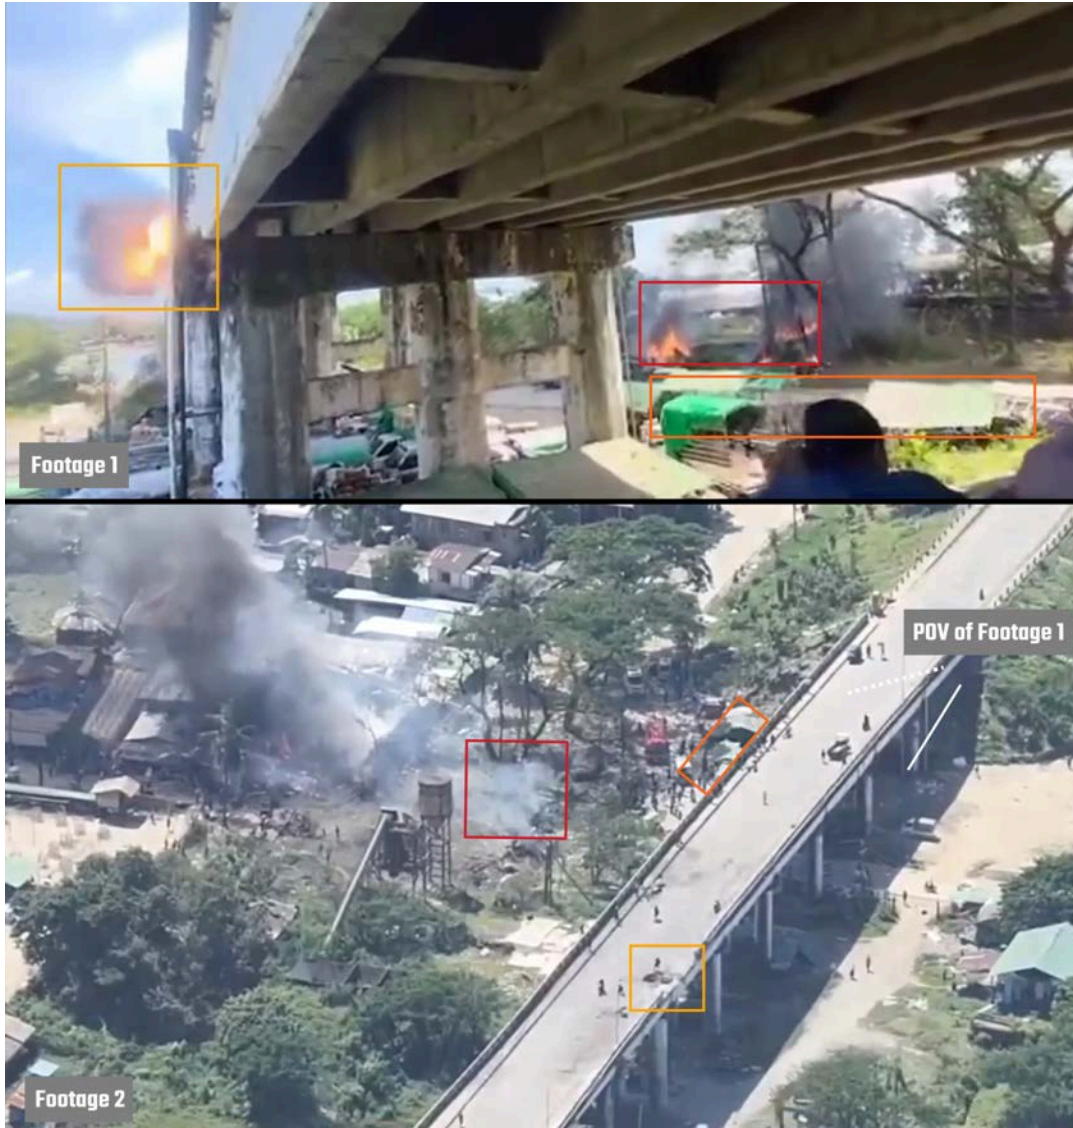
On 30 September 2026, a freelance journalist posted a video described as real-time footage of the incident showing civilians hiding under a bridge after the first bomb allegedly dropped (source removed due to privacy concerns). The video then shows a second explosion on the bridge at approximately 0:12, as referenced in its timestamp (figure 6).

Myanmar Witness's weapons specialist analysed the video to assess whether the incident was consistent with an airstrike. Myanmar Witness assessed both the sound and visual evidence of the explosion, as well as the scale of the blast, as consistent with a heavy-weapon impact.

Figure 6: [Top] UGC shows an explosion caused by a reported airstrike on the bridge. [Bottom] Aerial view of the explosion (Source removed due to graphic concerns).

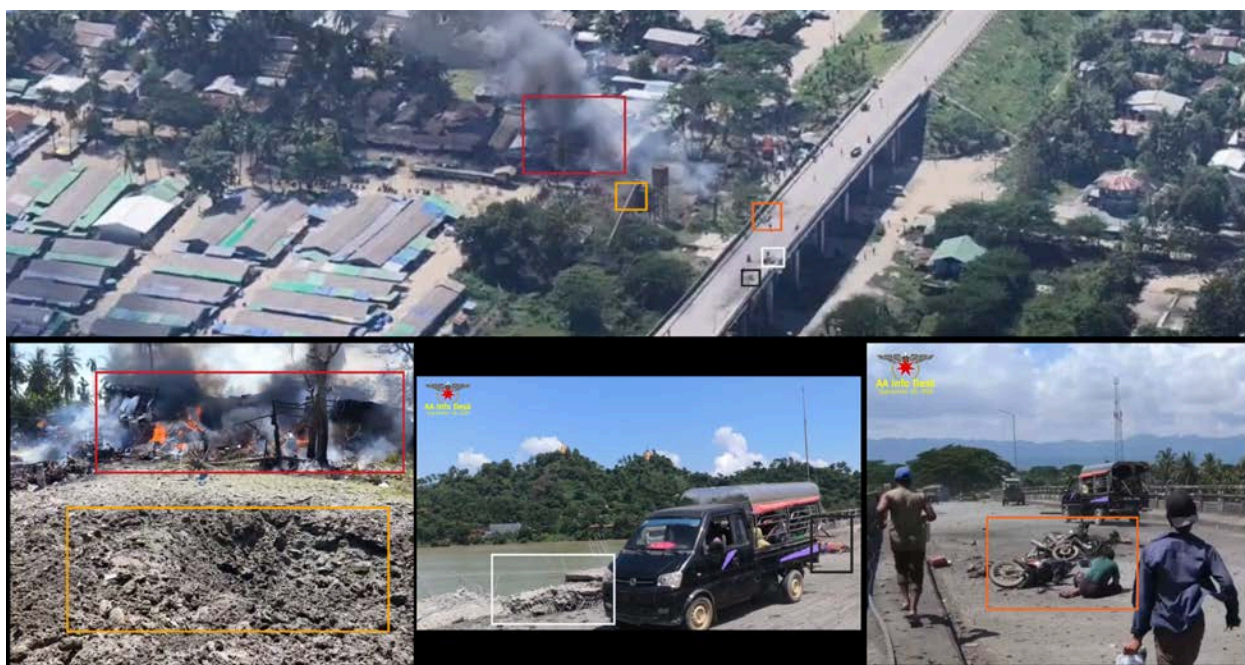
Footage published by AA Info Desk also shows a nearby crater on the bridge and damage that Myanmar Witness observes to be consistent with a heavy-weapon impact (figure 7). While the footage does not provide definitive attribution of the cause of the individuals' deaths, the proximity of each body to the impact damage is consistent with their having been killed or injured in an airstrike.

Figure 7: Geolocation of casualties and damage on Kacchapnadi Bridge, burning location nearby, and a crater visible (Source removed due to graphic concerns)

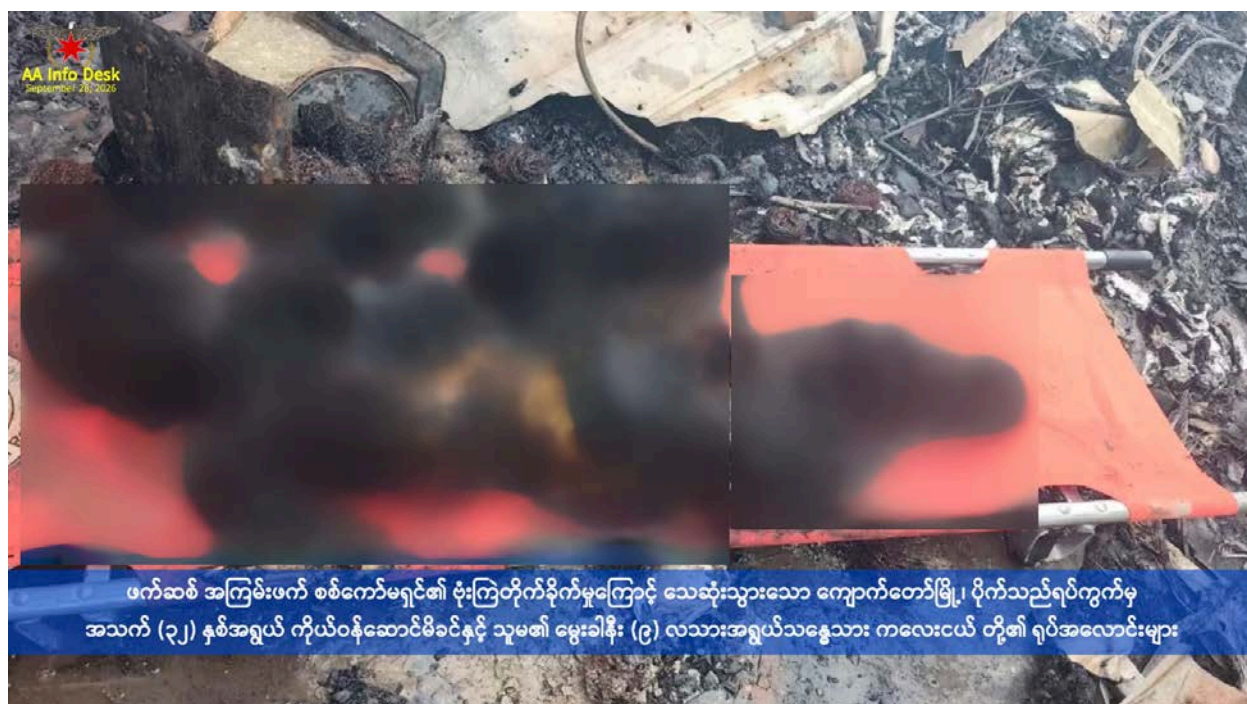
Myanmar Witness also analysed an image published by Than Lwin Khet News that reportedly relates to the aftermath of the incident (figure 8) (source removed due to graphic concerns). The image depicts two severely burnt sets of human remains: one

apparently adult-sized, and the other much smaller. However, due to the extent of thermal damage on the corpses, Myanmar Witness could not independently determine the sex, ages or relationship and precise cause of death.

Than Lwin Khet News reported that the image was showing a 32-year-old woman who was nine months pregnant, and a newborn allegedly delivered when a fire had broken out (source removed due to graphic concerns). Notably, Myanmar Witness could not verify these specific details from the image alone. However, the visible fire damage is consistent with the broader reports that fires occurred following the reported strike.

Figure 8: AA Info Desk released image of an alleged 32-year-old pregnant woman with a newborn's corpse (Source: removed due to graphic concerns)
